## **APPENDIX A**

### **SECTION 19 REPORT – ARNOLD – JUNE 19**

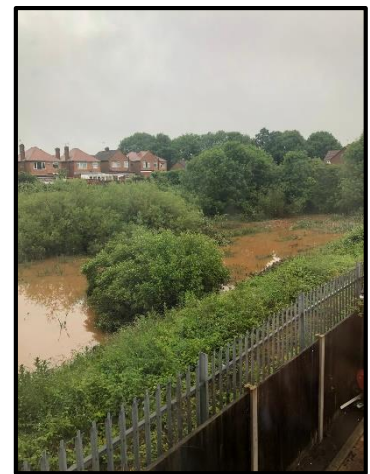
On the evening of the 12<sup>th</sup> of June, the attenuation area was already at full capacity following the previous days rainfall (see photo adjacent). The storage area then broke its bank allowing the excess surface water to run overland, eventually finding a natural valley along the rear gardens of Bentwell Avenue. This channelled the water downstream at a gradually increasing rate causing extensive damage along its path. The water was following a natural route described on page 4.

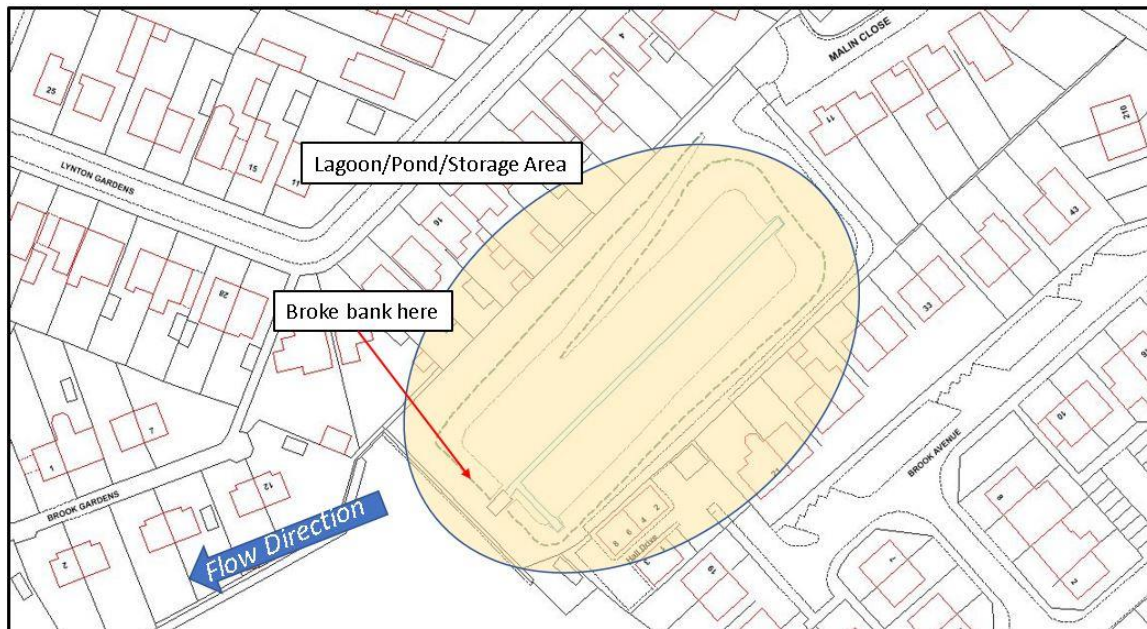
Figure 2. Plan showing location of storage attenuation area

Figure 2 is a plan showing a surface water attenuation area situated between Malin Close to the North East and Brook Gardens to the South West. Immediately to the South of the attenuation area is the Rolleston Drive Highway Depot. The attenuation area is maintained by GBC with a STW surface water sewer permitted to flow into and out of it. When functioning correctly the attenuation area collects water from the STW surface water network upstream and discharges that water back into the STW surface water network downstream but at a controlled rate.

- 10. GBC and STW will carry out a joint investigation into how the pond operated during the flood event.

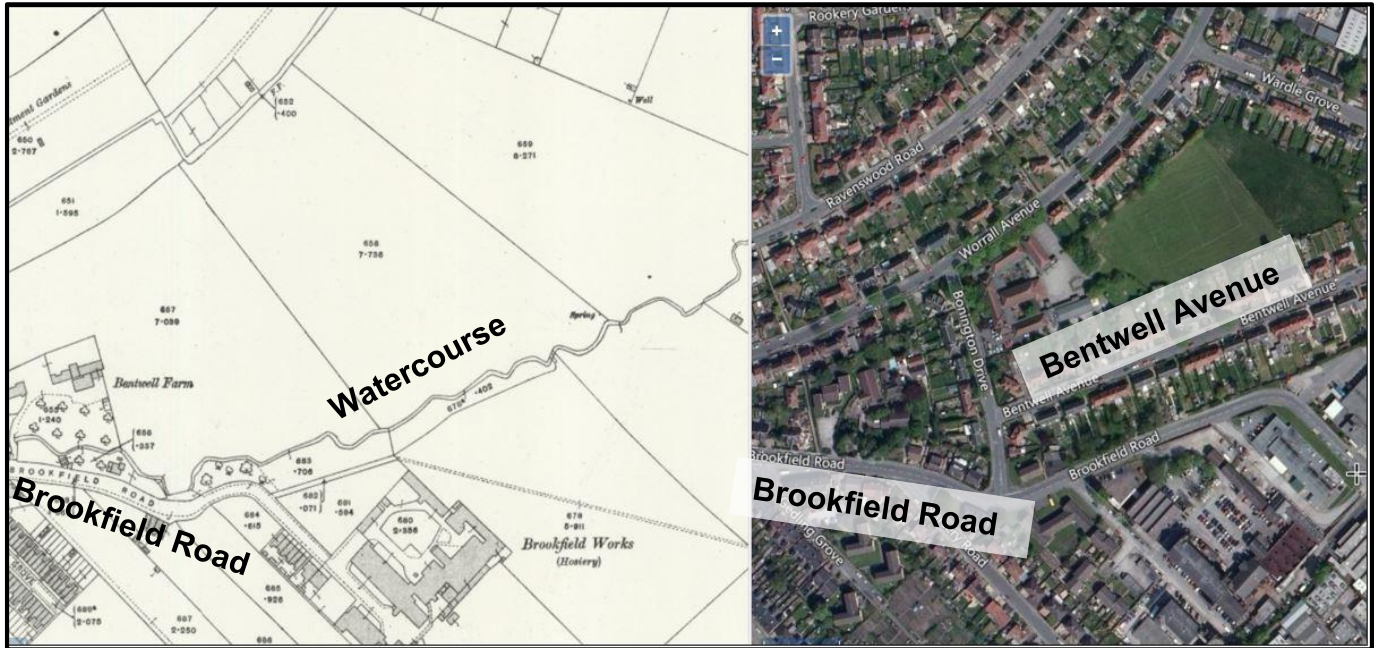
Figure 3. Historic map showing line of original watercourse.

Figure 3 has to the left an historic map which shows the line of the original watercourse meandering towards Brookfield Road, and the aerial photo to the right clearly shows that now Brook Gardens and Bentwell Avenue are on that historic route. This area of Arnold has flooded along this route on a number of occasions with previous documented events in 1998, 1999, 2006, 2010 and 2013.

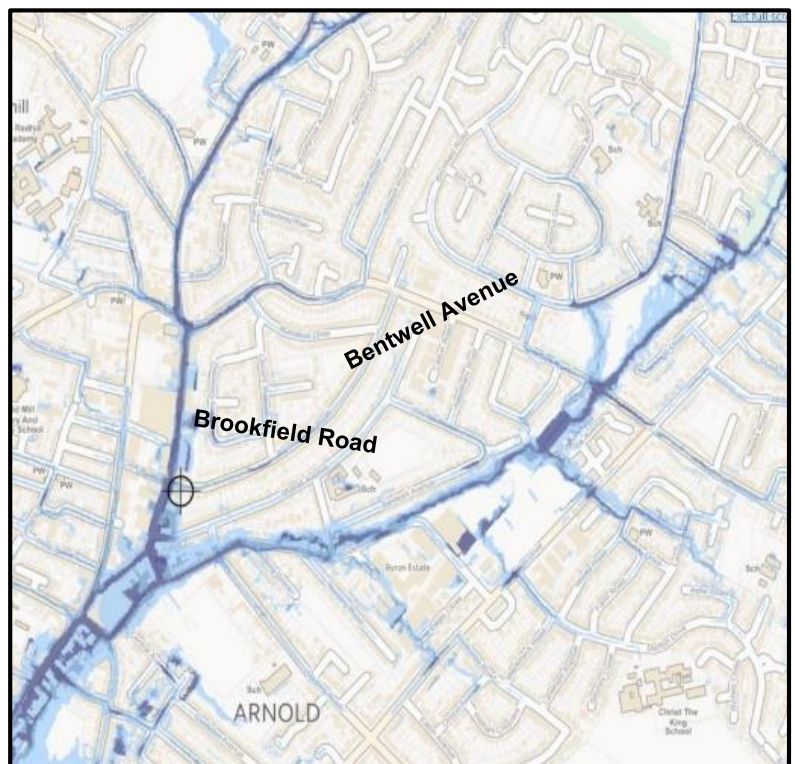
Figure 4. Surface Water Flood Map

This observation is illustrated further by Figure 4 the surface water map of the area provided by The Environment Agency which shows predicted flow routes during periods of heavy rain. As you can see the flow route follows the line of the historical water course now Bentwell Avenue and other residential areas.

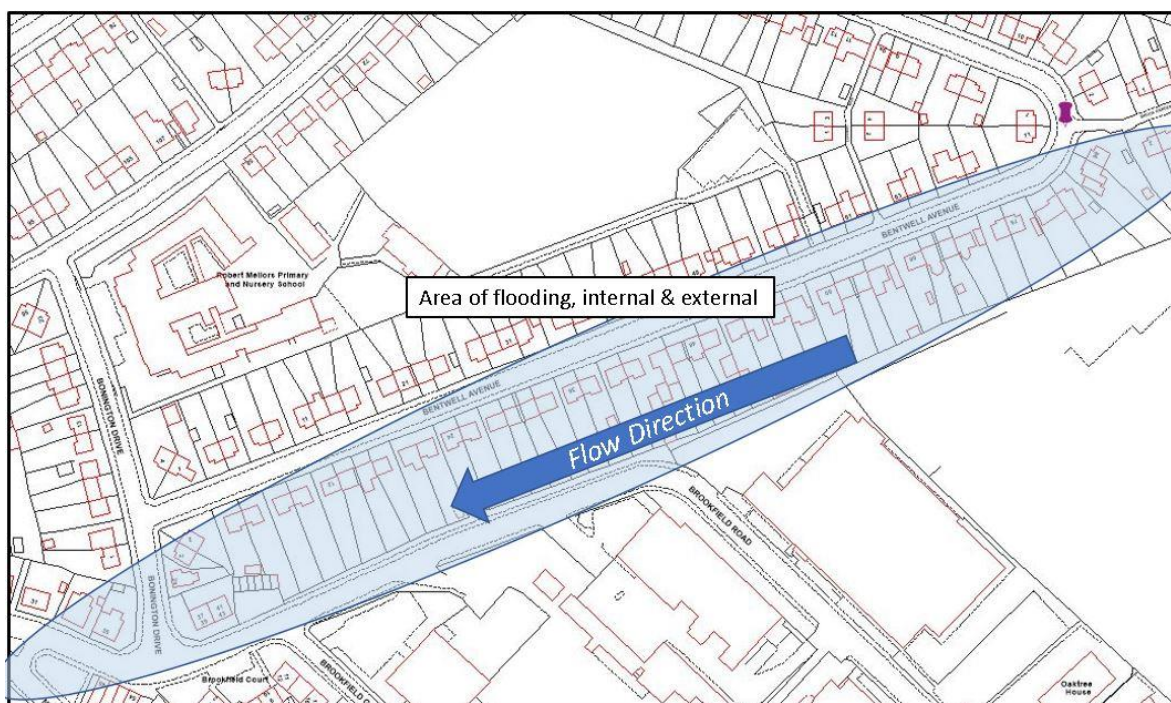
Fig 5. Bentwell Avenue and surrounding area.

Once the water in the storage attenuation area had broken bank it began to flow along the route shown in figure 5, channeling the water through rear gardens and into some houses along Brook Gardens, Bentwell Avenue and Bonnington Drive. At some points the water depth was observed to be up to 4ft in depth.

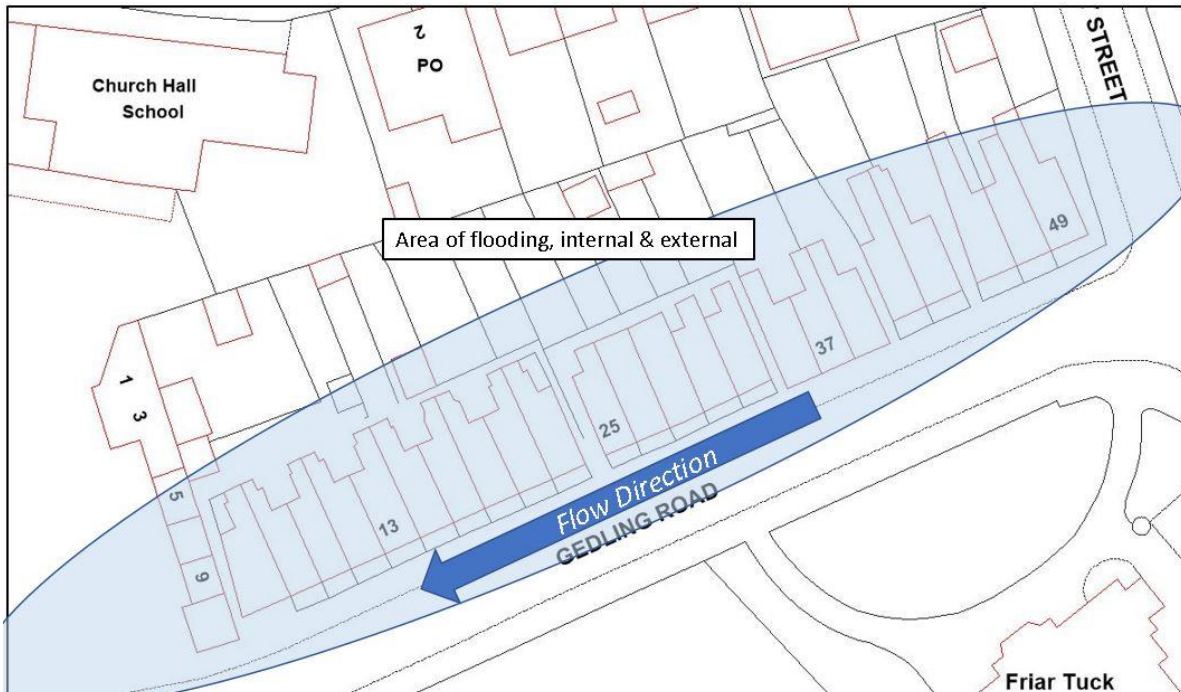
Fig 6. Gedling Road and surrounding area.

Using Brookfield Road as a channel the water continued to flow along Gedling Road and along the frontages of the terrace houses, shown in figure 6. The water was of sufficient depth at this point to enter some of these houses through the front doors. The photo between Figures 4 and 5 above shows damage to slabs along a raised sloping bank, indicating flow depth.

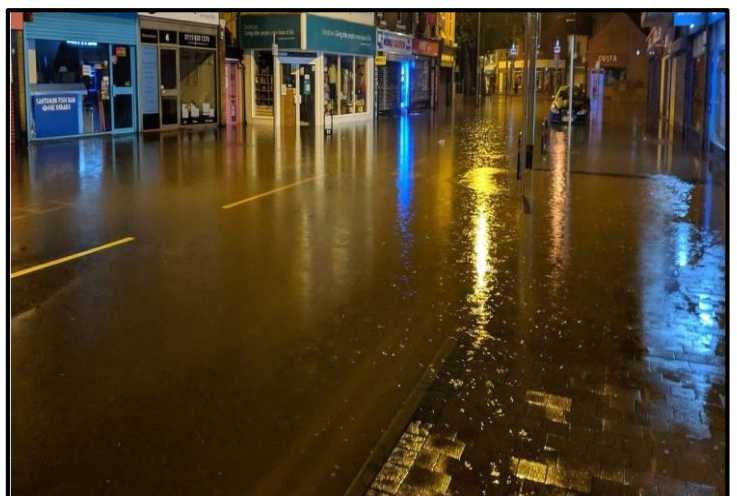
The lower end of Front Street and the Market Place are at the bottom of an urbanised natural valley, so flood water flowed to this point, ponded and flooded a number of businesses. The adjacent photo looks down at the flooding on Lower Front Street and the Market Place.

Evidence suggests that surface water flowed from upper Front Street using the road as a channel, the road was closed to traffic over night for safety.

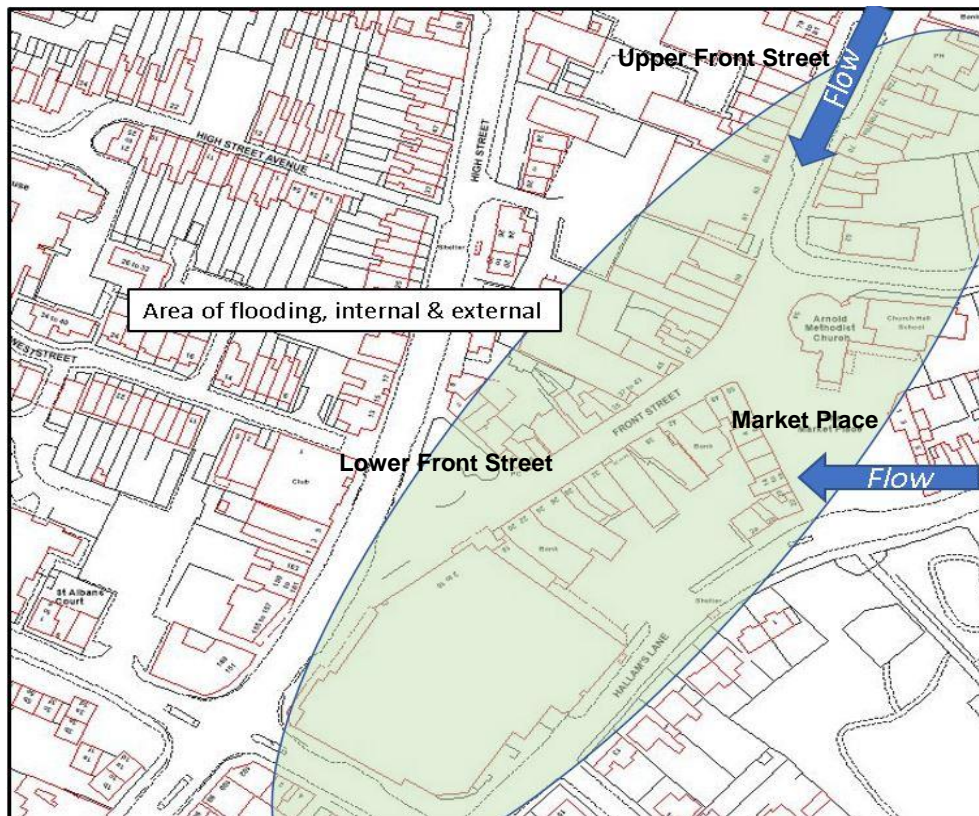
The flow route mentioned previously also channeled water towards the Market Place where it collected with water from Front Street adding to the flooded area.

The Highway Drainage at this low point is not designed to cope with this amount of water so was simply overwhelmed and could not drain to the Surface Water Sewer quickly enough. The water simply had nowhere to go until the rain began to subside, it was then observed to clear quite quickly.

NCC and STW will look at how the Highway Drainage system works with the Public Sewer system at the Front Street and Market Place area.
