Asbestos Inspection Report

P-338178 - Targeted Refurbishment Survey

01134 : Intake Farm Primary School

Survey date : 4-Jul-2019

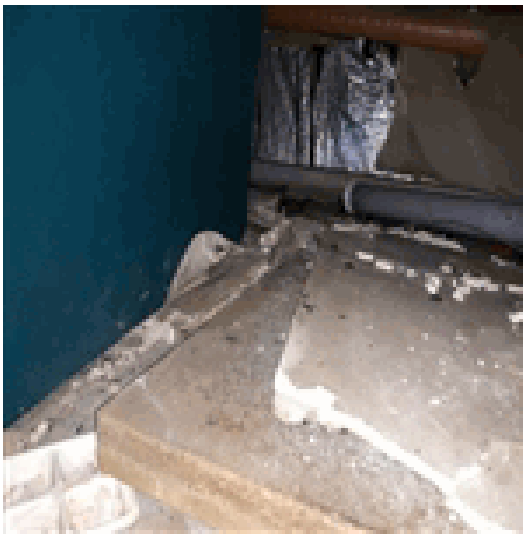
Reference	293	Sample number	01134-02-005-EE002
Survey date	4-Jul-19	Presumed	No
Building :	02 00 Nursery & Store		
Floor		Room	005 Dis WC
Location	Debris within roof void		
Quantity sampled	12 m2	Use	Asbestos Insulating Board

Product type	Asb-Reinfd comps, etc (see Use) (1)
Damage/deterioration	Good-no damage (0)
Surface treatment	Composite materials (0)
Asbestos type	Not asbestos (0)

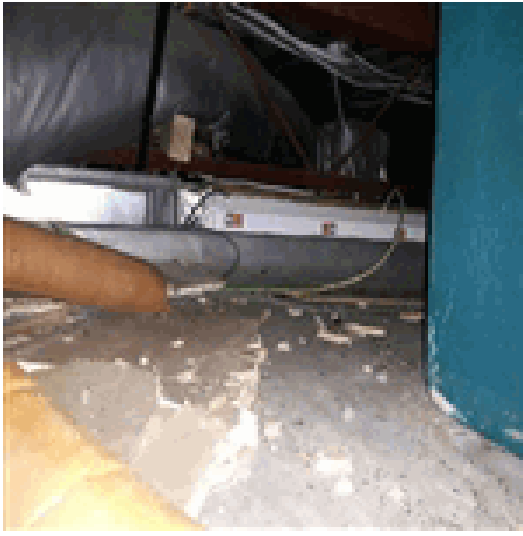
Reference	294	Sample number	01134-02-005-EEP001
Survey date	4-Jul-19	Presumed	No
Building :	02 00 Nursery & Store		
Floor		Room	005 Dis WC
Location	Panels to wall edges		
Quantity sampled	6 m2	Use	Asbestos Insulating Board

Product type	AIB, Textiles, Rope, etc (see Use) (2)
Damage/deterioration	Low damage (1)
Surface treatment	Enc Lagging & Sprays, AIB, etc (1)
Asbestos type	Crocidolite (3)

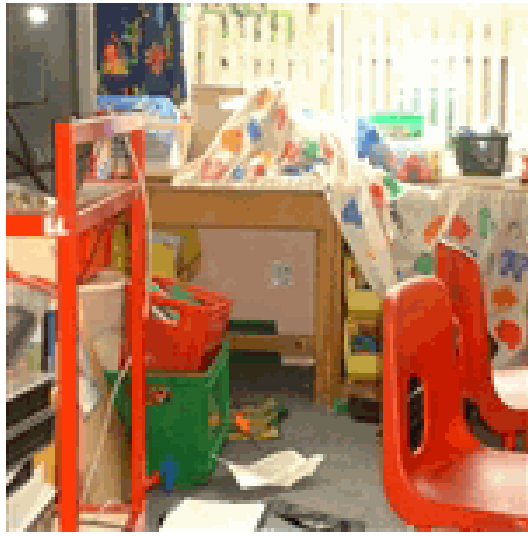
Reference	118	Sample number	01134-01-24-01
Survey date	20-May-19	Presumed	No
Building :	01 00 Main School Building		
Floor		Room	024 Classroom
Location	PANEL BELOW WINDOWS		
Quantity sampled	10 X 1M2	Use	Asbestos Insulating Board

Product type AIB, Textiles, Rope, etc (see Use) (2)
Damage/deterioration Low damage (1)
Surface treatment Enc Lagging & Sprays, AIB, etc (1)
Asbestos type Amphibole ex. Crocidolite (2)

A number of panels have either been replaced or encapsulated with timber.

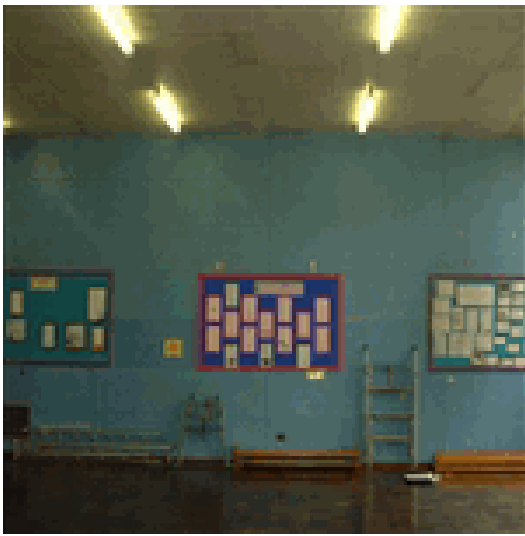
Reference	124	Sample number	01134-01-21-01
Survey date	20-May-19	Presumed	No
Building :	01 00 Main School Building		
Floor	G	Room	021 Hall
Location	WALLS	Use	
Quantity sampled	100M2

Product type	AIB, Textiles, Rope, etc (see Use) (2)
Damage/deterioration	Low damage (1)
Surface treatment	Enc Lagging & Sprays, AIB, etc (1)
Asbestos type	Amphibole ex. Crocidolite (2)

Asbestos insulation board present to walls from floor to ceiling, including storage area. Cracking of plaster skim by the wall between Rms 21 and 11. Damaged asbestos in this area has been sealed previously. (Mar 2016 - this area has been over boarded with mdf). There are signs of deterioration in one plaster skimmed panel above rooms 30/33/34.

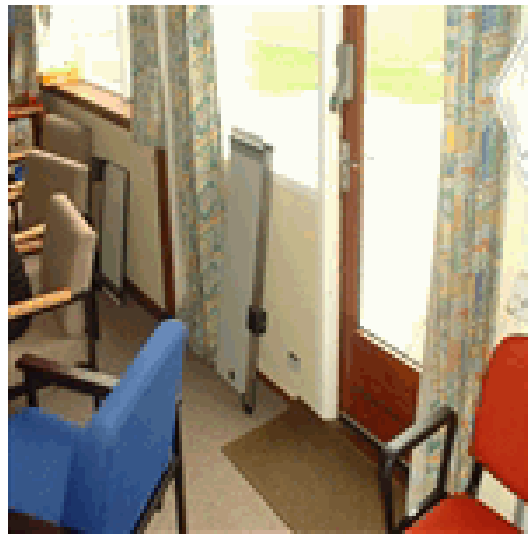
Reference	138	Sample number	01134-01-15-01
Survey date	20-May-19	Presumed	No
Building :	01 00 Main School Building	Room	015 Staff Room
Floor			
Location	PANEL BELOW WINDOW	Use	Asbestos Insulating Board
Quantity sampled	4M2		
Material assessment			
Product type	AIB, Textiles, Rope, etc(see Use) (2)		
Damage/deterioration	Good condition (0)		
Surface treatment	Enc Lagging&Sprays,AIB,etc (1)		
Asbestos type	Amphibole ex. Crocidolite (2)		
Priority assessment			
Type of activity	Low disturbance activity (1)		
Location	Rooms up to 100m2 (2)		
Accessibility	Occasionally disturbed (1)		
Extent	<10m2 or 10m pipe run (1)		
Occupants using space	4 to 10 (2)		
Frequency of use	Daily (3)		
Average time of use	<1 hour (0)		
Type of maintenance	Low disturbance (1)		
Frequency of maintenance	<1 per year (1)		
		Material score	5
		Priority score	5
		Banding	Removed

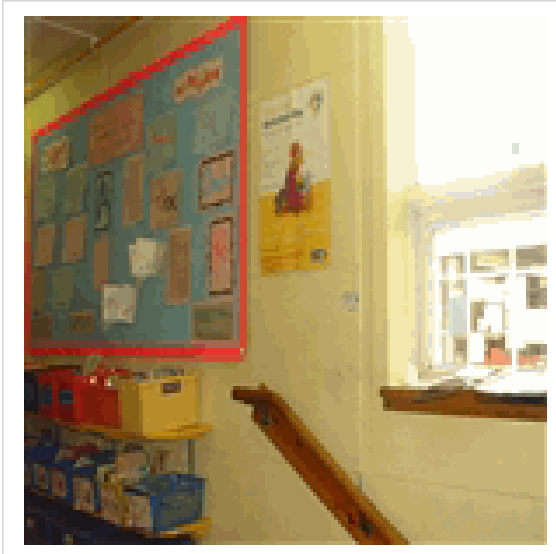
Reference	141	Sample number	01134-01-13-01
Survey date	20-May-19	Presumed	No
Building :	01 00 Main School Building		
Floor		Room	013 Circulation
Location		Use	
Quantity sampled	35M2		
Material assessment			
Product type	AIB, Textiles, Rope, etc (see Use) (2)		
Damage/deterioration	Low damage (1)		
Surface treatment	Enc Lagging & Sprays, AIB, etc (1)		
Asbestos type	Amphibole ex. Crocidolite (2)		
Priority assessment			
Type of activity	Low disturbance activity (1)		
Location	Rooms up to 100m2 (2)		
Accessibility	Occasionally disturbed (1)		
Extent	>10m2 to <50m2 or >10m to <50m (2)		
Occupants using space	1 to 3 (1)		
Frequency of use	Daily (3)		
Average time of use	<1 hour (0)		
Type of maintenance	Low disturbance (1)		
Frequency of maintenance	<1 per year (1)		
		Material score	6
		Priority score	5
		Banding	Low

Restrict Access

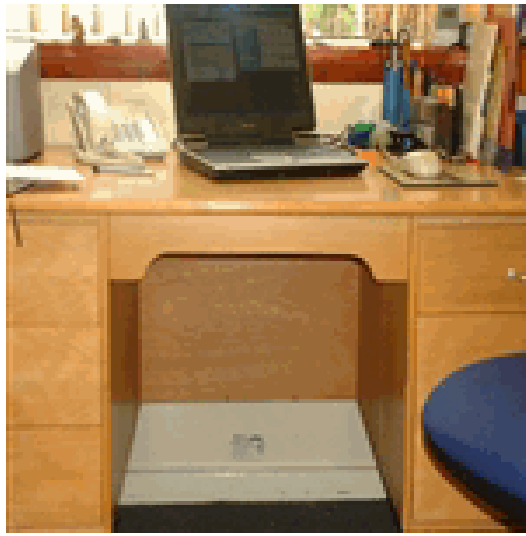
Reference	147	Sample number	01134-01-08-01
Survey date	20-May-19	Presumed	No
Building :	01 00 Main School Building		
Floor		Room	008 Office
Location	PANEL BELOW WINDOW		
Quantity sampled	2M2	Use	Asbestos Insulating Board

Product type AIB, Textiles, Rope, etc (see Use) (2)
Damage/deterioration Good condition (0)
Surface treatment Enc Lagging & Sprays, AIB, etc (1)
Asbestos type Amphibole ex. Crocidolite (2)

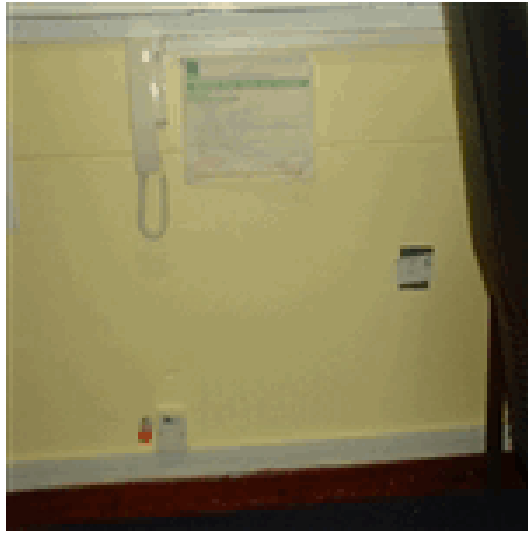
Reference	149	Sample number	01134-01-07-01
Survey date	20-May-19	Presumed	No
Building :	01 00 Main School Building		
Floor		Room	007 Office
Location	REAR WALL BELOW WINDOW		
Quantity sampled	2M2	Use	Asbestos Insulating Board

Product type	AIB, Textiles, Rope, etc (see Use) (2)
Damage/deterioration	Good condition (0)
Surface treatment	Unsealed AIB, enc Lagging & Spray (2)
Asbestos type	Amphibole ex. Crocidolite (2)

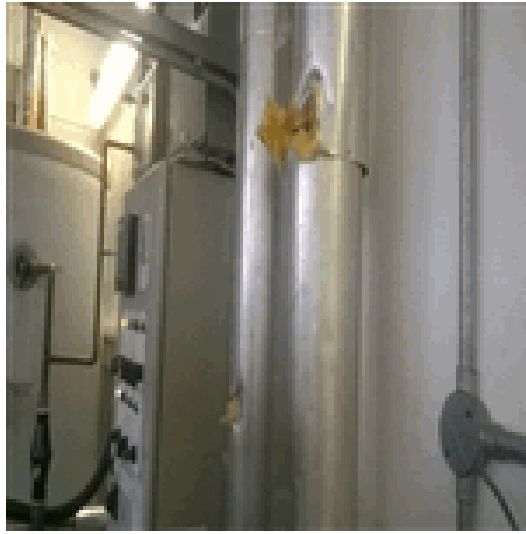
Reference	197	Sample number	01134-01-26-HO000623
Survey date	20-May-19	Presumed	No
Building :	01 00 Main School Building		
Floor		Room	26 Boiler Room
Location			
Quantity sampled	13 m	Use	Debris

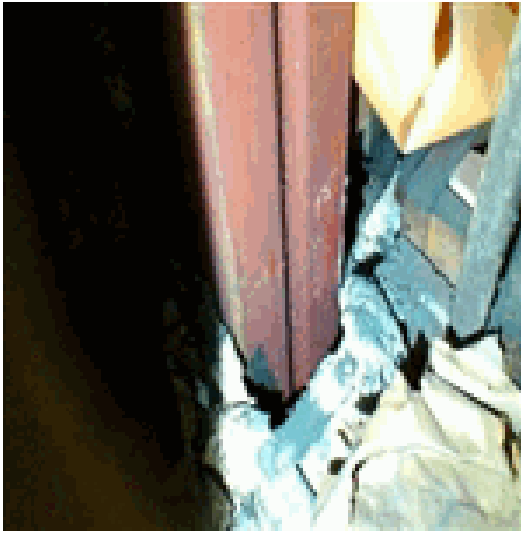
Reference	255	Sample number	01134-01-011-EEX004
Survey date	20-May-19	Presumed	No
Building :	01 00 Main School Building		
Floor	G	Room	011 Dining
Location	Columns - Impregnated bitumen pa		
Quantity sampled	8 Approx Number	Use	Bitumen products

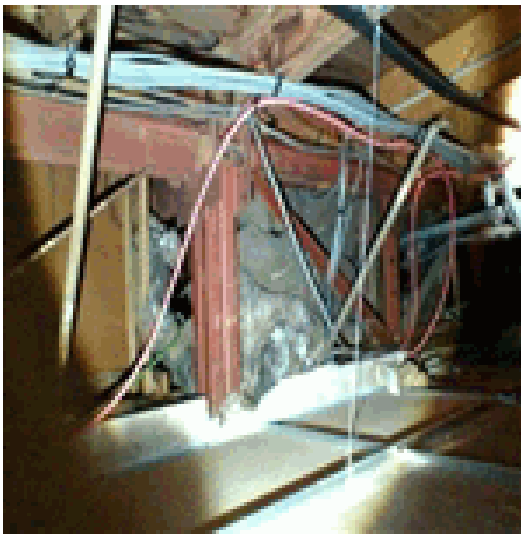
Reference	256	Sample number	01134-01-011-EEX007
Survey date	20-May-19	Presumed	No
Building :	01 00 Main School Building		
Floor	G	Room	011 Dining
Location	Ceiling void - String ties to MMMF f		
Quantity sampled	4 m linear	Use	Cloth

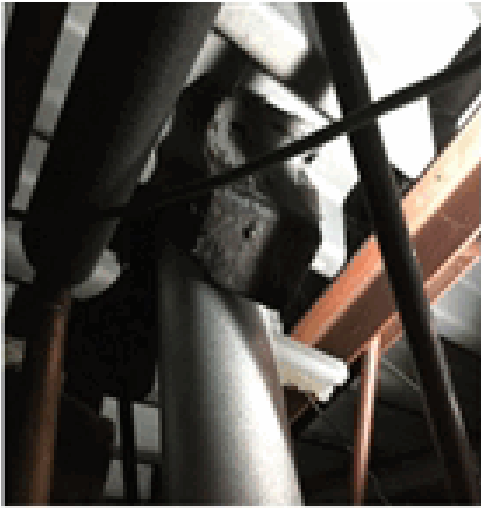
Reference	221	Sample number	01134-02-01-02
Survey date	20-May-19	Presumed	No
Building :	02 00 Nursery & Store		
Floor		Room	001 Nursery
Location		Use	Bitumen products
Quantity sampled	1m2		
Material assessment			
Product type	()		
Damage/deterioration	()		
Surface treatment	()		
Asbestos type	Not asbestos (0)

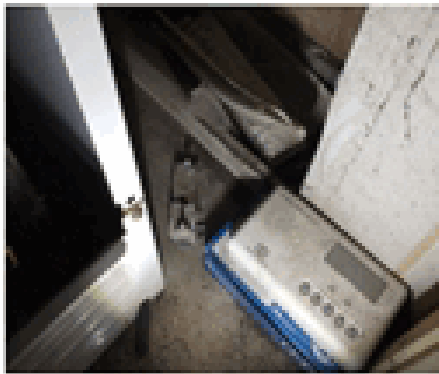
Reference	222	Sample number	01134-02-06-03
Survey date	20-May-19	Presumed	No
Building :	02 00 Nursery & Store		
Floor		Room	006 Storage
Location		Use	Asbestos Insulating Board
Quantity sampled	1m2		
Material assessment			
Product type	AIB, Textiles, Rope, etc (see Use) (2)		
Damage/deterioration	High damage (3)		
Surface treatment	Unsealed AIB, enc Lagging & Spray (2)		
Asbestos type	Amphibole ex. Crocidolite (2)

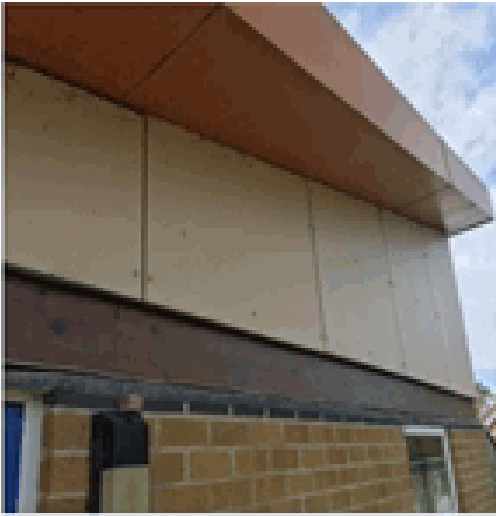
Reference	291	Sample number	01134-03-00-01
Survey date	20-May-19	Presumed	No
Building :	03 00 New Classroom		
Floor		Room	000 External/Fixtures
Location		Use	Cement
Quantity sampled	50m2		Semi-compressed sheets
Material assessment			
Product type	()		
Damage/deterioration	()		
Surface treatment	()		
Asbestos type	Not asbestos (0)

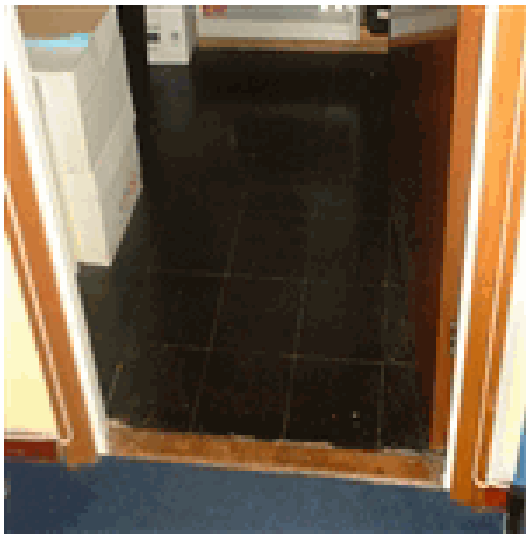
Reference	87	Sample number	01134-50-05-01
Survey date	20-May-19	Presumed	No
Building :	50 00 Catering Services		
Floor		Room	005 Staff WC
Location	W.C FLOOR	Use	Flooring
Quantity sampled	2M2		
Material assessment			
Product type	Asb-Reinfd comps,etc (see Use) (1)		
Damage/deterioration	Good condition (0)		
Surface treatment	Composite materials (0)		
Asbestos type	Chrysotile (1)

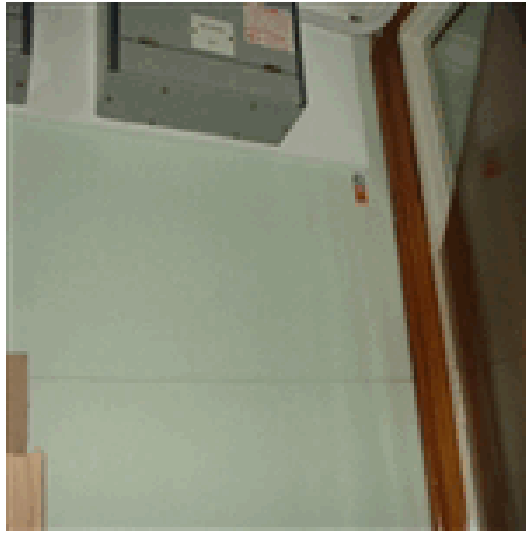
Reference	92	Sample number	01134-50-02-01
Survey date	20-May-19	Presumed	No
Building :	50 00 Catering Services		
Floor		Room	002 Storage
Location	STORE INTERNAL PARTITION WA		
Quantity sampled	2M2	Use	Asbestos Insulating Board

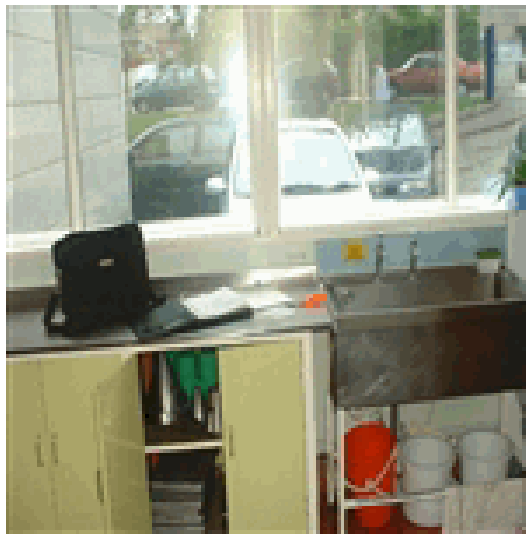
Reference	93	Sample number	01134-50-01-02
Survey date	20-May-19	Presumed	No
Building :	50 00 Catering Services		
Floor	G	Room	001 Kitchen
Location	KITCHEN PANEL BELOW WINDOW		
Quantity sampled	3M2	Use	Asbestos Insulating Board

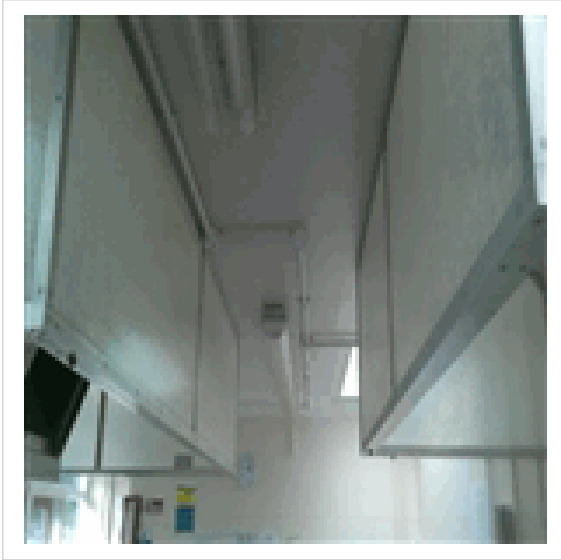
Reference	212	Sample number	01134-50-01-BR001087
Survey date	20-May-19	Presumed	No
Building :	50 00 Catering Services		
Floor	G	Room	001 Kitchen
Location	Insulating board to ceiling		
Quantity sampled	50 m2	Use	No asbestos detected

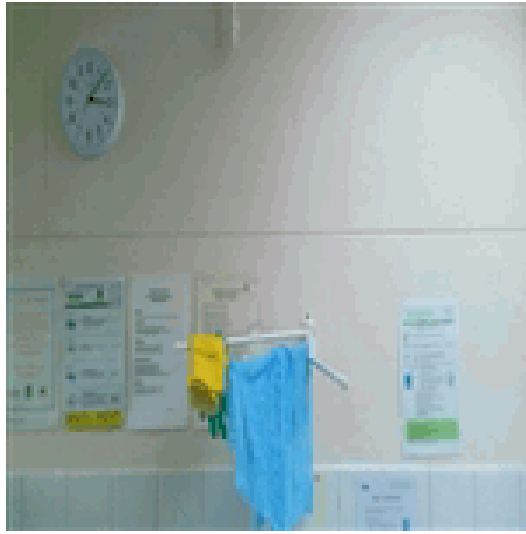
Reference	213	Sample number	01134-50-01-BR001088
Survey date	20-May-19	Presumed	No
Building :	50 00 Catering Services		
Floor	G	Room	001 Kitchen
Location	Insulating board panels to dividing		
Quantity sampled	9 m2	Use

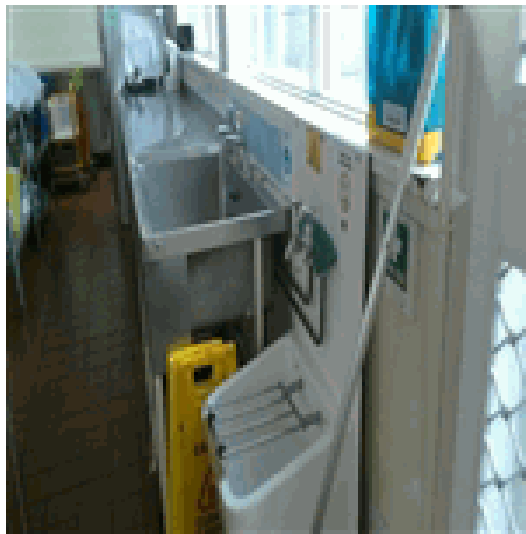
Reference	214	Sample number	01134-50-01-BR001089
Survey date	20-May-19	Presumed	No
Building :	50 00 Catering Services		
Floor	G	Room	001 Kitchen
Location	Insulating board panels below win		
Quantity sampled	20 m2	Use

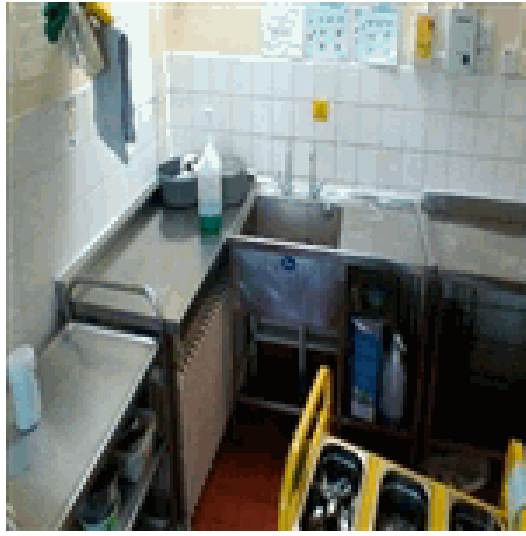
Reference	238	Sample number	01134-50-001-EE012
Survey date	20-May-19	Presumed	No
Building :	50 00 Catering Services	Room	001 Kitchen
Floor	G		
Location	Work units - Bitumen paint	Use	Bitumen products
Quantity sampled	5 Number

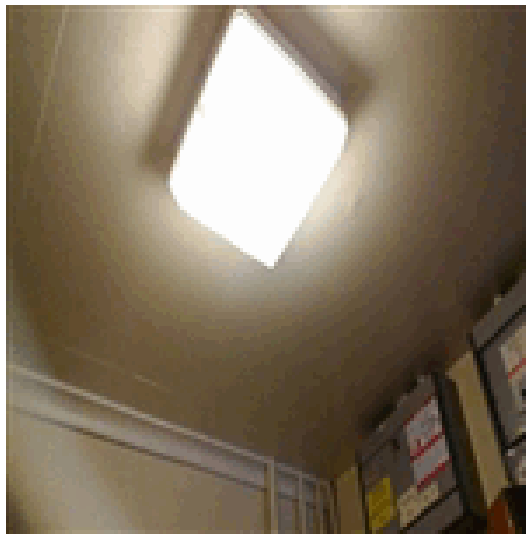
Reference	239	Sample number	01134-50-002-EE014
Survey date	20-May-19	Presumed	No
Building :	50 00 Catering Services	Room	002 Storage
Floor			
Location	Ceiling - Panels	Use	
Quantity sampled	2 m2

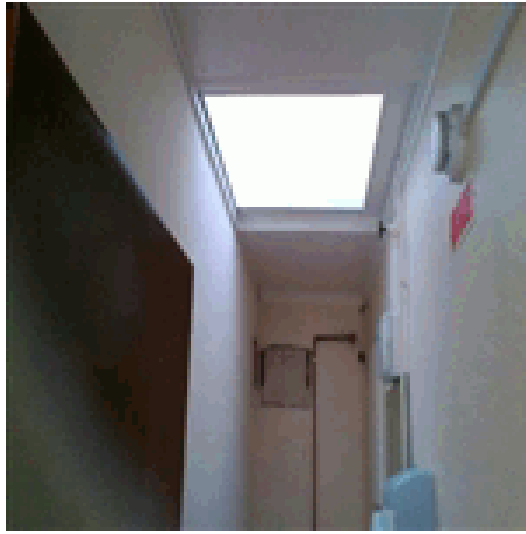
Reference	244	Sample number	01134-50-005-EEP003
Survey date	20-May-19	Presumed	No
Building :	50 00 Catering Services		
Floor		Room	005 Staff WC
Location	Ceiling void - Asbestos insulating		
Quantity sampled	3 m2	Use

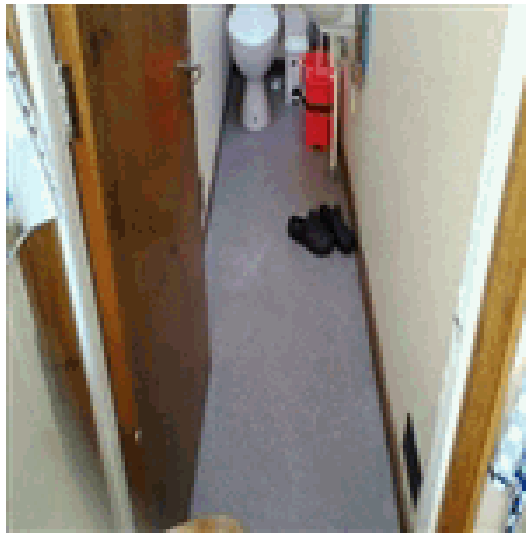
Reference	245	Sample number	01134-50-005-EE015
Survey date	20-May-19	Presumed	No
Building :	50 00 Catering Services		
Floor		Room	005 Staff WC
Location	Floor - Bitumen adhesive beneath		
Quantity sampled	3 m2	Use	Bitumen products

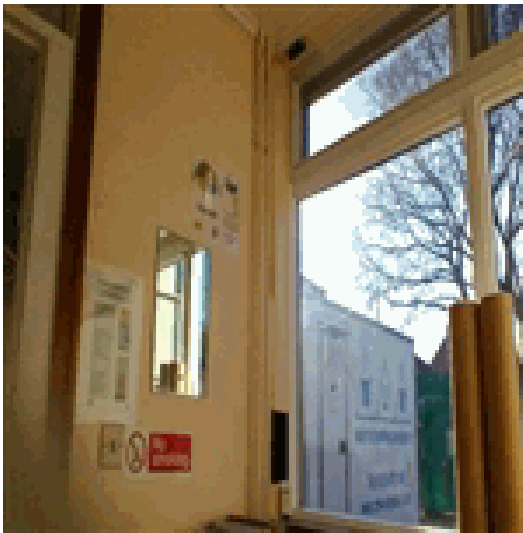
Reference	247	Sample number	01134-50-004-EEX004
Survey date	20-May-19	Presumed	No
Building :	50 00 Catering Services		
Floor		Room	004 Office
Location	Columns - Impregnated bitumen pa		
Quantity sampled	2 Approx Number	Use	Bitumen products
