Ollerton Roundabout

Road Safety Audit Stage 1 - Completion of Preliminary Design

SA2166A
March 2018

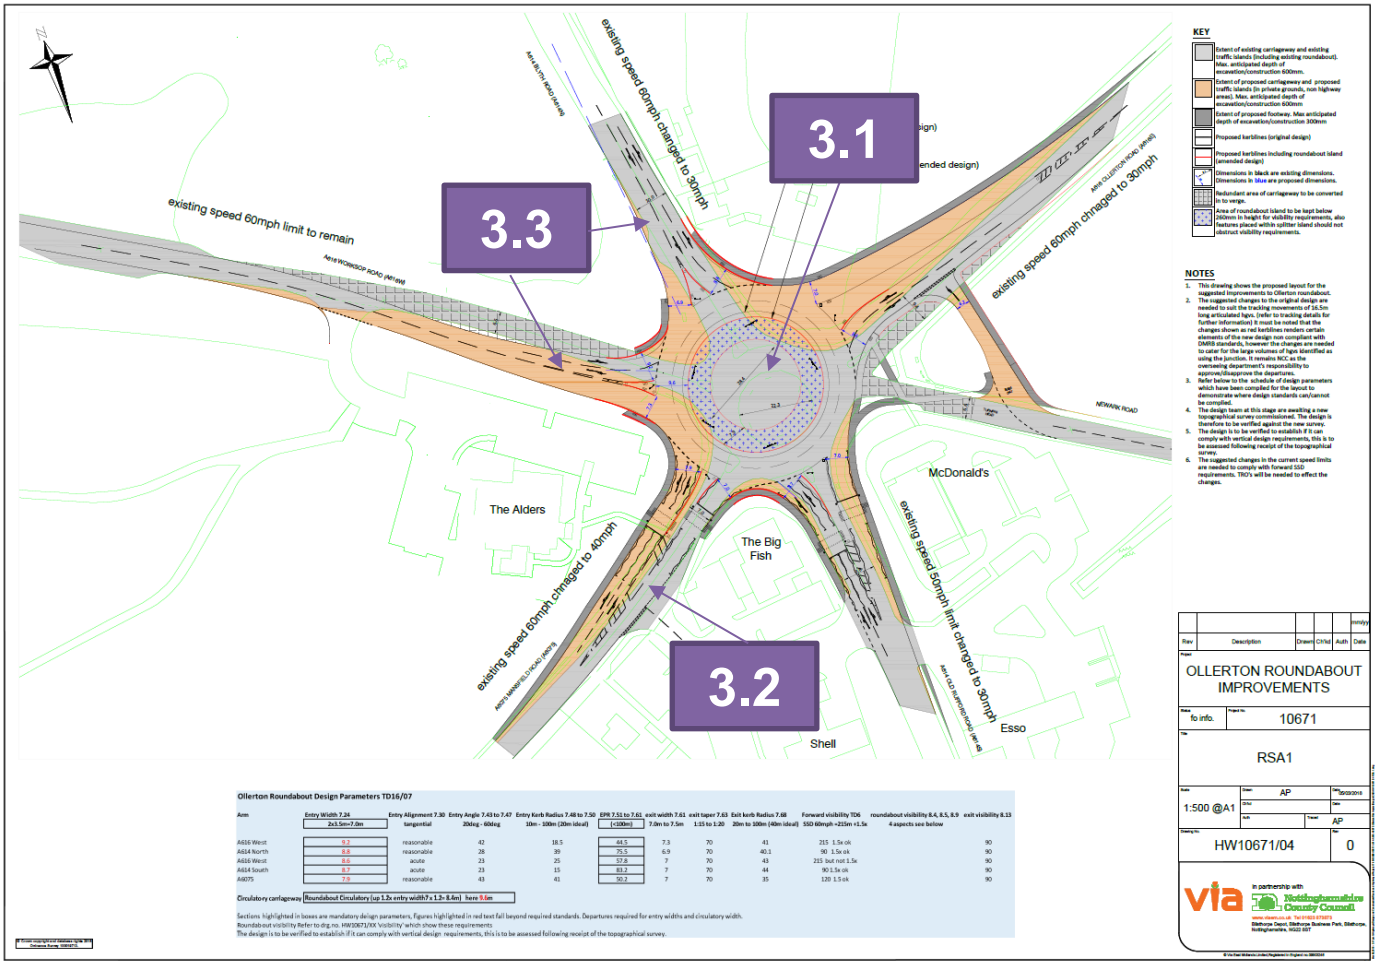
4. Reference Locations

Location: 3.1 – Ollerton Roundabout.

Summary: Increased number of entry and circulating lanes leading to an increase in conflicts and vehicular collisions.

Increasing the number of entry lanes and circulating lanes will lead to an increase in conflicts and an increase in collisions. The arms of the roundabout are very close to each other and drivers will have to make decisions very quickly about whether to enter the roundabout or not, while considering the movements of vehicles in two lanes of circulatory carriageway and 2 entry lanes. Entry versus circulating accidents are likely to occur, resulting in injury to vehicle occupants.

Location: 3.2 – A6075/Entrance to The Big Fish.

Summary: Collisions between vehicles exiting The Big Fish and vehicles on the A6075

Collisions at the junction with The Big Fish may increase as there are now 2 lanes approaching the roundabout and a 2 to 1 lane merge on the exit from the roundabout.

Location: 3.3 – A616 west of the roundabout and the A614 north of the roundabout.

Summary: Head on collisions due to lack of physical separation.

There is no physical separation between opposing lanes. Vehicles exiting the roundabout, that merge late, may cross into the opposing carriageway and collide head on with opposing vehicles, resulting in injury to vehicle occupants.

Enlarge the roundabout.

Alter the access arrangements to The Big Fish to prevent vehicles emerging from this access. The internal layout could be altered to allow vehicles to use the access on the A614.

Lengthen the proposed splitter islands or provide small satellite islands.
