A614/Mickledale Lane, Bilsthorpe

Road Safety Audit Stage 1 - Completion of Preliminary Design

SA2501A October 2021

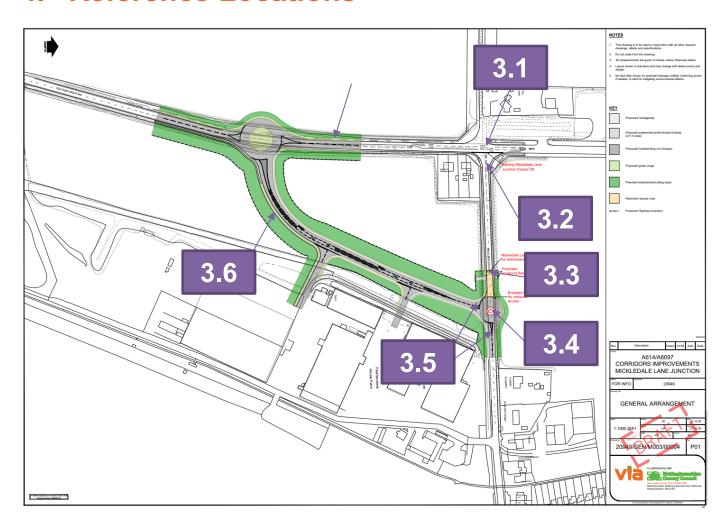
4. Reference Locations

Familiar drivers, who haven't travelled on the A614 for a while, may fail to notice that Mickledale Lane has been closed. There is a small risk of them attempting to turn into Mickledale Lane and colliding with the closure and a higher risk of them slowing and hesitating/being confused by the closure and being hit by a following vehicle. Vehicle occupants could be injured in these collisions.

There may be occasions where the gate on Mickledale Lane is left open and unauthorised users drive along Mickledale Lane. If they think they can still access the A614, or it is not obvious that it is closed, they may collide with the closure.

Unauthorised users may exit the roundabout onto the restricted access section of Mickledale Lane. They may fail to notice the gate, particularly at night, and collide with it. Vehicle occupants could be injured.

It is assumed that the gated access will be used infrequently. Drivers who regularly negotiate the roundabout will rarely have to give way to another vehicle, the junction will operate more as a bend. They may not anticipate another vehicle entering or exiting the gated access and may fail to give way to them. They may collide with them, resulting in injury to vehicle occupants.

There is footway/cycleway proposed on each leg of the roundabout, but no provision for crossing the carriageway at the roundabout. Pedestrians may be injured if they trip on a kerb and cyclists may fall from their cycles and be injured trying to mount the kerb.

There is a missing section of footway/cycleway, between the roundabout and the new access closest to the roundabout. Any pedestrians/cyclists wanting to travel on this section would have to do so on the verge, where they may slip, or in the carriageway where they are vulnerable to being hit by a vehicle. Pedestrians and cyclists could be injured in these collisions.

Ensure the closure is obvious day & night. Remove any signing & road markings that may make drivers think there is still a road there. Erect some temporary signing warning of the closure.

Ensure the closure is obvious day & night. Remove any signing & road markings that may make drivers think they can still access the A614.

Erect clear signing of the restriction and gate and ensure the gate is obvious day & night.

The only real solution to this problem is to install an alternative type of junction.

Provide dropped crossings on the footway and refuges, if it is a shared use footway/cycleway the refuges will need to be large enough to accommodate a cycle.

Dropped crossings will also be necessary to cross the side roads off the new road, if there is footway both sides.

Provide footway/cycleway on this section.
