A614 Warren Hill Gyratory

**Road Safety Audit
Stage 1 - Completion of Preliminary Design**

SA2288B
Dec 2019

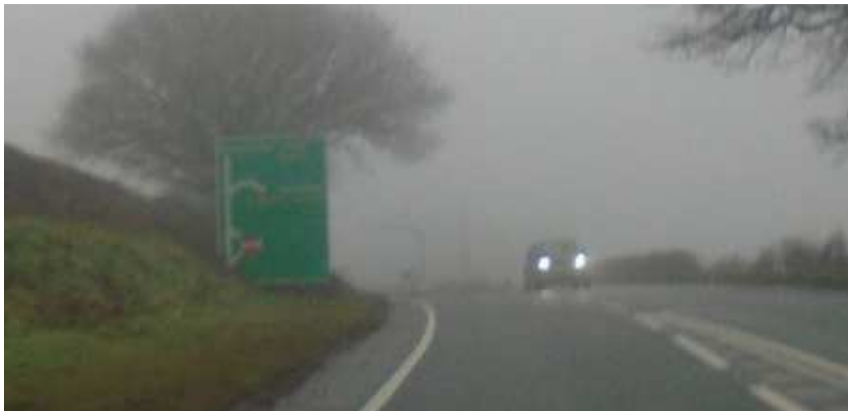
Location: No reference – Caravan car park/ Baulker Lane.

Summary: Unexpected & inappropriate U turn accidents resulting in driver/rider injury.

Currently northbound drivers on the A614 can access the A6097 (and the A46) via the signed route to the north of the gyratory. In this proposal this movement is not allowed. Consequently, drivers may choose to use the caravan car park to the north of the gyratory or Baulker Lane crossroads to U turn and access the A6097. Neither of the junctions could accommodate an HGV making such a manoeuvre easily. This could lead to shunt type accidents on a relatively high-speed road and subsequent driver/rider injury.

Assess the demand for this movement and provide a suitable alternative route for drivers which is appropriately signed well in advance of the gyratory.

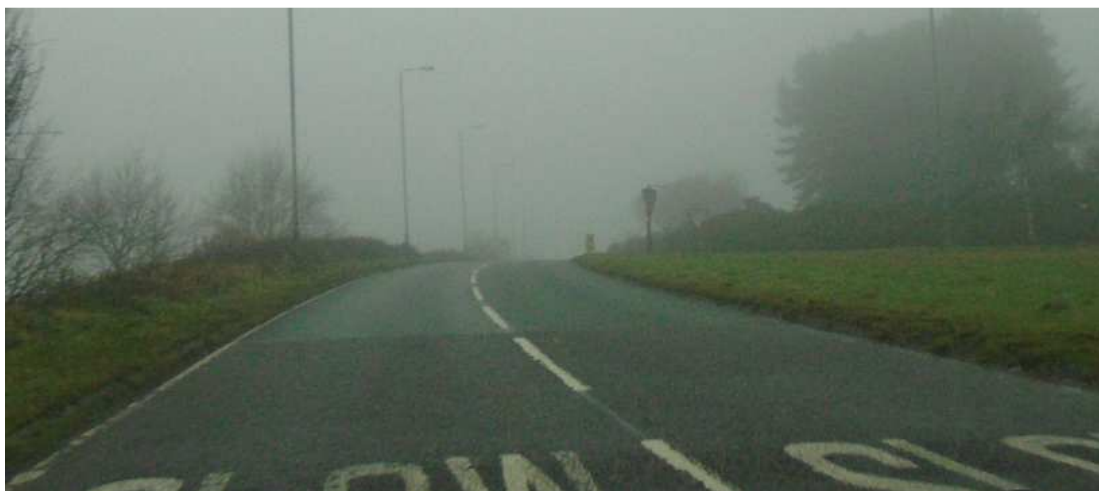
Location: A614 northbound proposed hatching in offside lane.

Summary: A614 northbound drivers failing to observe the hatch markings leading to overtaking accidents/side swipe accidents and resulting in driver/rider injury.

Presently, A614 northbound drivers can travel in two lanes until the DWL system north of the gyratory. Drivers may still use the hatched lane to overtake slower moving vehicles in the nearside lane. The slight crest on the A614 may mask a vehicle joining the A614 stream at the merge as this will now be over the crest. This could result in overtaking/side swipe accidents at high speed resulting in driver/rider injury.

Physically reduce the A614 northbound approach to one lane with hard kerbing to prevent overtaking.
