Lowdham Roundabout Improvements

**Road Safety Audit
Stage 1 - Completion of Preliminary Design**

SA2222B
June 2020

Stage 1 Road Safety Audit

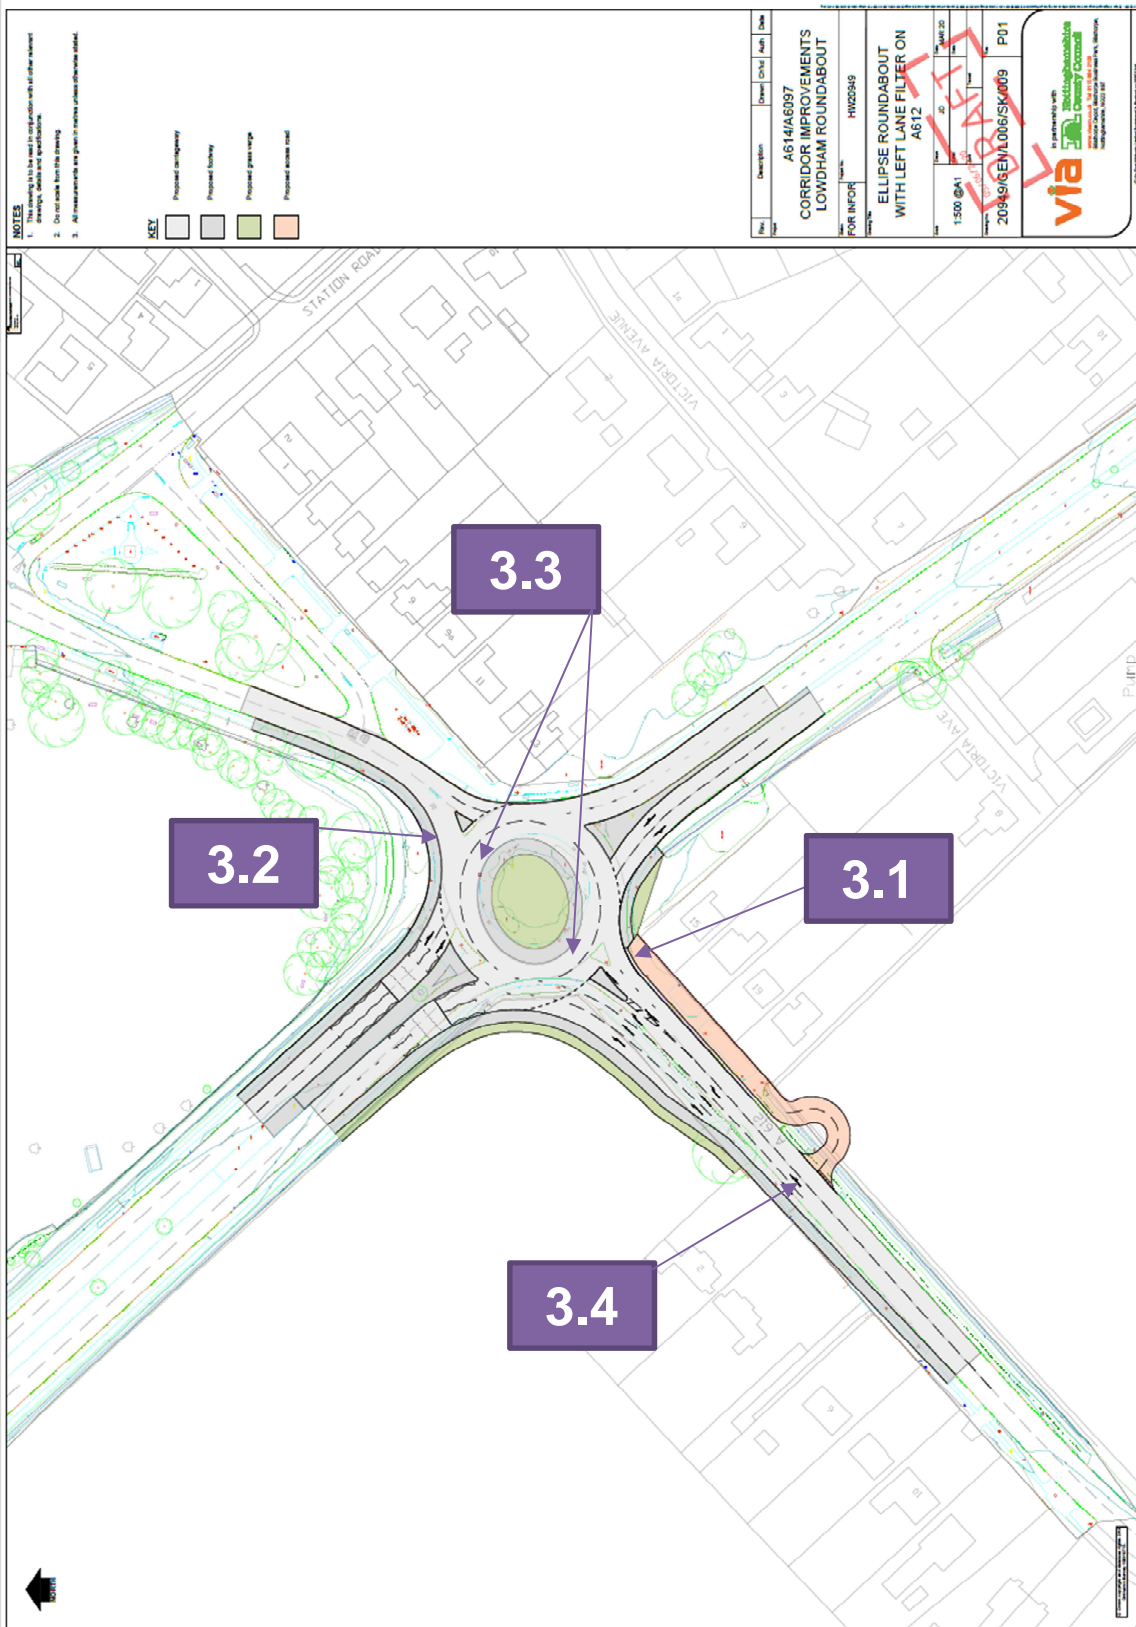
4. Reference Locations

Location: 3.1 – A612 westbound exit from the roundabout.

Summary: Side swipe collisions or head on collisions with opposing traffic.

There are two lanes shown on the A612 WB exit from the roundabout with a very short merge. Drivers of vehicles in the offside lane who try and merge at the end of the two lanes may collide with vehicles in the nearside lane or may collide head on with opposing vehicles, or those waiting to turn right into the service road. Vehicle occupants could be injured.

Location: 3.2 – A612 eastbound exit from the roundabout.

Summary: Side swipe collisions at roundabout exit.

All the roundabout entries have 2 ahead lanes and all the exits have 2 lanes, except for the A612 eastbound. Drivers on the A612 eastbound may mistakenly travel ahead in the offside right turn lane, side swipe collisions could occur with vehicles in the nearside lane if they try and exit the roundabout at the same time, as there is only one lane on the exit. This is likely to become more of a problem as the road markings become worn.

Location: 3.3 – Tighter parts of roundabout.

Summary: Vehicle loss of control due to sharp radii on roundabout causing side swipe accidents.

The proposed roundabout isn't round which means at points of the oval shape the angle tightens which doesn't allow a smooth transition. Drivers will have to adjust their steering wheel mid manoeuvre which can catch drivers out especially when negotiating at speed. A driver could lose control of the vehicle which could lead to hitting another object on or off the carriageway. A more common scenario is a driver just doesn't get their vehicle into lane due to the unusual shape and enters another lane causing a side swipe accident with another vehicle. With this being a route heavily used by HGVs large vehicles will find it the most difficult and could enter more than one lane regularly. Any collision between vehicles could lead to accidents for vehicle occupants.

Location: 3.4 – Private service road.

Summary: Turning right in right turn could be seen as for roundabout and be shunted.

In order to get three lanes on the SW entry arm (Burton Joyce) the lane widening occurs before the new service road with lane markings added where vehicles would need to turn right into the service road. This could cause confusion for drivers following a vehicle ahead intending to turn into the service road. It could look to the following driver as though the vehicle ahead is intending to turn right at the roundabout. When the right turner stops the vehicle being could shunt them causing injury to vehicle occupants.

Capacity over safety will be required in the decision process but does this arm need 2 lanes capacity from Lowdham towards Burton Joyce. If this merge is only being provided for the Entry Arm on Lowdham side of A612 it should be removed. This entry arm could be signed for Left turn only (n/s) and ahead/right (o/s) so that two vehicle merge on the opposing arm is removed.

At detailed design add hatch lines on this exit to strengthen that it is a single lane.

A standard round roundabout would be the safest option. If this oval option is pursued, then it should be shown at stage 2 RSA that vehicles can circulate within their own lanes. The road surface should be brought up to a very good level of grip and maintained regularly to help any loss of control incidents. This could be frequent due to the level of HGV polishing of the road surface.

The service road should join the main road at a point past the lane divergence. Another potential option could be to have a left turn in only at the service road forcing drivers to circulate the roundabout rather than turn right. This is not likely going to be wanted by the residents and the left turn in needs to be made strong with kerb lines and physical restriction such as a splitter island so that drivers aren't tempted to disregard a right turn ban.
