A6097-Kirk Hill East Bridgford

**Road Safety Audit
Stage 1 - Completion of Preliminary Design**

SA2404A
Nov 2020

Stage 1 Road Safety Audit

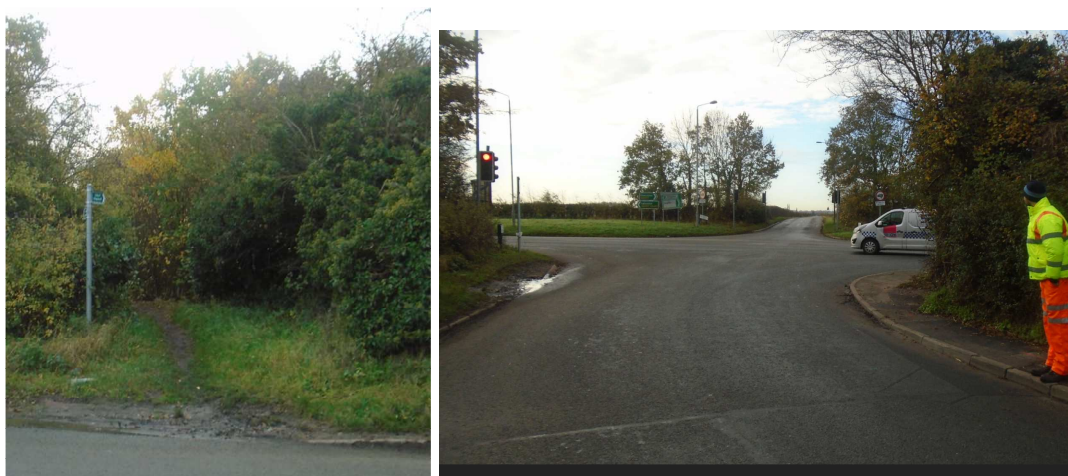
Location: Ref 3.4 Kirk Hill Public Footpath.

Summary: Pedestrians injured in collision with vehicles at junction.

There is an existing footway on the north side of the A6097 from Gunthorpe to the signal junction and then a public footpath that connects to the A46 junction. The footpath looks well used. Pedestrians have no view of a left turning vehicle from the A6097, which could result in pedestrians stepping into the path of vehicles, with the potential for serious injuries to arise from any collisions that occur.

Incorporate a push button- controlled crossing for pedestrians across this arm and improve inter-visibility between vehicles and pedestrians by removing vegetation on this radius (see problem 3.1)

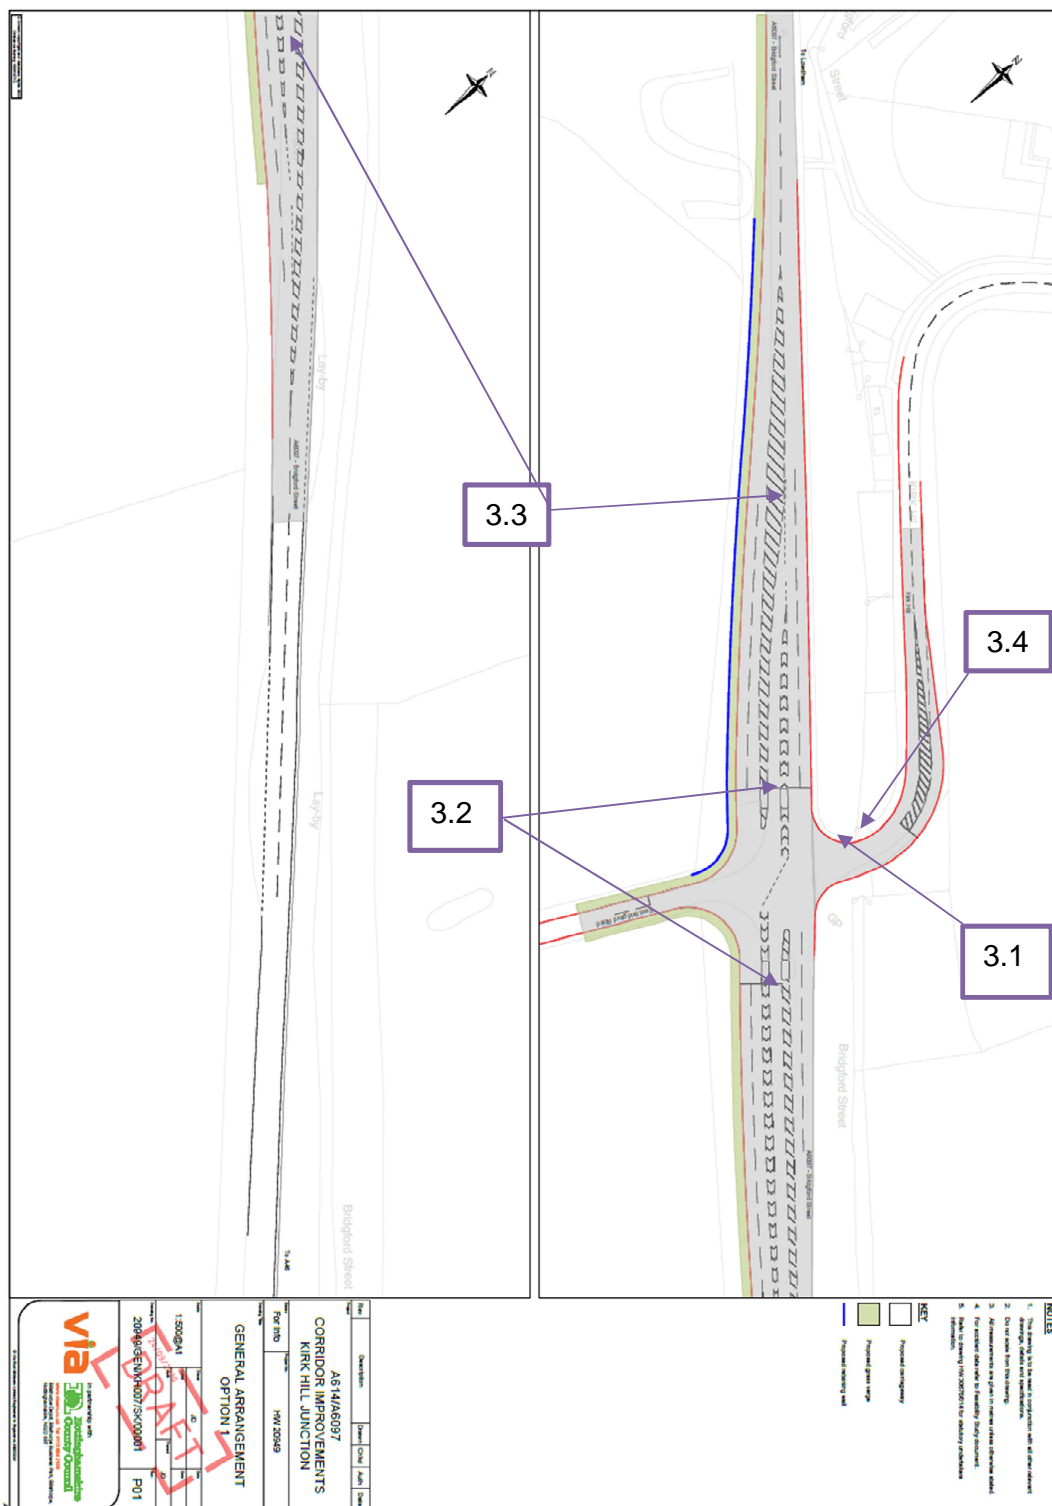
4. Reference Locations

Location: Ref 3.1 Junction inter-visibility zone

Vegetation restricts the view left and right along the A6097 when emerging from both side roads. This could lead to collisions between vehicles in the junction in the event of red-light violations by drivers, or if/when failures of the traffic signals occur.

Location: Ref 3.2 A6097 NW & SE approaches to the signals

Widening the A6097 carriageway and providing two ahead lanes at this junction will increase speeds through the junction and as a result the risk increases of higher severity shunt/overtaking/right turn signal violation accidents whenever drivers make errors of judgement.

Location: Ref 3.3 A6097 NW & SE approaches central hatched area

The proposed layout permits overtaking on the A6097 through the junction. Head-on collisions could occur when drivers continue to overtake beyond the length of carriageway available to do this safely. This is likely to result in driver/rider/passenger injuries.

Achieve the required visibility by seeking better sight lines. Bring the stop lines forward and remove vegetation on the inner radius of Kirk Hill.

To mitigate, install double height signal heads on both A6097 approaches to make them as conspicuous as possible, and ensure that all the advanced traffic signal warning signs and direction signs are re- located to give clear visibility of the signal heads & extend the existing HFS to provide 1m per kilometre per hour on each approach.

Install central refuges on each approach and reduce the length of the 2 lane markings on each exit to encourage drivers to merge sooner.
