APPENDIX F

SECTION 19 REPORT – RADCLIFFE ON TRENT FEBRUARY 2020

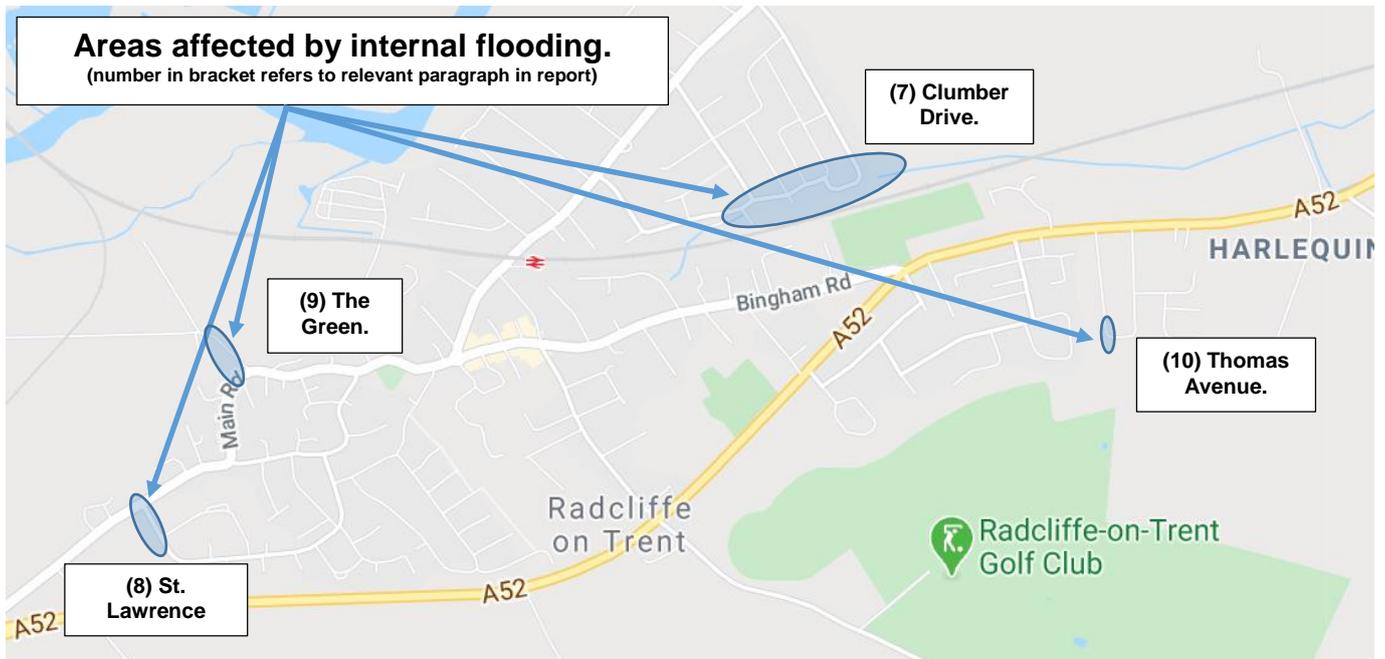
Figure 3. Plan highlighting areas affected by internal flooding

On the 16th of February 2020 parts of Radcliffe on Trent suffered a significant flood event with 37 reported incidents of internal property flooding and many gardens, curtilages and public highways in the village affected. Figure 3 shows the areas of Radcliffe on Trent that were affected by internal property flooding.

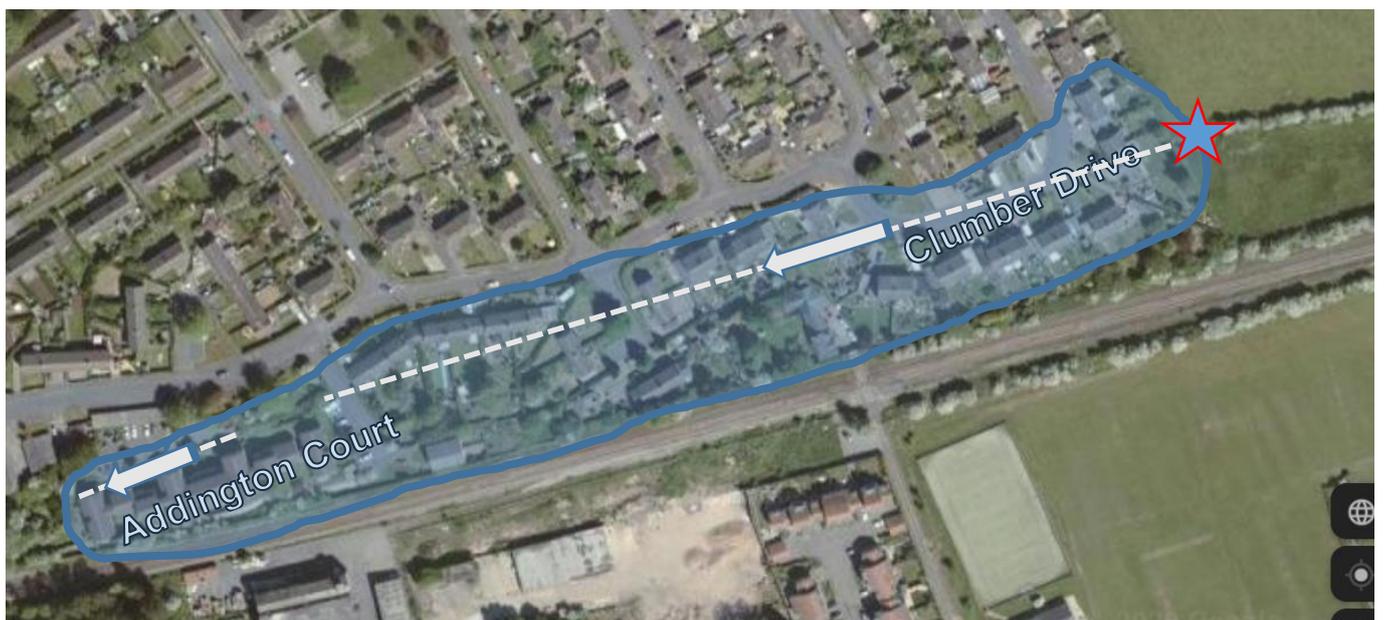
Figure 4. Flood outline for Clumber Drive area and line of (culverted) Sykes Drain.

In the very early hours (from approx. 2:30am) of Sunday 16th Feb the area shown on Figure 4 below was subjected to flooding with 29 properties reporting internal flooding and at-least 11 others suffering external flooding. Some residents had to be rehomed due to the severity of the flooding.

The area affected lies along the line of the Sykes Drain, an ordinary watercourse that serves a rural area to the east of Radcliffe and ultimately flows into the centre of the village via a primarily culverted route. Figure 4 overleaf shows the approximate line of the Sykes Drain, shown dotted, in the area affected by flooding. The star on Figure 4 shows the point that the Sykes Drain enters its culverted section, to the rear of Number 87 Clumber Drive.

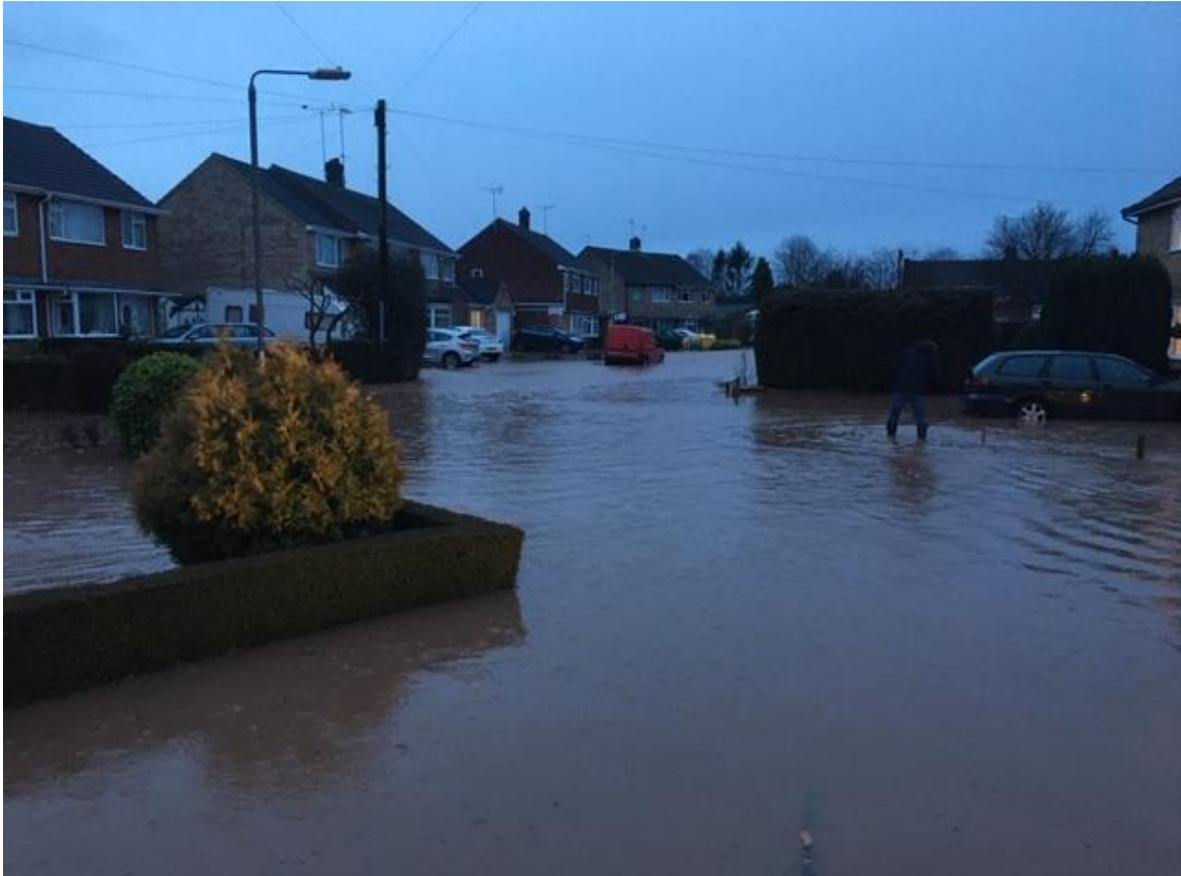
Photo 1. View of flooding from driveway of 83 Clumber Drive

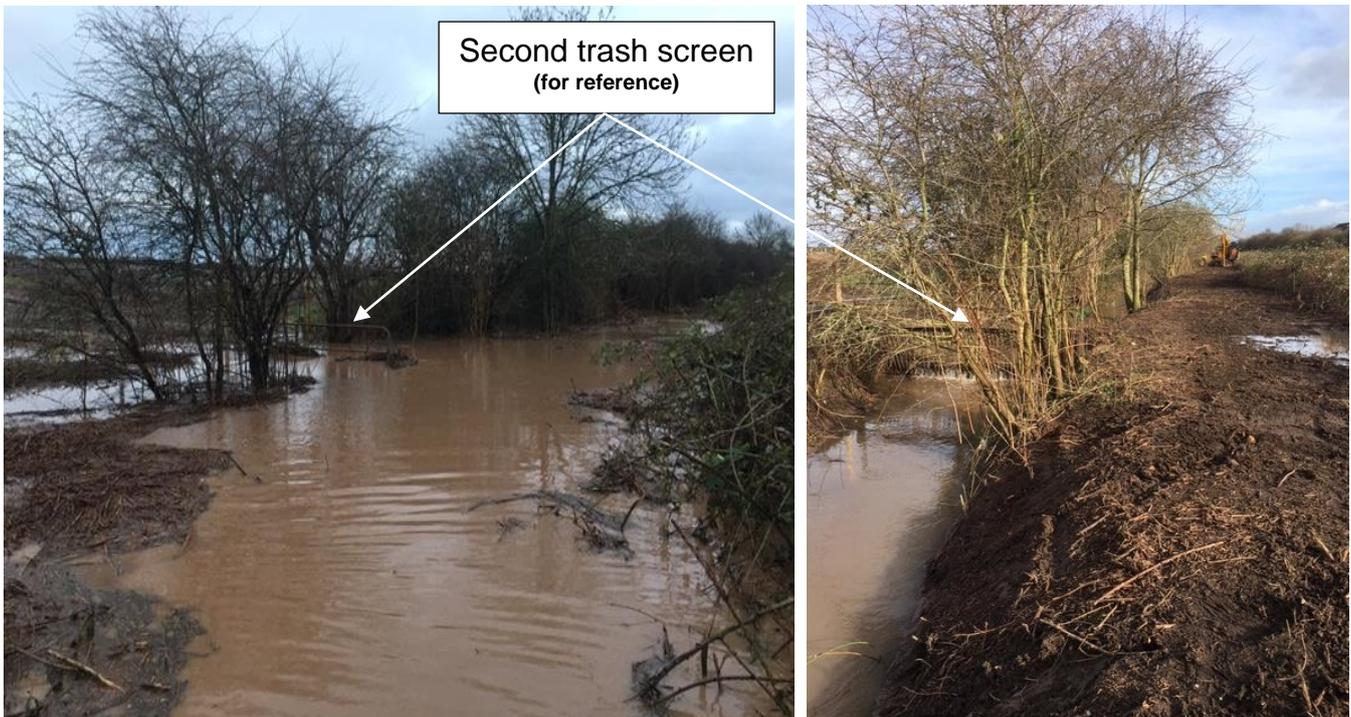
Photo 2. (left) Sykes Drain looking upstream from boundary of 87 Clumber Drive showing surcharge on Sunday 16th February and Photo 3. (right) after trash screens and banks of watercourse cleared on Monday 17th February.

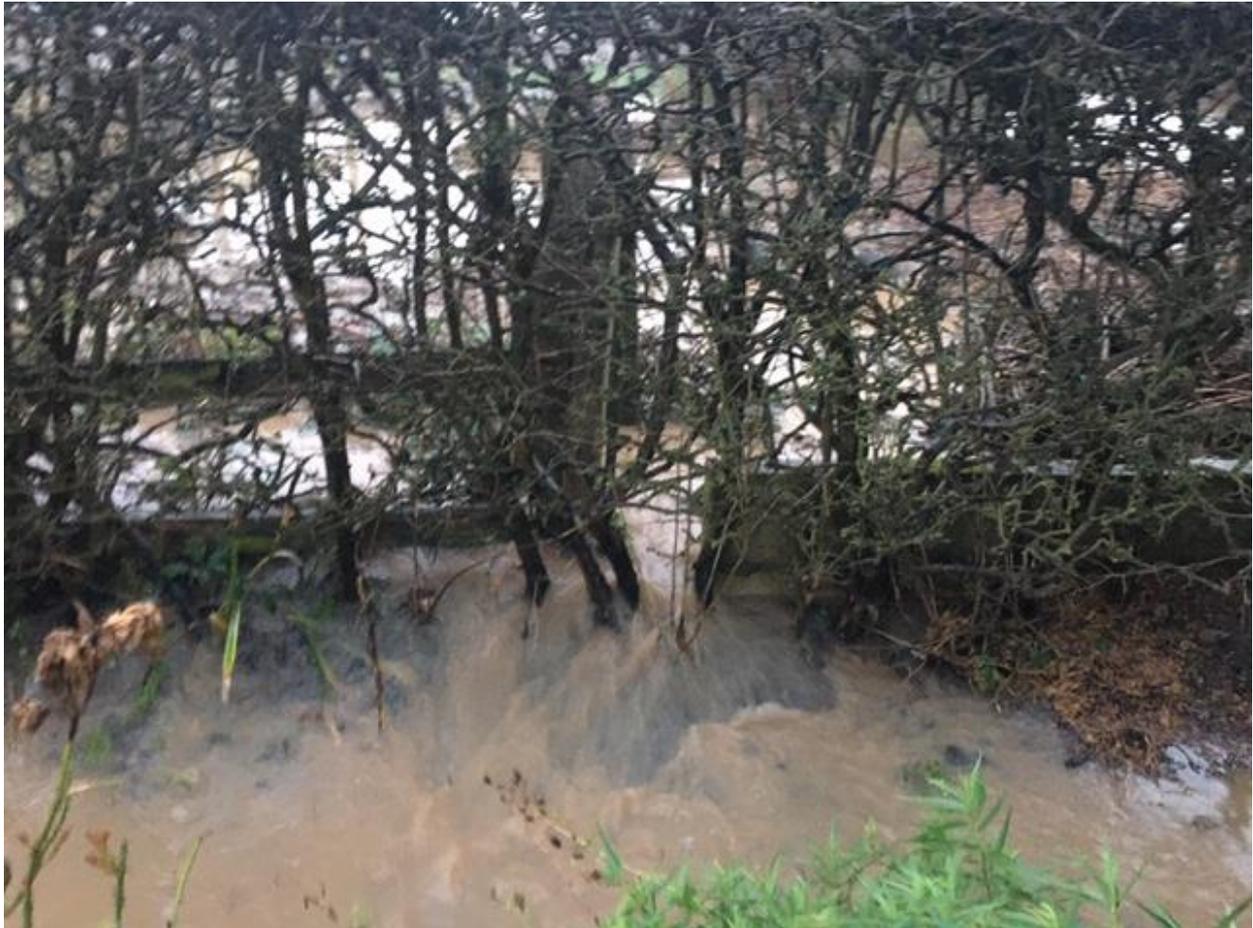
Photo 4. taken at 0730 on Sunday 16th February from the garden of 87 Clumber Drive and showing water still flowing over the boundary from the surcharged Sykes drain.

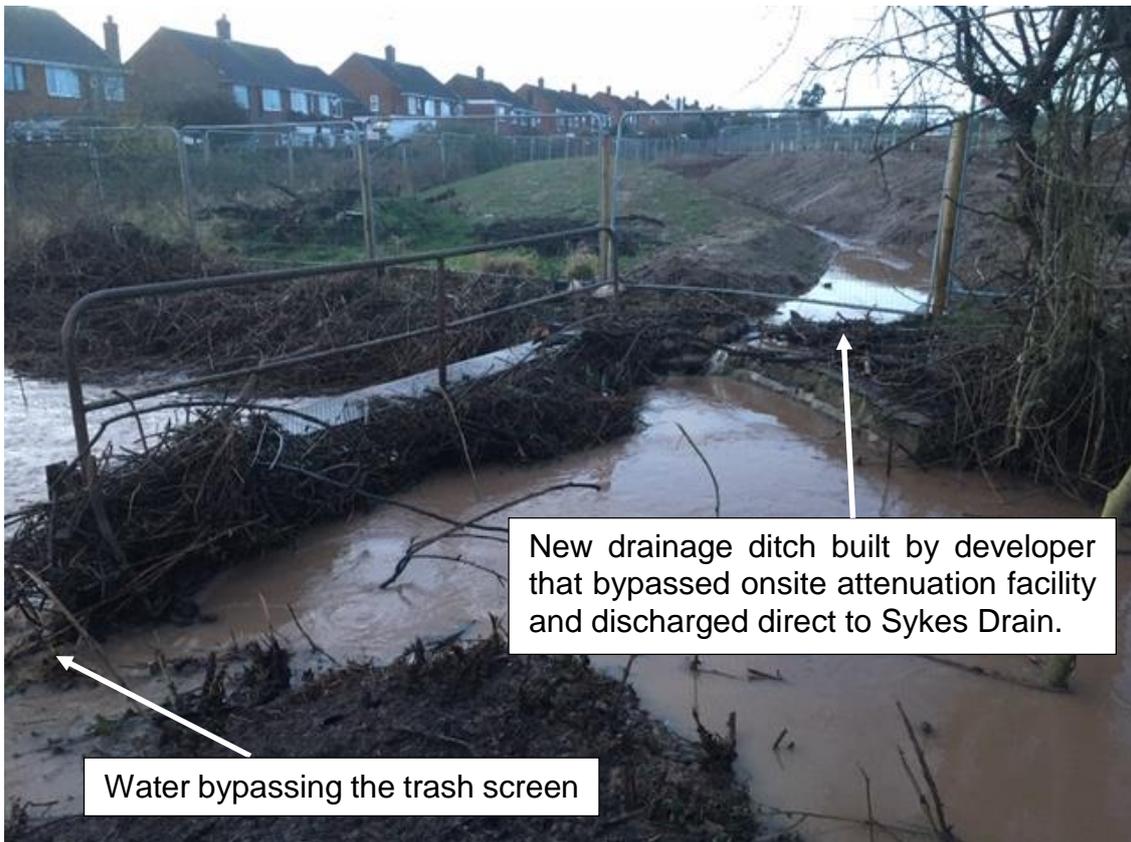
Evidence shown in Photo 5. overleaf shows the upstream trash screen to be completely blocked with the flow of water finding its own path around the outside of the screen. It also shows a drainage ditch constructed by William Davis Ltd. that discharged surface water directly into the ditch and bypassed the onsite attenuation facility that forms an integral part of the surface water management for the development. Photo 6. shows the trash screen on the mouth of the culvert almost entirely blocked with a significant amount of debris to the point that it is not visible.

Photo 5. (Sunday 16th February) showing the trash screen upstream of the culvert to be completely blocked to the extent that water is bypassing the screen on the left-hand side and the additional drainage ditch.

The evidence collated during the investigations suggests that the blockages to both the trashscreens was caused primarily by the debris left on site during the site clearance discussed earlier in the report, with potential less obvious contributions from other debris washed down from upstream of the trashscreen.

18. Nottinghamshire County Council will liaise with William Davis Ltd. in order to ensure robust future maintenance regimes for the trash screens and Skyes Drain within the Princes Place estate.

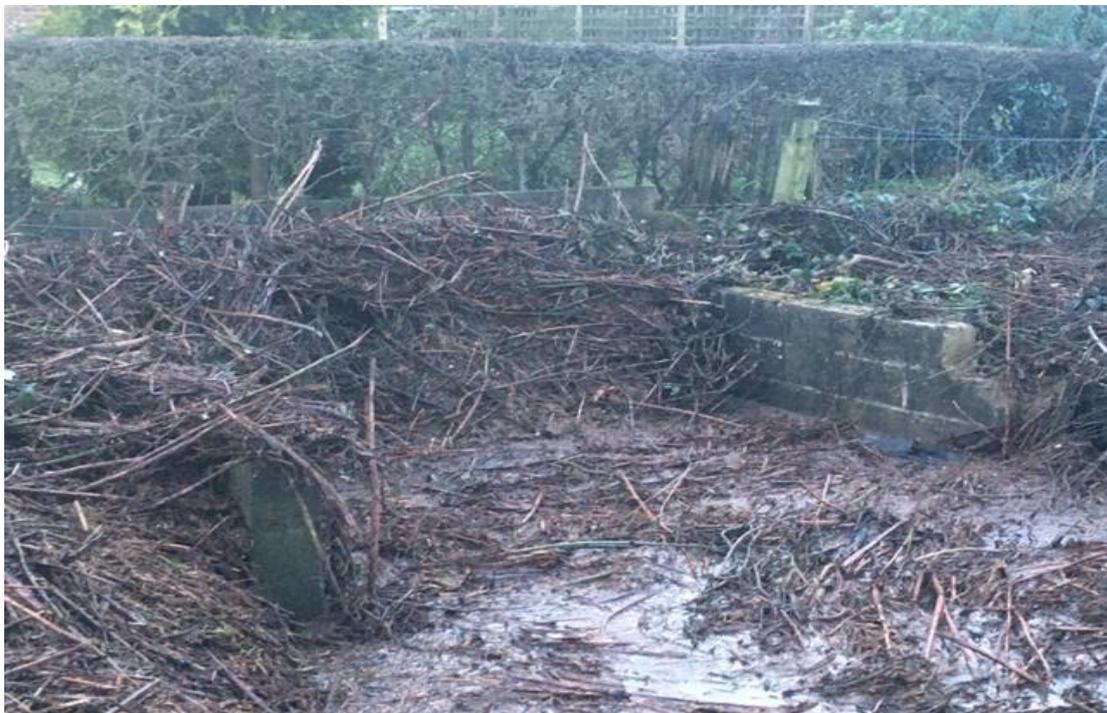
Photo 6. (Sunday 16th February.) showing the debris blocking the trash screen on the mouth of the culvert. The trash screen is not visible due to the amount of debris.

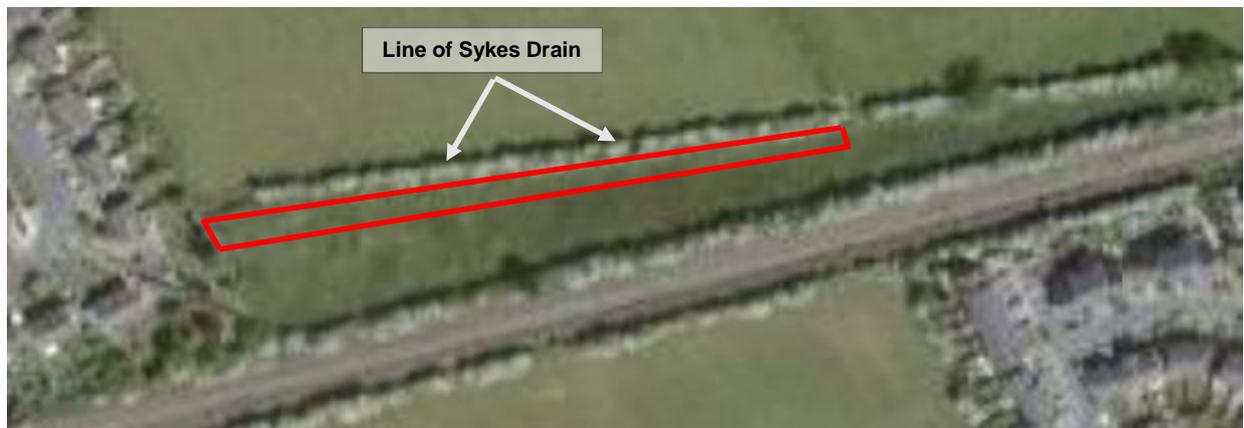
Figure 7. Area of land that had been stripped of vegetation and overgrowth before the flooding event.

It was also clear that a strip of land (approximately 6-10m) wide and shown highlighted in red on Figure 7. overleaf) had been cleared of overgrowth (brambles) at some point before the flooding event.

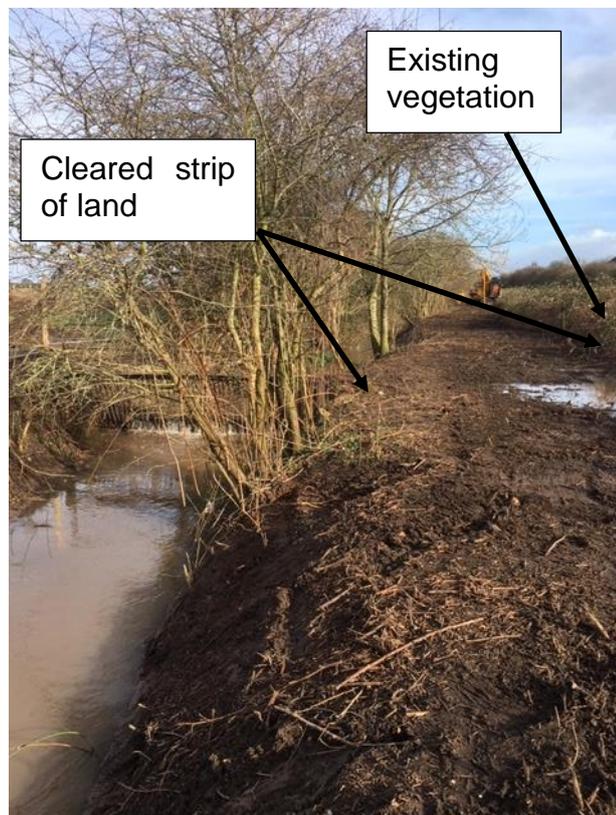
The significant volume of debris held by the trash screens was something that warranted further investigation as it appeared unusual for the circumstances. The debris itself was primarily heavy-set brambles and further investigations showed this type of debris to be very evident further along the upstream banks of the Sykes Drain.

Photo 7. The strip of land adjacent to the Sykes Drain in William Davis Ltd.'s land that had been cleared prior to the flooding event. (this photo was taken on Monday 17th February after the debris had been cleared).

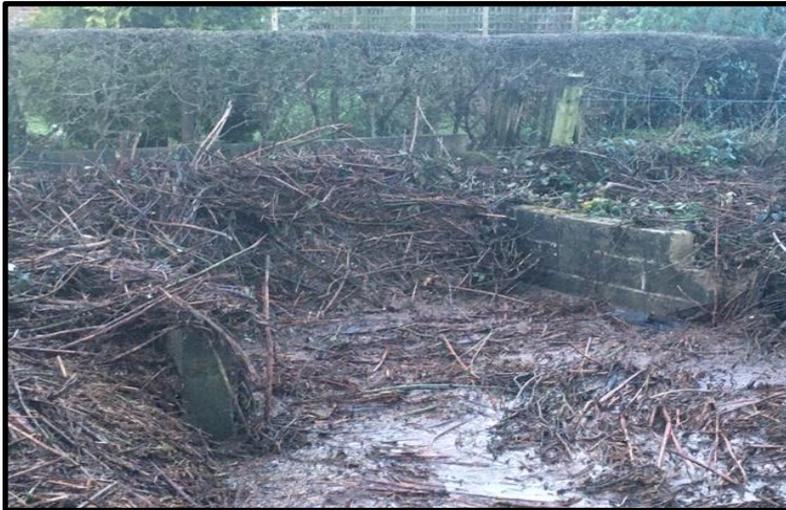
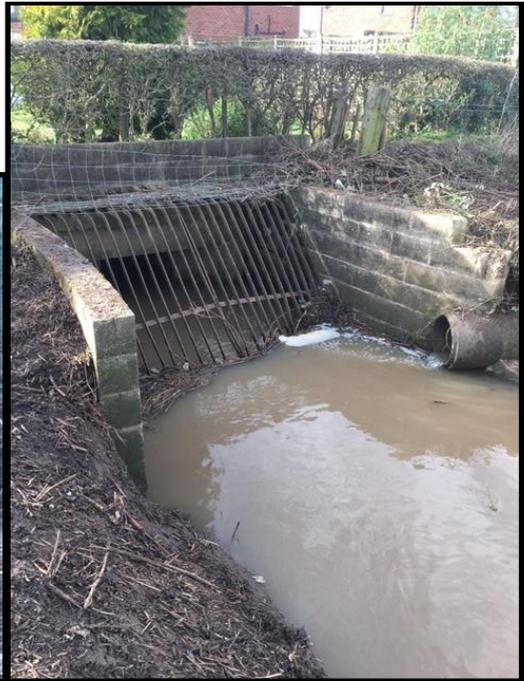
Photos 7. (left) and 8. (right) of the trashscreen on mouth of culvert.

The pictures below show both the trashscreens before (Sunday 16th) and after (Monday 17th) cleaning.

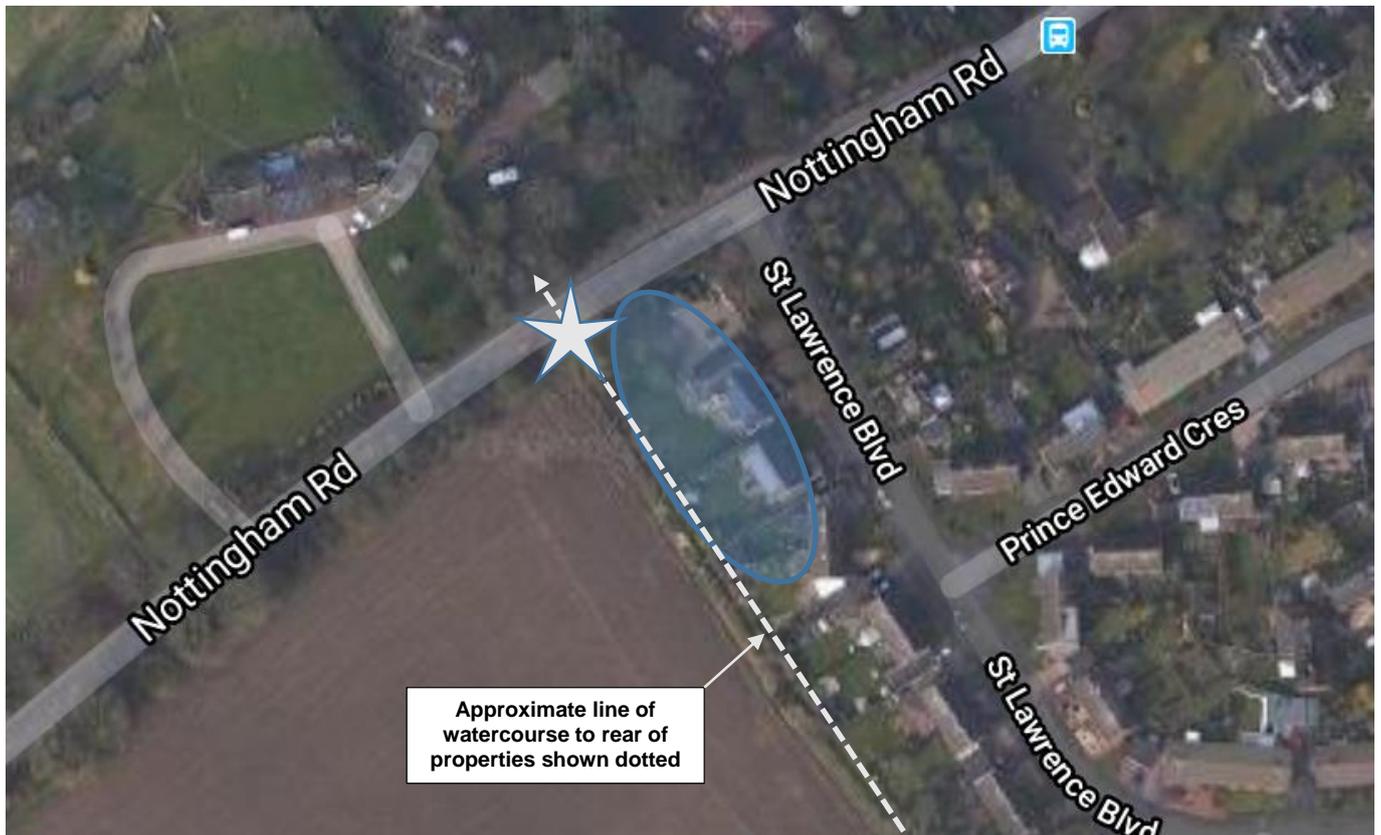
Figure 5. Flood outline for St. Lawrence Boulevard area.

The area shown on Figure 5 was subjected to flooding on the 16th February. This area has a history of flooding. However, apart from in November last year, the severity of past incidents has prevented internal flooding. On this occasion the flooding affected 4 properties internally and the curtilages of several others.

The flooding emanates from the ordinary watercourse that runs along the rear boundaries of properties on St. Lawrence Boulevard, as shown by the dotted line on Figure 5. Under excessive rainfall conditions the watercourse surcharges and starts to flood Nottingham Road in the location shown by the star on Figure 5 and its junction with St Lawrence Boulevard. Due to the volume of rain on this occasion the flooding spread resulting in internal flooding to properties and curtilages.

20. Investigations into the condition and connectivity of the surface water system in the St. Lawrence Boulevard area and Main Road / The Green are scheduled for mid 2020. These findings will be shared and actioned as appropriate.

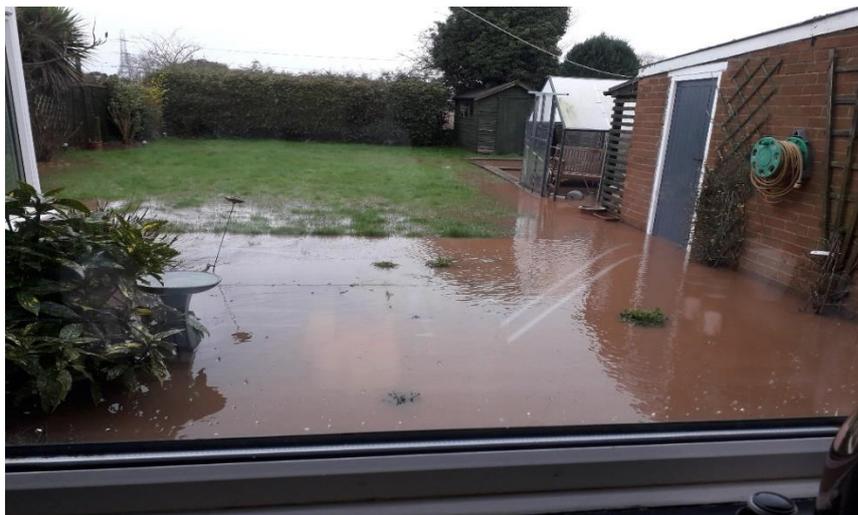
Photo 11. View of flooding to rear of property on St Lawrence Boulevard.

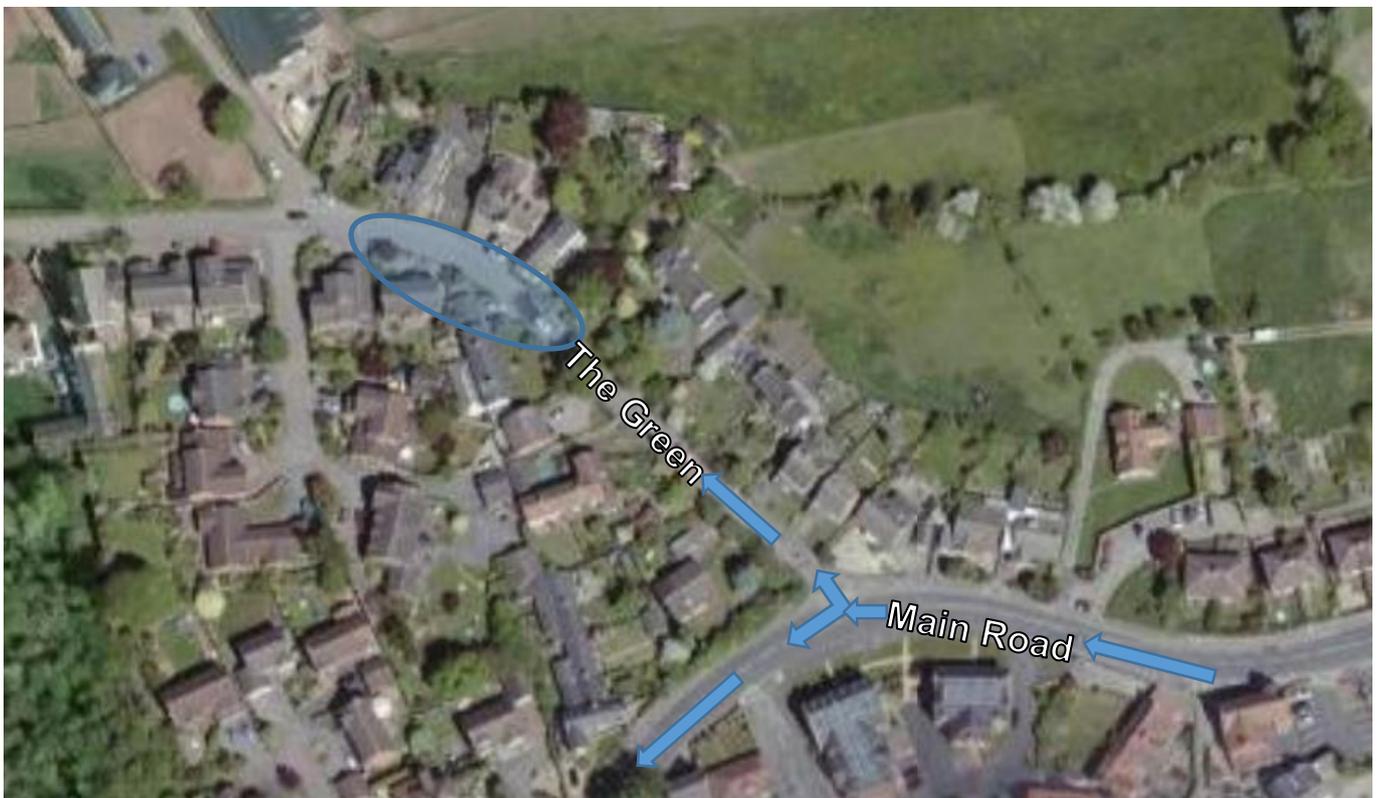
Figure 7. Flood outline for The Green area showing surface water flow paths.

Figure 7 shows the area affected by flooding on The Green. Three properties reported internal flooding with several others narrowly missing out thanks to proactive measures taken by residents during the flooding.

Affected residents confirmed that the flooding at this location was a result of excessive overland flows running off Main Road and into The Green.
