Asbestos Inspection Report

01038 : Bracken Lane Primary and Nursery

Survey date : 17-Jul-2017

Type of survey **Management Survey**

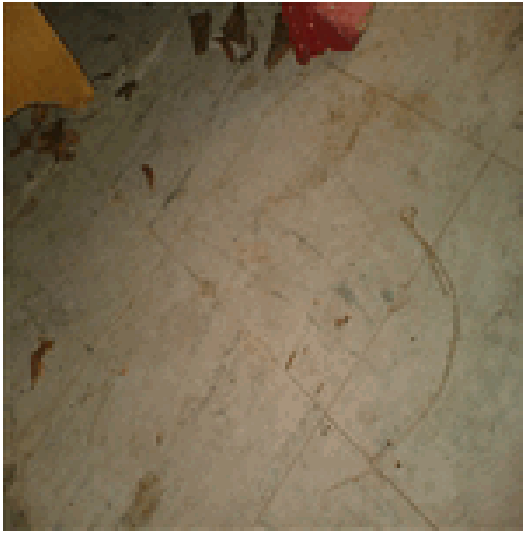
Reference	96	Sample number	01038-01-50-30
Survey date	17-Jul-17	Presumed	No
Building :	01 00 Main School		
Floor		Room	050 External Store
Location			
Quantity sampled	10 SQ M	Use	Flooring

Product type	Asb-Reinfd comps,etc (see Use) (1)
Damage/deterioration	Low damage (1)
Surface treatment	Composite materials (0)
Asbestos type	Chrysotile (1)

Occupants using space	1 to 3 (1)	Material score	3
Frequency of use	Daily (3)	Priority score	4
Average time of use	<1 hour (0)	Banding	Removed
Type of maintenance	Minor disturbance (0)		
Frequency of maintenance	ACM unlikely to be disturbed (0)

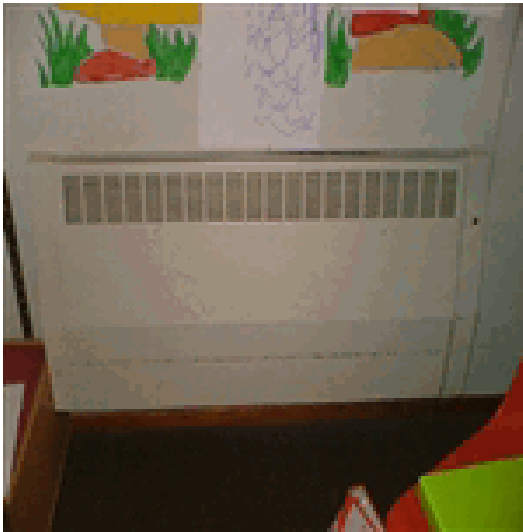
Reference	97	Sample number	01038-01-49-P01
Survey date	17-Jul-17	Presumed	Yes
Building :	01 00 Main School		
Floor		Room	049 Nursery
Location	WALL MOUNTED		
Quantity sampled	0.5M2	Use	Asbestos Insulating Board

Product type	AIB,Textiles,Rope,etc(see Use) (2)
Damage/deterioration	Good condition (0)
Surface treatment	Unsealed AIB,enc Lagging&Spray (2)
Asbestos type	Crocidolite (3)

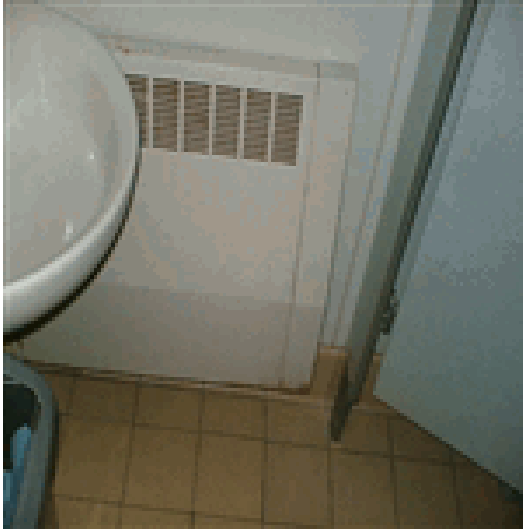
Reference	98	Sample number	01038-01-48-P01
Survey date	17-Jul-17	Presumed	Yes
Building :	01 00 Main School		
Floor		Room	048 Staff WC
Location	WALL MOUNTED		
Quantity sampled	1 NO	Use	Asbestos Insulating Board

Product type	AIB, Textiles, Rope, etc (see Use) (2)
Damage/deterioration	Low damage (1)
Surface treatment	Unsealed AIB, enc Lagging & Spray (2)
Asbestos type	Crocidolite (3)

Presumed crocidolite asbestos. No access. Presumed to contain Insulation board and gaskets

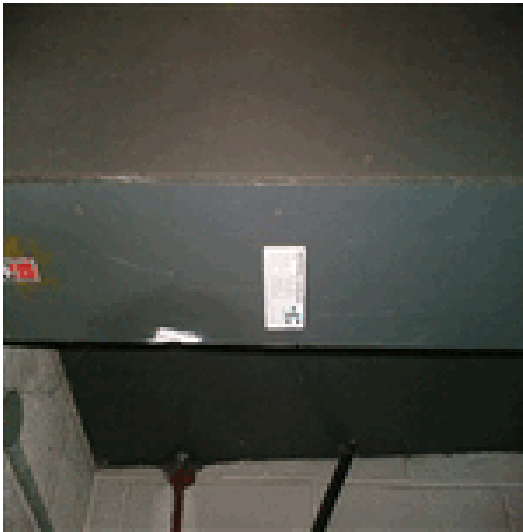
Reference	99	Sample number	01038-01-46-27
Survey date	17-Jul-17	Presumed	No
Building :	01 00 Main School		
Floor		Room	046 Boiler Room
Location	CEILING AND CLADDING TO PIPES		
Quantity sampled	15 M2	Use	Asbestos Insulating Board

Product type	AIB, Textiles, Rope, etc (see Use) (2)
Damage/deterioration	Low damage (1)
Surface treatment	Enc Lagging & Sprays, AIB, etc (1)
Asbestos type	Amphibole ex. Crocidolite (2)

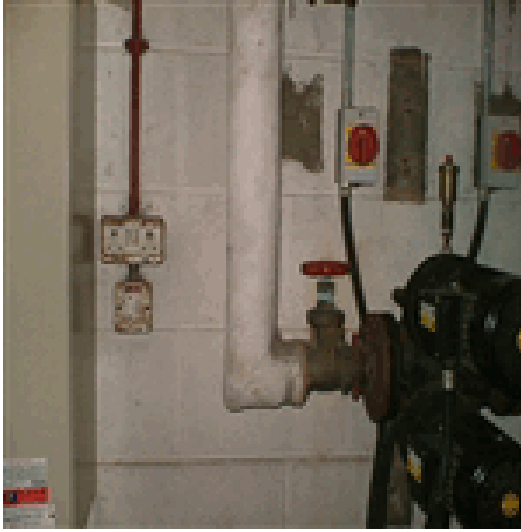
Reference	100	Sample number	01038-01-46-28
Survey date	17-Jul-17	Presumed	No
Building :	01 00 Main School		
Floor		Room	046 Boiler Room
Location	OLD WHITE PIPE LAGGING		
Quantity sampled	20 M2	Use	Asbestos Insulating Board
Material assessment			
Product type	Therm-Ins,Spray,etc (see Use) (3)		
Damage/deterioration	Low damage (1)		
Surface treatment	Enc Lagging&Sprays,AIB,etc (1)		
Asbestos type	Not asbestos (0)

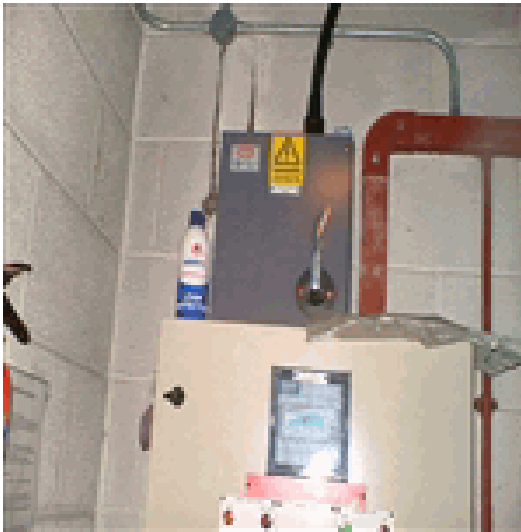
Reference	101	Sample number	01038-01-46-P01
Survey date	17-Jul-17	Presumed	Yes
Building :	01 00 Main School		
Floor		Room	046 Boiler Room
Location	WALL MOUNTED		
Quantity sampled	1 NO	Use	Asbestos Insulating Board
Material assessment			
Product type	AIB,Textiles,Rope,etc(see Use) (2)		
Damage/deterioration	Low damage (1)		
Surface treatment	Unsealed lagging&sprays (3)		
Asbestos type	Crocidolite (3)

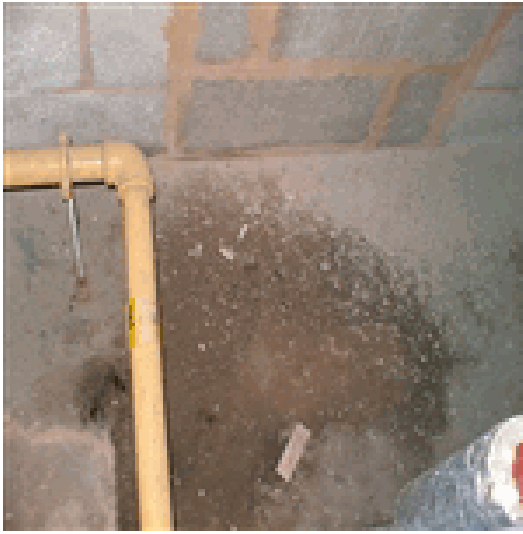
Reference	102	Sample number	01038-01-46-29
Survey date	17-Jul-17	Presumed	No
Building :	01 00 Main School		
Floor		Room	046 Boiler Room
Location	FLOOR BEHIND BOILERS		
Quantity sampled	2 M2	Use	Debris
Material assessment			
Product type	AIB, Textiles, Rope, etc(see Use) (2)		
Damage/deterioration	High damage (3)		
Surface treatment	Unsealed lagging&sprays (3)		
Asbestos type	Not asbestos (0)

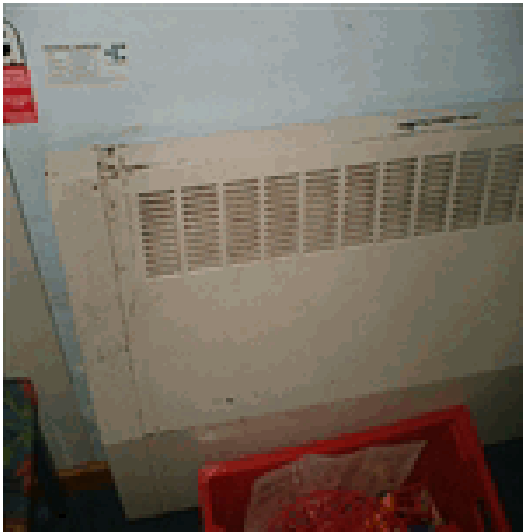
Reference	103	Sample number	01038-01-45-P01
Survey date	17-Jul-17	Presumed	Yes
Building :	01 00 Main School		
Floor	G	Room	045 Quiet room
Location	WALL MOUNTED		
Quantity sampled	1 NO	Use	Asbestos Insulating Board
Material assessment			
Product type	AIB, Textiles, Rope, etc(see Use) (2)		
Damage/deterioration	Low damage (1)		
Surface treatment	Unsealed AIB, enc Lagging&Spray (2)		
Asbestos type	Crocidolite (3)

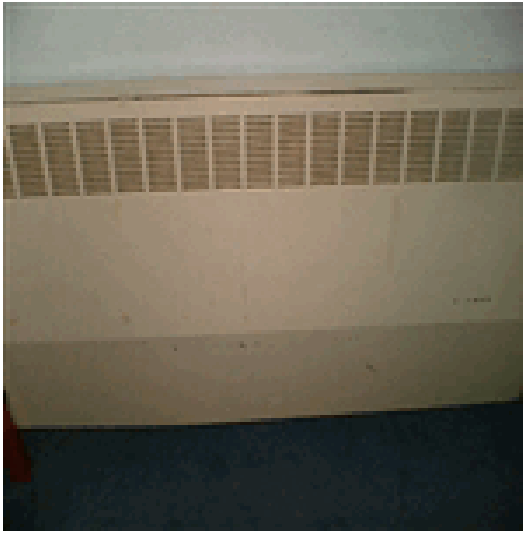
Reference	106	Sample number	01038-01-43-P01
Survey date	17-Jul-17	Presumed	Yes
Building :	01 00 Main School		
Floor	G	Room	043 Quiet room
Location	WALL MOUNTED		
Quantity sampled	1 NO	Use	Asbestos Insulating Board

Product type	AIB, Textiles, Rope, etc (see Use) (2)
Damage/deterioration	Low damage (1)
Surface treatment	Unsealed AIB, enc Lagging & Spray (2)
Asbestos type	Crocidolite (3)

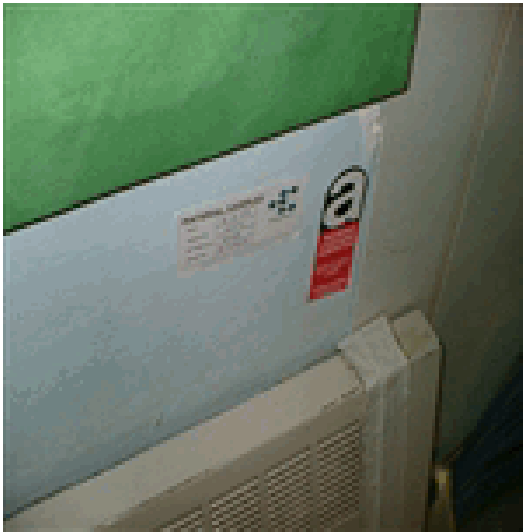
Reference	107	Sample number	01038-01-43-25
Survey date	17-Jul-17	Presumed	No
Building :	01 00 Main School		
Floor	G	Room	043 Quiet room
Location	UNDER WINDOW		
Quantity sampled	3M2	Use

Product type	AIB, Textiles, Rope, etc (see Use) (2)
Damage/deterioration	Medium damage (2)
Surface treatment	Enc Lagging & Sprays, AIB, etc (1)
Asbestos type	Amphibole ex. Crocidolite (2)

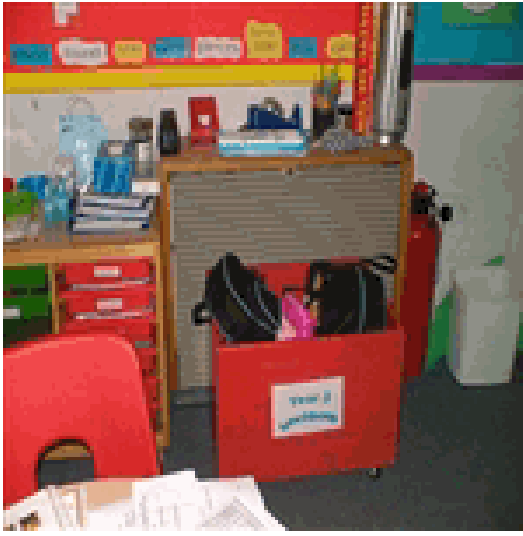
Reference	108	Sample number	01038-01-42-P01
Survey date	17-Jul-17	Presumed	No
Building :	01 00 Main School		
Floor		Room	042 Classroom
Location	WALL MOUNTED		
Quantity sampled	1 NO	Use	Asbestos Insulating Board

Product type	AIB, Textiles, Rope, etc (see Use) (2)
Damage/deterioration	High damage (3)
Surface treatment	Unsealed AIB, enc Lagging & Spray (2)
Asbestos type	Crocidolite (3)

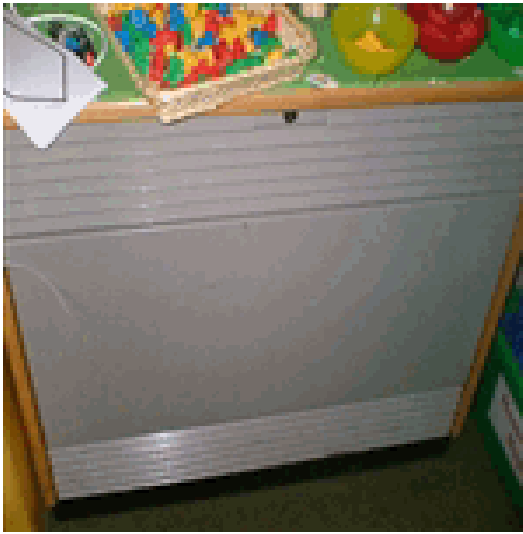
Reference	109	Sample number	01038-01-40-P01
Survey date	17-Jul-17	Presumed	No
Building :	01 00 Main School		
Floor	G	Room	040 Classroom
Location	WALL MOUNTED		
Quantity sampled	1 NO	Use	Asbestos Insulating Board

Product type	AIB, Textiles, Rope, etc (see Use) (2)
Damage/deterioration	High damage (3)
Surface treatment	Unsealed AIB, enc Lagging & Spray (2)
Asbestos type	Crocidolite (3)

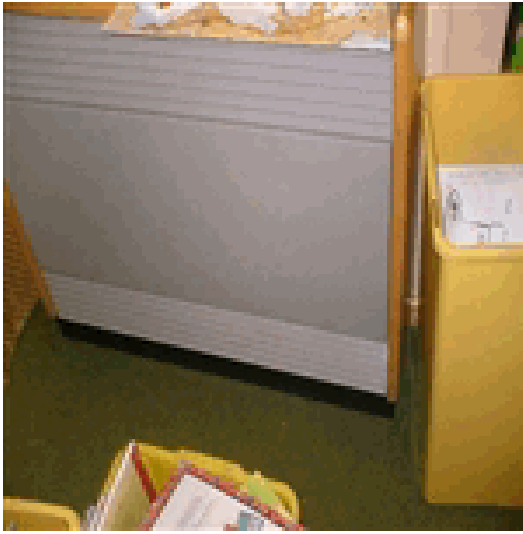
Reference **110** Sample number **01038-01-38-P01**
 Survey date **17-Jul-17** Presumed **Yes**
 Building : **01 00 Main School**
 Floor Room **038 Classroom**
 Location **WALL MOUNTED**
 Quantity sampled **1 NO** Use **Asbestos Insulating Board**

Product type AIB, Textiles, Rope, etc (see Use) (2)
 Damage/deterioration Low damage (1)
 Surface treatment Unsealed AIB, enc Lagging & Spray (2)
 Asbestos type Crocidolite (3)

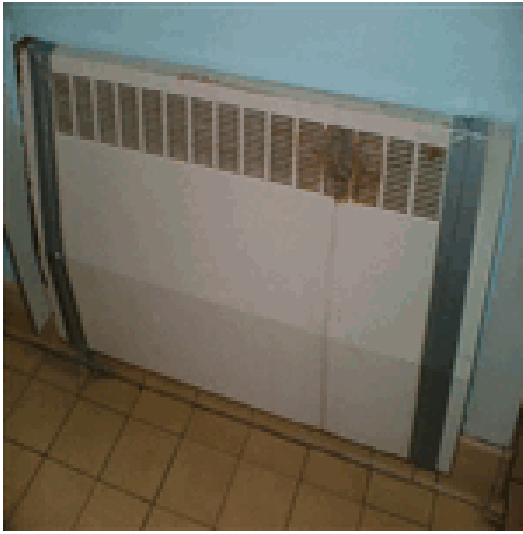
Reference	116	Sample number	01038-01-32-P01
Survey date	17-Jul-17	Presumed	Yes
Building :	01 00 Main School		
Floor		Room	032 Pupil WC
Location	WALL MOUNTED		
Quantity sampled	1 NO	Use	Asbestos Insulating Board

Product type	AIB, Textiles, Rope, etc (see Use) (2)
Damage/deterioration	Low damage (1)
Surface treatment	Unsealed AIB, enc Lagging & Spray (2)
Asbestos type	Crocidolite (3)

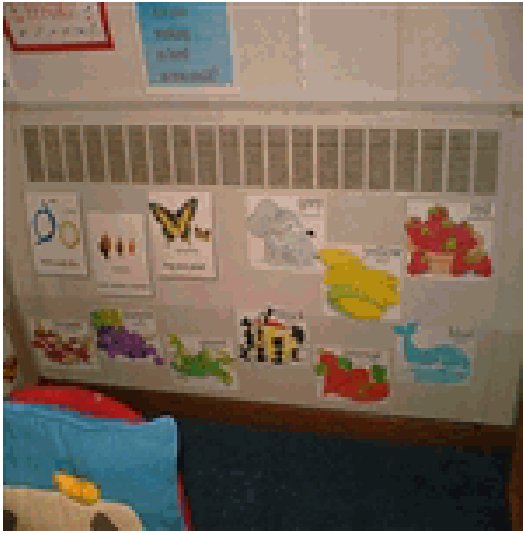
Reference	120	Sample number	01038-01-29-P01
Survey date	17-Jul-17	Presumed	Yes
Building :	01 00 Main School		
Floor	G	Room	029 Office
Location	WALL MOUNTED		
Quantity sampled	1 NO	Use	Asbestos Insulating Board

Product type	AIB, Textiles, Rope, etc (see Use) (2)
Damage/deterioration	Low damage (1)
Surface treatment	Unsealed AIB, enc Lagging & Spray (2)
Asbestos type	Crocidolite (3)

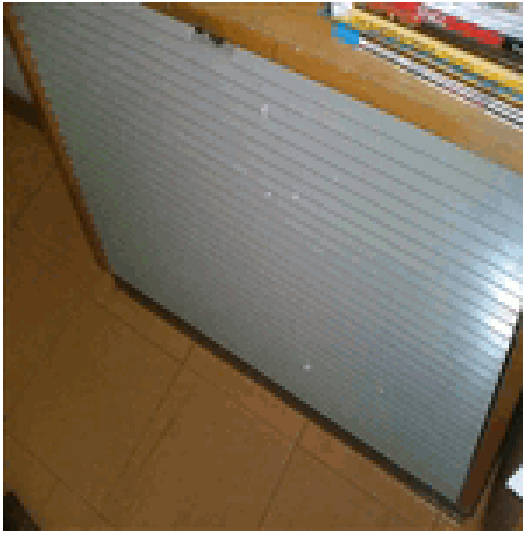
Reference	122	Sample number	01038-01-27-P01
Survey date	17-Jul-17	Presumed	No
Building :	01 00 Main School		
Floor		Room	027 Classroom
Location	WALL MOUNTED		
Quantity sampled	1 NO	Use	Asbestos Insulating Board

Product type	AIB, Textiles, Rope, etc (see Use) (2)
Damage/deterioration	High damage (3)
Surface treatment	Unsealed AIB, enc Lagging & Spray (2)
Asbestos type	Crocidolite (3)

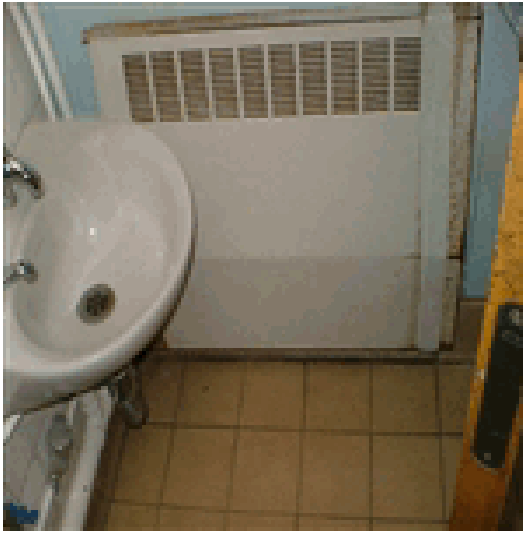
Reference	124	Sample number	01038-01-26-P01
Survey date	17-Jul-17	Presumed	Yes
Building :	01 00 Main School		
Floor		Room	026 Pupil WC
Location	WALL MOUNTED		
Quantity sampled	1 NO	Use	Asbestos Insulating Board

Product type	AIB, Textiles, Rope, etc (see Use) (2)
Damage/deterioration	Low damage (1)
Surface treatment	Unsealed AIB, enc Lagging & Spray (2)
Asbestos type	Crocidolite (3)

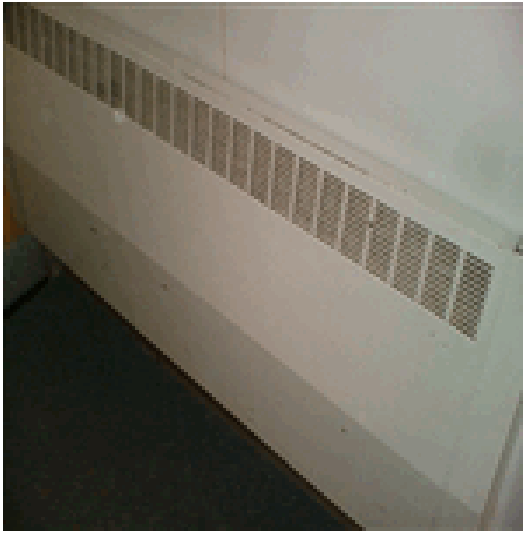
Reference	126	Sample number	01038-01-24-P01
Survey date	17-Jul-17	Presumed	Yes
Building :	01 00 Main School		
Floor		Room	024 Circulation
Location	WALL MOUNTED		
Quantity sampled	1 NO	Use	Asbestos Insulating Board

Product type	AIB, Textiles, Rope, etc (see Use) (2)
Damage/deterioration	Low damage (1)
Surface treatment	Unsealed AIB, enc Lagging & Spray (2)
Asbestos type	Crocidolite (3)

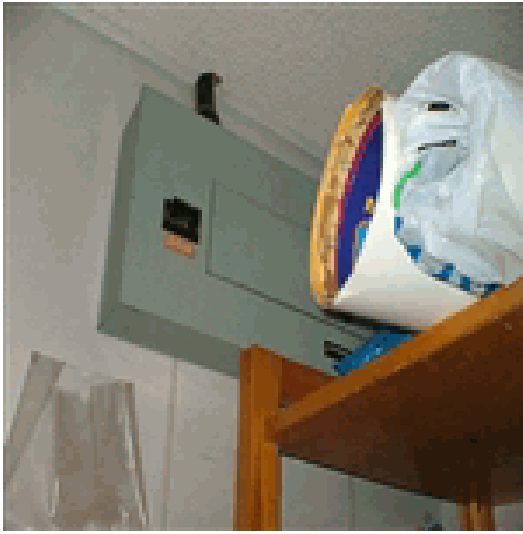
Reference	130	Sample number	01038-01-22-P02
Survey date	17-Jul-17	Presumed	Yes
Building :	01 00 Main School		
Floor		Room	022 Classroom
Location	WALL MOUNTED		
Quantity sampled	1 NO	Use	Asbestos Insulating Board

Product type	AIB, Textiles, Rope, etc(see Use) (2)
Damage/deterioration	Low damage (1)
Surface treatment	Unsealed AIB, enc Lagging&Spray (2)
Asbestos type	Crocidolite (3)

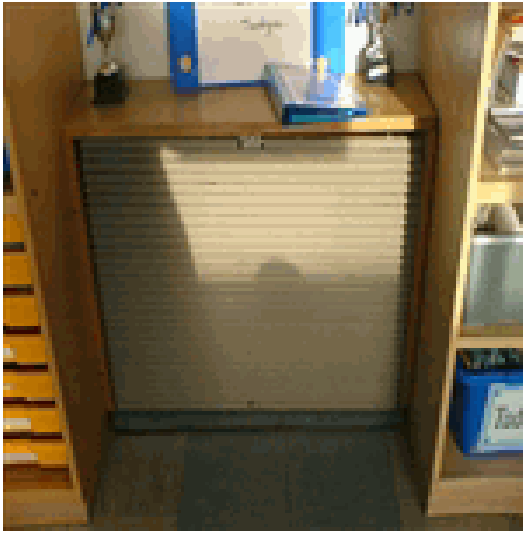
Reference	139	Sample number	01038-01-15-P01
Survey date	17-Jul-17	Presumed	Yes
Building :	01 00 Main School		
Floor	G	Room	015 Resources
Location	WALL MOUNTED		
Quantity sampled	1 NO	Use	Asbestos Insulating Board

Product type	AIB, Textiles, Rope, etc (see Use) (2)
Damage/deterioration	High damage (3)
Surface treatment	Unsealed AIB, enc Lagging & Spray (2)
Asbestos type	Crocidolite (3)

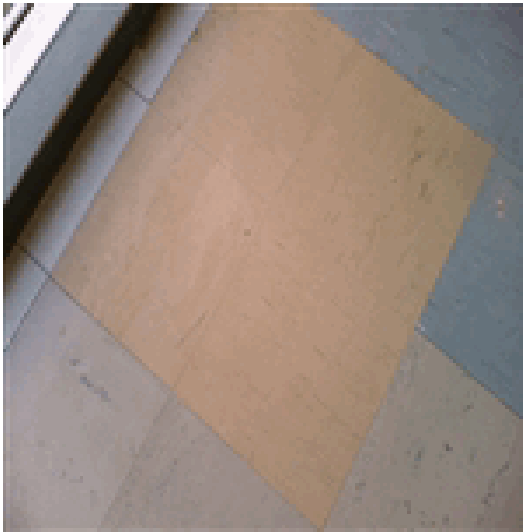
Reference	142	Sample number	01038-01-15-22
Survey date	17-Jul-17	Presumed	No
Building :	01 00 Main School		
Floor	G	Room	015 Resources
Location	BEIGE TILE PATCHES TO FLOOR		
Quantity sampled	2M2	Use	Flooring
Material assessment			
Product type	Asb-Reinfd comps,etc (see Use) (1)		
Damage/deterioration	Good condition (0)		
Surface treatment	Composite materials (0)		
Asbestos type	Chrysotile (1)

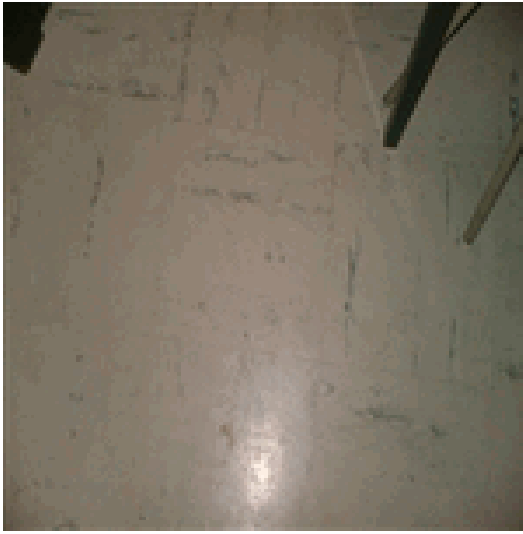
Reference **145** Sample number **01038-01-14-08**
 Survey date **17-Jul-17** Presumed **No**
 Building : **01 00 Main School**
 Floor Room 014 Craft Room
 Location GREY AND BLACK. WHOLE FLOO
 Quantity sampled 30M2 Use Flooring

Product type Asb-Reinfd comps,etc (see Use) (1)
 Damage/deterioration Good condition (0)
 Surface treatment Composite materials (0)
 Asbestos type Chrysotile (1)

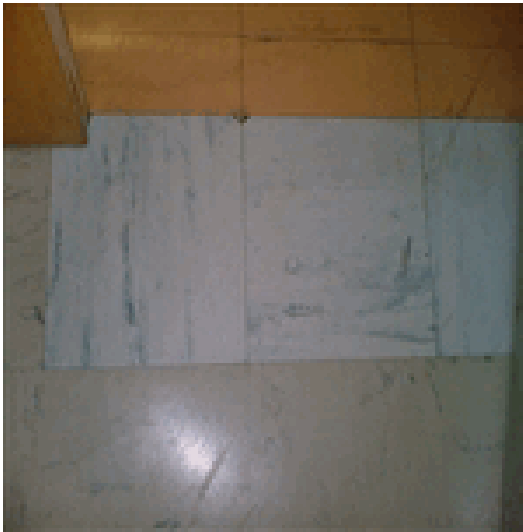
Reference	148	Sample number	01038-01-14-12
Survey date	17-Jul-17	Presumed	No
Building :	01 00 Main School		
Floor		Room	014 Craft Room
Location	GREY FLOOR TILES		
Quantity sampled	2M2	Use	Flooring
Material assessment			
Product type	Asb-Reinfd comps,etc (see Use) (1)		
Damage/deterioration	Good condition (0)		
Surface treatment	Composite materials (0)		
Asbestos type	Chrysotile (1)

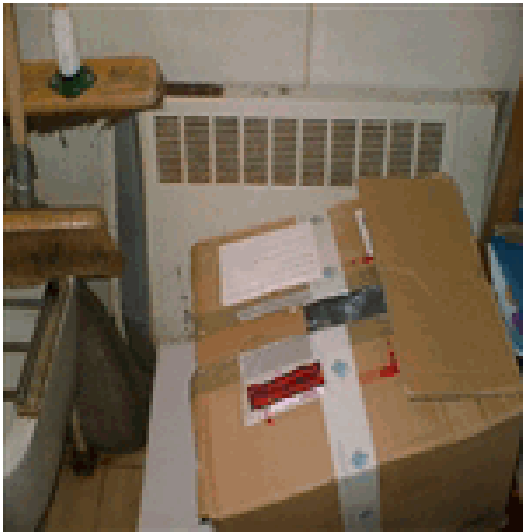
Reference	166	Sample number	01038-01-04-P01
Survey date	17-Jul-17	Presumed	Yes
Building :	01 00 Main School		
Floor		Room	004 Caretaker
Location	WALL MOUNTED		
Quantity sampled	1 NO	Use	Asbestos Insulating Board
Material assessment			
Product type	AIB,Textiles,Rope,etc(see Use) (2)		
Damage/deterioration	Low damage (1)		
Surface treatment	Unsealed AIB,enc Lagging&Spray (2)		
Asbestos type	Crocidolite (3)

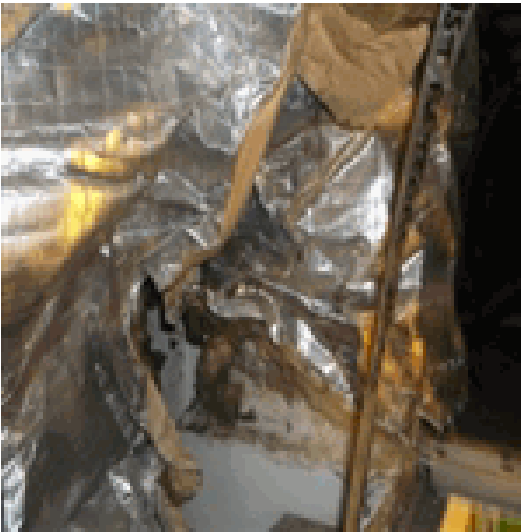
Reference	196	Sample number	01038-01-42-73
Survey date	17-Jul-17	Presumed	No
Building :	01 00 Main School		
Floor		Room	042 Classroom
Location			
Quantity sampled	>10m2 <50m2	Use	Asbestos Insulating Board
Material assessment			
Product type	AIB, Textiles, Rope, etc (0)		
Damage/deterioration	Low damage (1)		
Surface treatment	Unsealed AIB, enc Lagging & Spray (0)		
Asbestos type	Amphibole ex. Crocidolite (2)

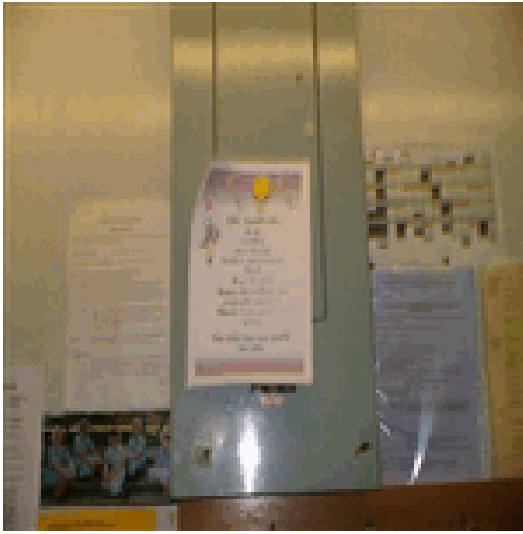
Reference **88** Sample number **01038-50-03-P01**
 Survey date **17-Jul-17** Presumed **Yes**
 Building : **50 00 Catering Services**
 Floor Room 003 Office
 Location WALL MOUNTED
 Quantity sampled 1 NO Use Asbestos Insulating Board

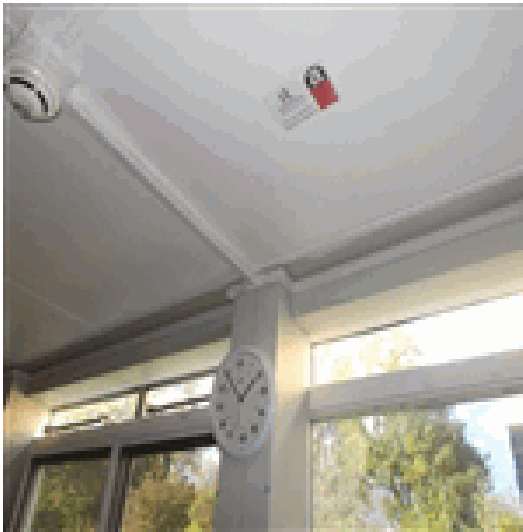
Reference 171 Sample number 01038-50-01-52P
Survey date 17-Jul-17 Presumed Yes
Building : 50 00 Catering Services
Floor G Room 001 Kitchen
Location
Quantity sampled 10m <50m linear Use Asbestos Insulating Board

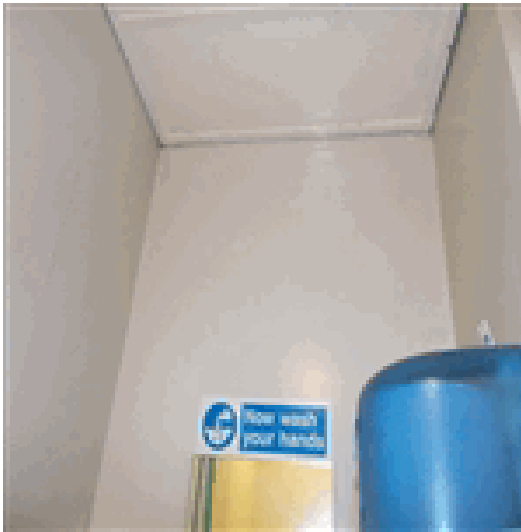
Reference 173 Sample number 01038-50-02-52P
Survey date 17-Jul-17 Presumed Yes
Building : 50 00 Catering Services
Floor Room 002 Staff WC
Location
Quantity sampled 10m linear Use Asbestos Insulating Board
