## **APPENDIX AL**

### **SECTION 19 REPORT – WOODBOROUGH – STORM BABET, OCTOBER 2023**

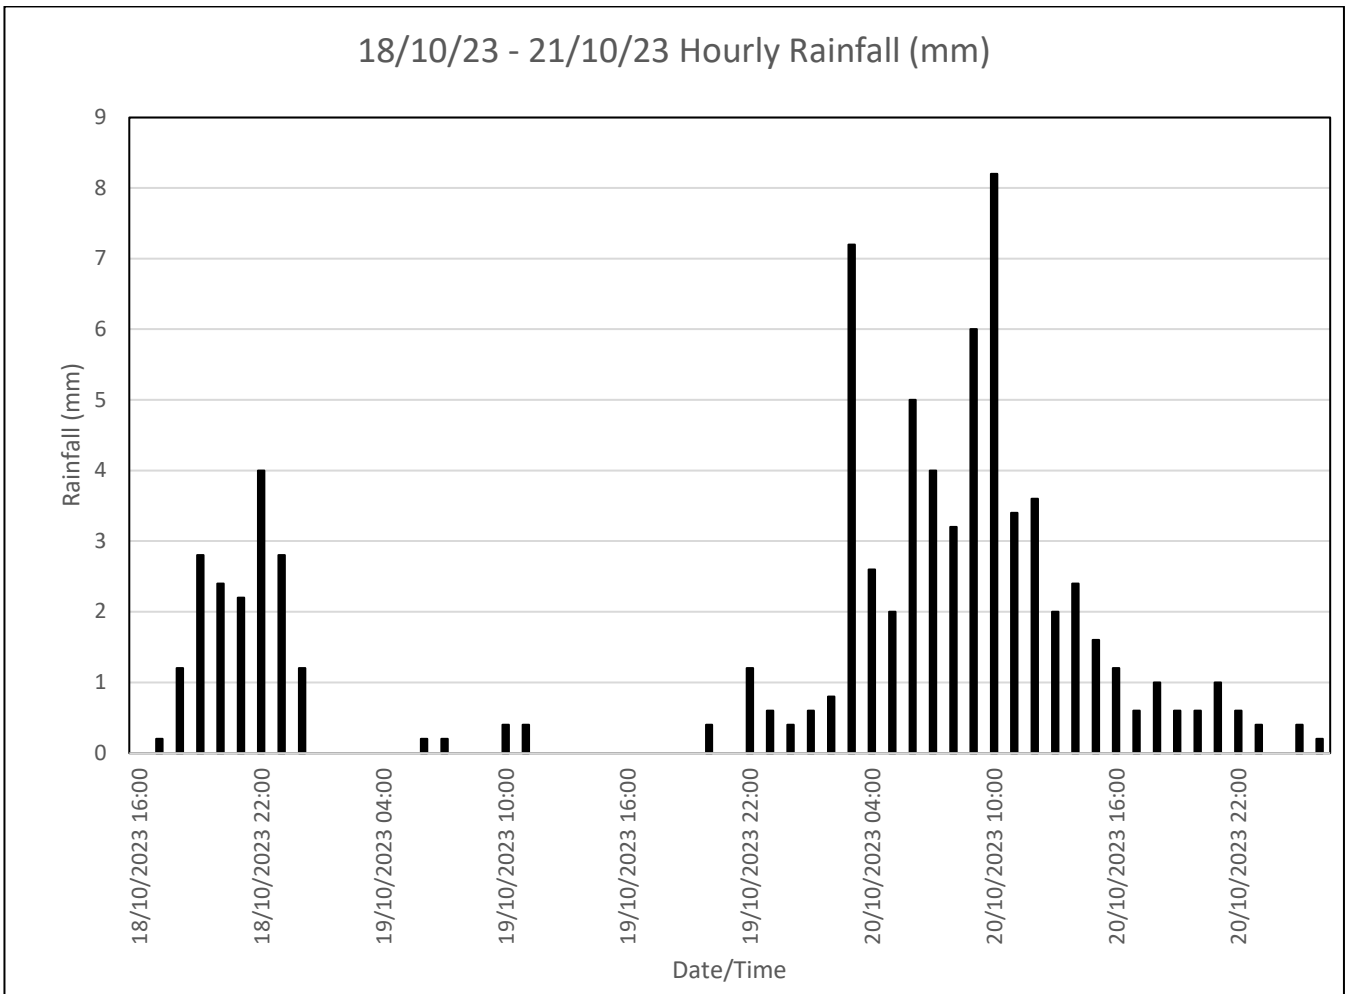
8. On the 20<sup>th</sup> October, during Storm Babet, Woodborough suffered a flood event caused by sustained heavy rainfall. Between the 18<sup>th</sup> and 20<sup>th</sup> of October, 80mm of rainfall was recorded at the Calverton rain gauge (Figure 1). A peak water level of 1.115m was recorded at the Woodborough Brook Level Gauge at 11:45. Consequently, 49 residential properties were subject to internal flooding with more suffering flooding to gardens and outbuildings.
9. This storm came after a prolonged period of persistent rain which had saturated the ground resulting in flooding of roads and properties quicker than they would following a dry period.

**Figure 1.** Calverton Hourly Rainfall 18<sup>th</sup> October 2023. Data supplied by the Environment Agency.

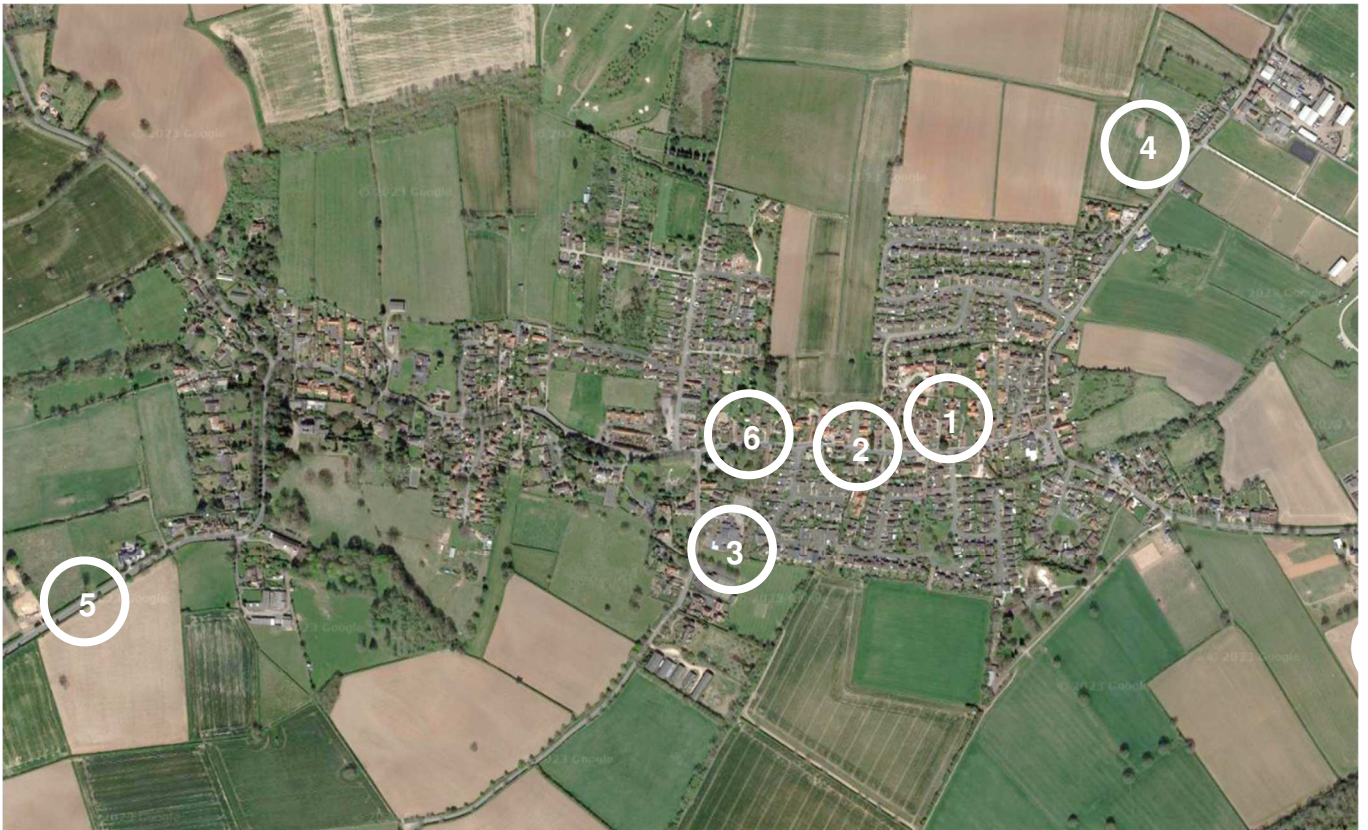
10. A location map of Woodborough is shown in Figure 2. The areas affected were:
  - Main Street (30 properties)
  - Smalls Croft (11 properties)
  - Pinfold Crescent (2 properties)
  - Shelt Hill (2 properties)
  - Bank Hill (3 properties)
  - Pinfold Close (1 property)

**Figure 2.** Flood affected areas across Woodborough. Main Street (1), Smalls Croft (2), Pinfold Crecent (3), Shelt Hill (4), Bank Hill (5), Pinfold Close (6).

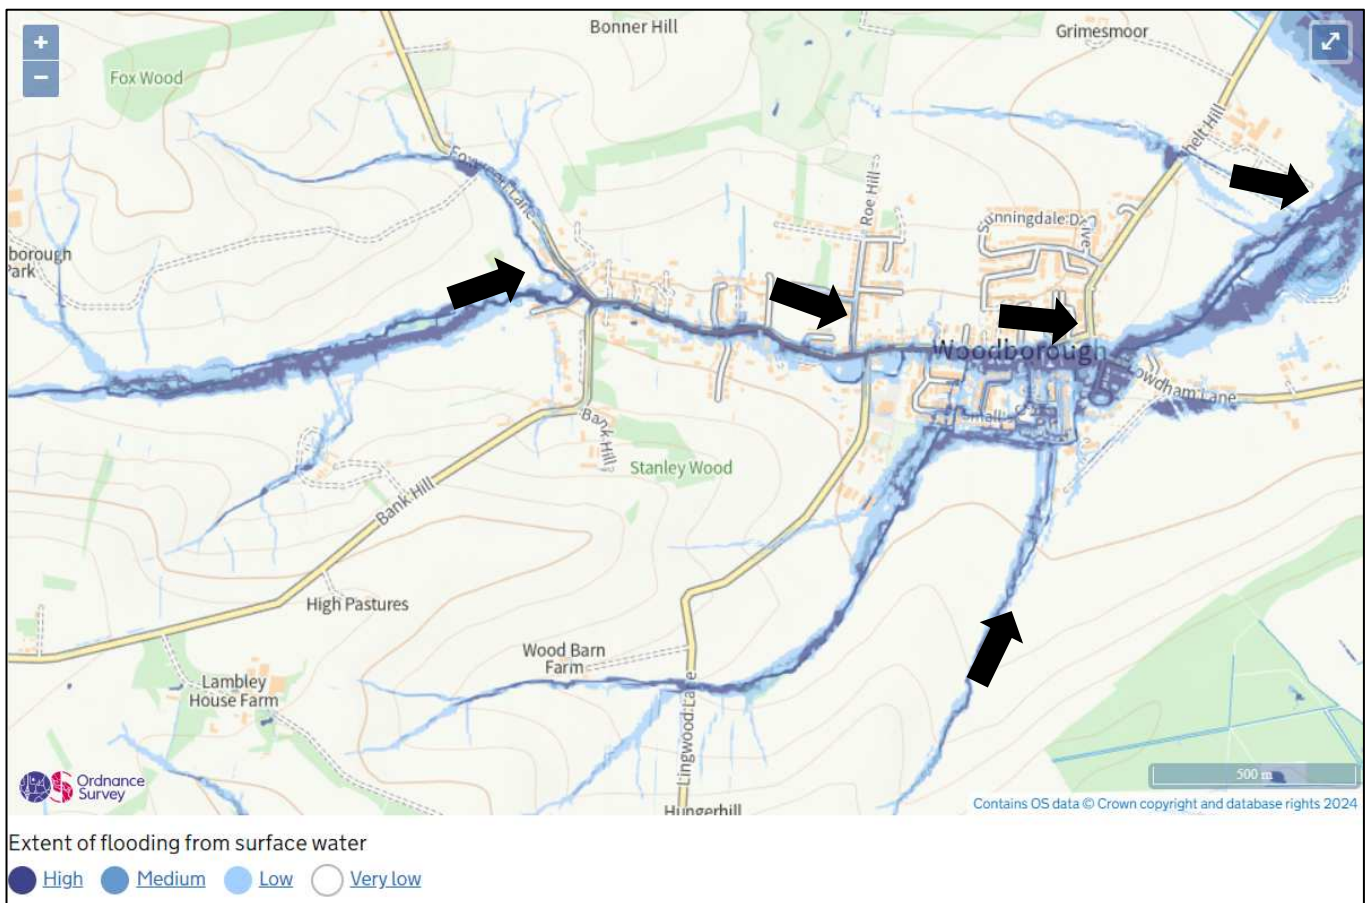
**Figure 3.** Surface Water Flood Risk Mapping for Woodborough. Main Street (1), Smalls Croft (2), Pinfold Crecent (3), Shelt Hill (4), Bank Hill (5), Pinfold Close (6).

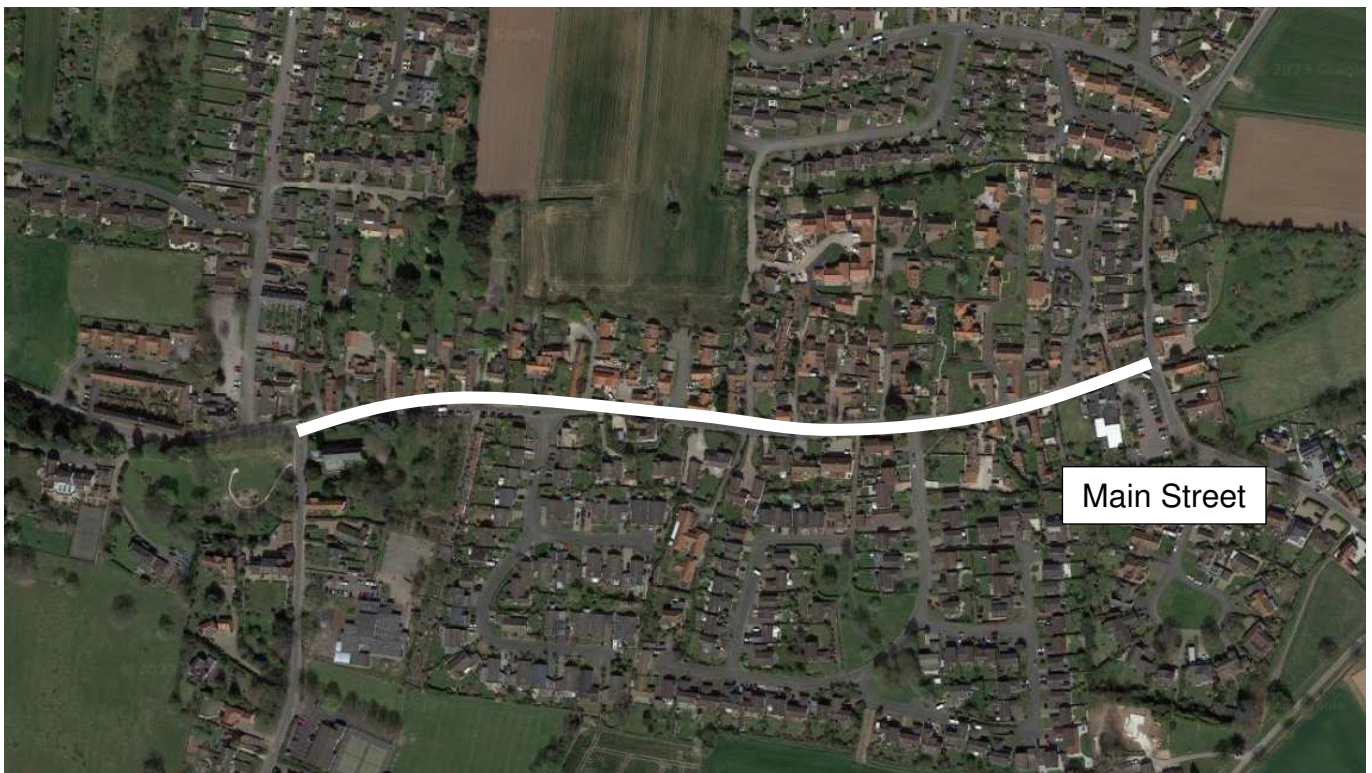
**Figure 4.** Main Street.

Areas impacted by flooding on Main Street are shown in Figure 4. In total, 28 residential properties and 2 businesses were impacted by flooding.

The Woodborough Brook flows along the south side of Main Street and is joined on Main Street by two tributaries originating from the south of the catchment.

During Storm Babet, upper catchment runoff influenced by intense rainfall caused a record water level to be recorded at the Woodborough Brook water level gauge. During the event, the watercourse burst its banks with water then flowing eastward along Main Street which is shown as a surface water flowpath in Figure 3. The water entered several properties as it flowed along the road. Some properties along Main Street are built at a lower elevation than the road itself. As a result, water flowing along the highway flowed through property boundaries and into some properties.

The flooding along Main Street also cut off many residents in Woodborough who were unable to get out or into the village for many hours.

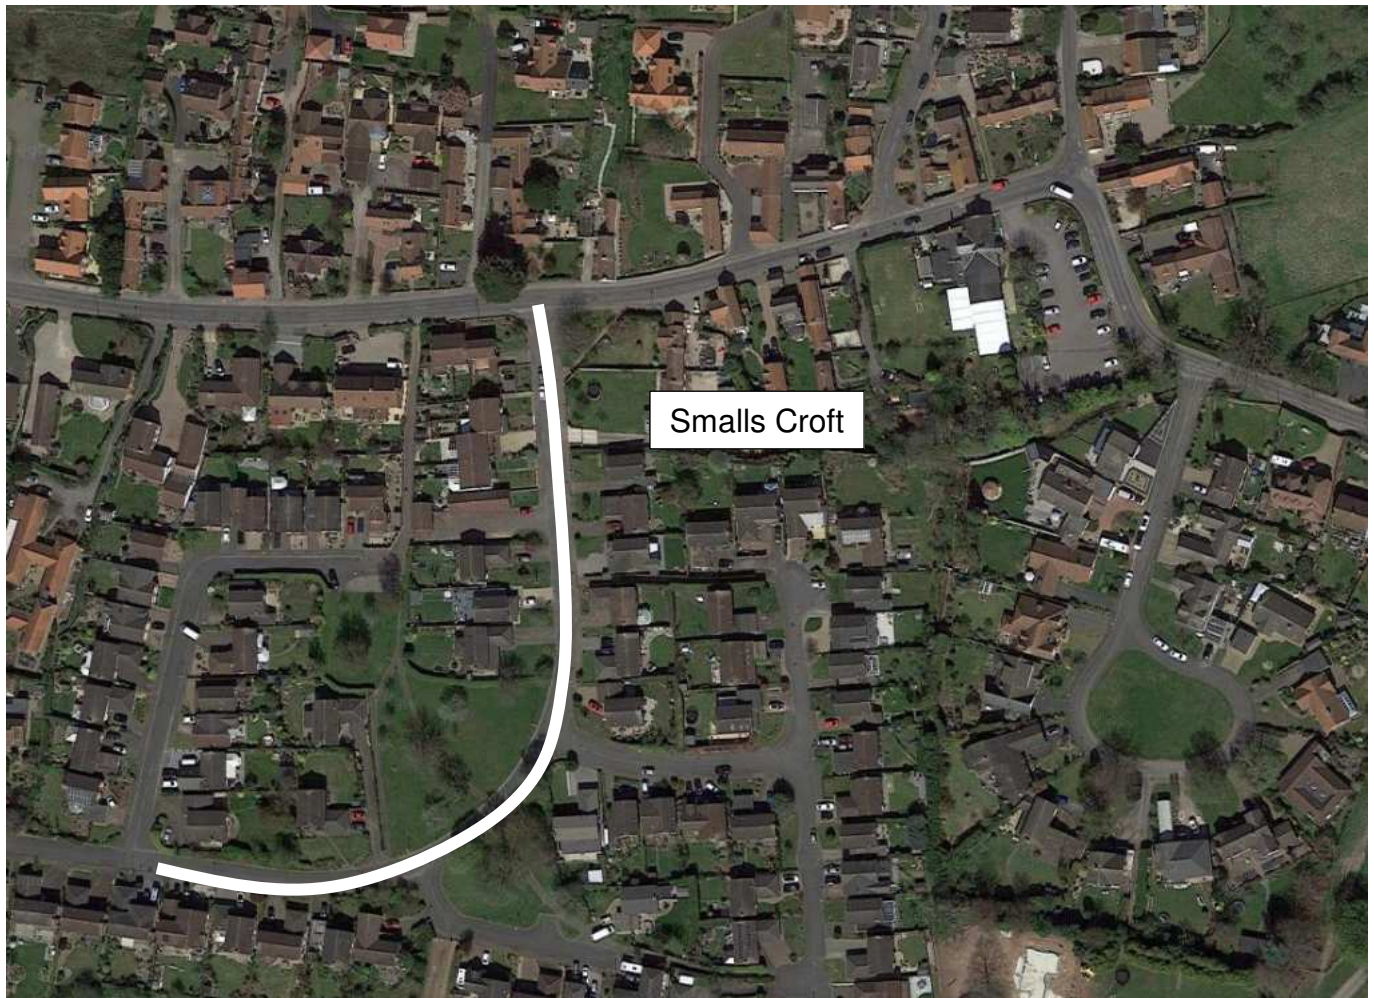
**Figure 5.** *Smalls Croft.*

On Smalls croft, 11 residential properties were internally flooded by water from the Woodborough Brook which burst it bank and flowed down Main Street. A location plan is shown in Figure 5. Due to its lower topography, water pooled on Smalls Croft which was observed to be of a depth of roughly 1m in some places.

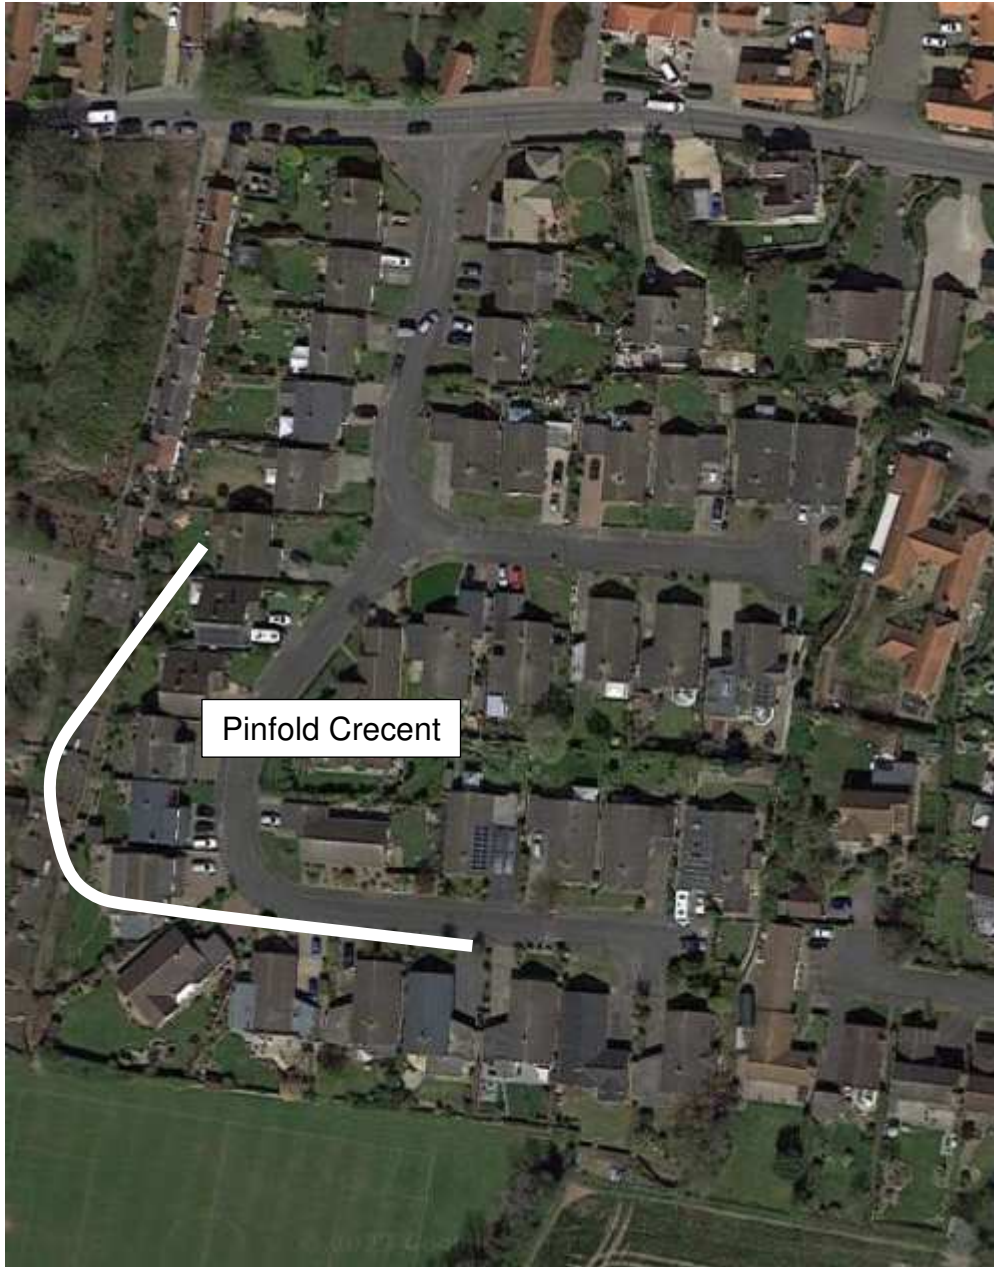
**Figure 6.** *Pinfold Crescent.*

On Pinfold Crescent, two residential properties were internally flooded (Figure 6). A ditch is present to the South of Pinfold Crescent which joins a tributary of the Woodborough Brook. A surface water flowpath is also present which flows across the field from the South. Intense rainfall and significant upper catchment runoff caused the ditch to flood some properties on Pinfold Crescent.

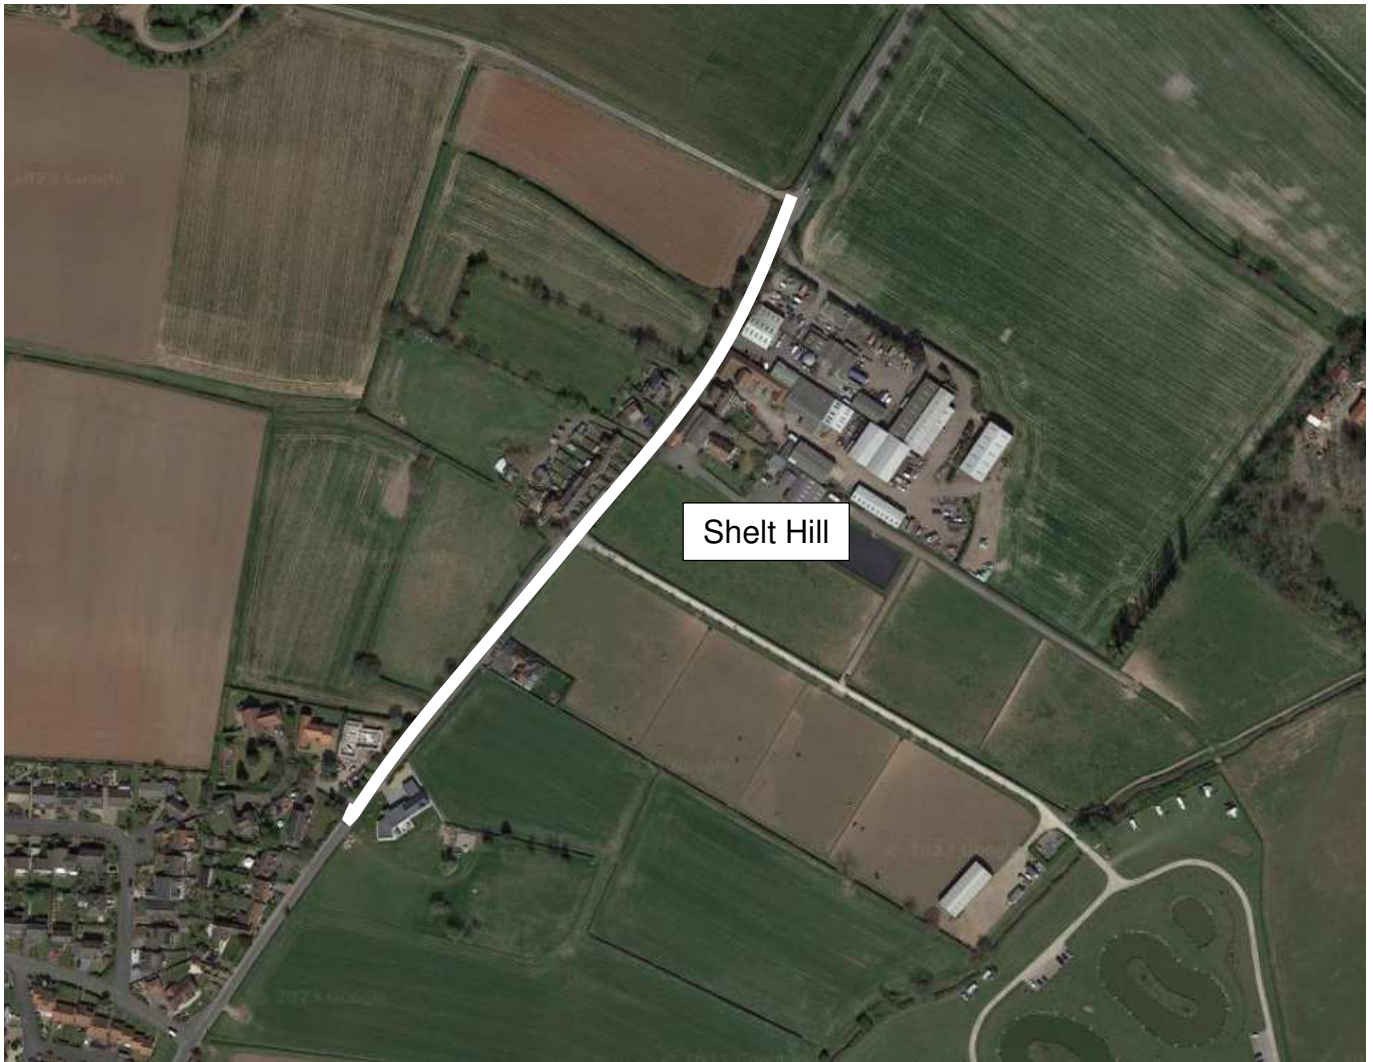
**Figure 7.** Shelt Hill.

Two residential properties suffered internal flooding on Shelt Hill (Figure 7). A surface water flowpath is present which flows from the west of Shelt Hill to the East (Figure 3). The water is managed by a drainage ditch system in the field which then flows under the road of Shelt Hill. Due to intense rainfall and enhanced overland flow, the culvert was overwhelmed and water pooled on the western side of the road as the road is higher than the properties. This caused internal flooding to properties adjacent to the road.

27. Investigations by NCC into flooding on Bank Hill and Shelt Hill are ongoing. Meetings with residents have been held to discuss the flooding experienced.

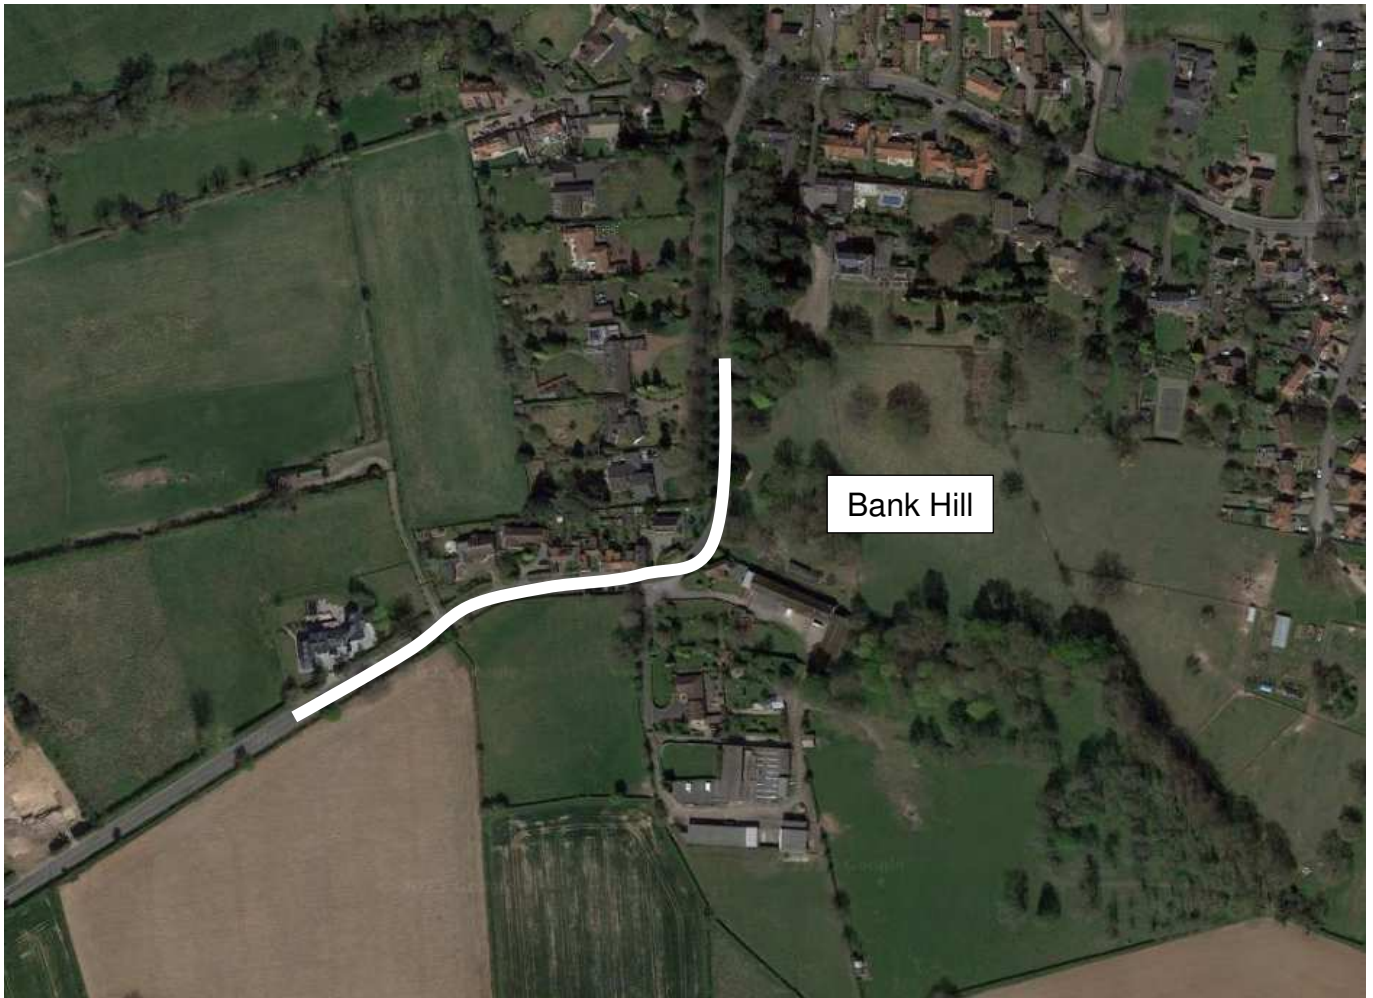
**Figure 8.** Bank Hill.

Three residential properties were flooded on Bank Hill (Figure 8). A drainage ditch on the south of Bank Hill flows into a culvert which was reported to be overwhelmed during Storm Babet. Water then flowed into properties after flowing along the highway.

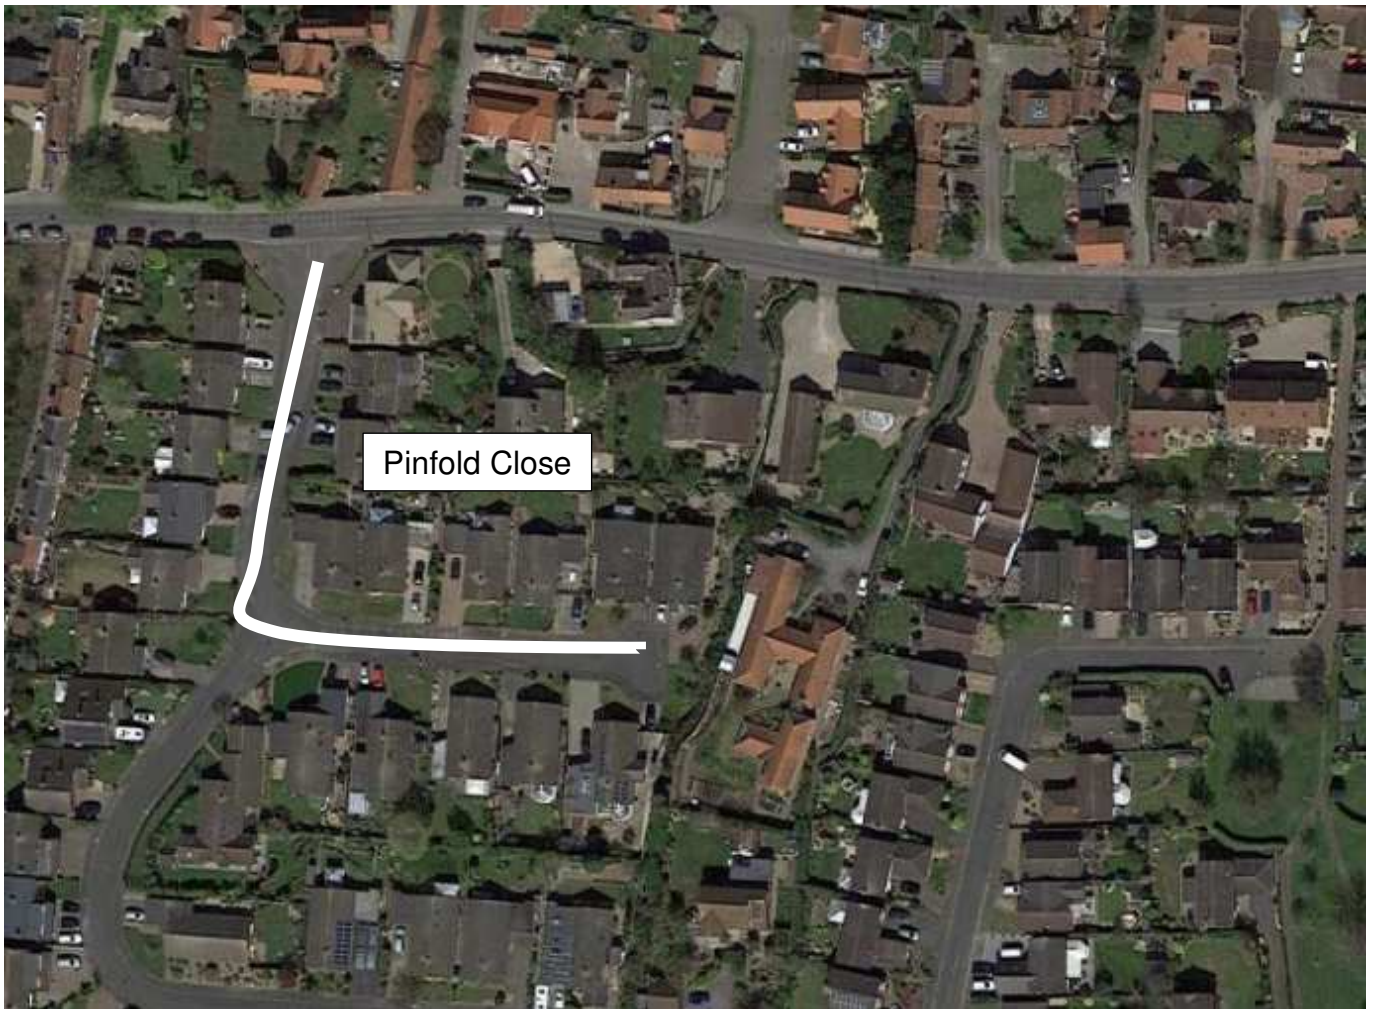
**Figure 9.** Pinfold Close.

On Pinfold Close, 1 residential property was internally flooded by water from the Woodborough Brook which burst its bank and flowed down Main Street (Figure 9). Due to its lower topography, water pooled in areas of Pinfold Close which then affected the property.
