## **APPENDIX A**

### **SECTION 19 REPORT – SUTTON ON TRENT – 2 JUNE 2018**

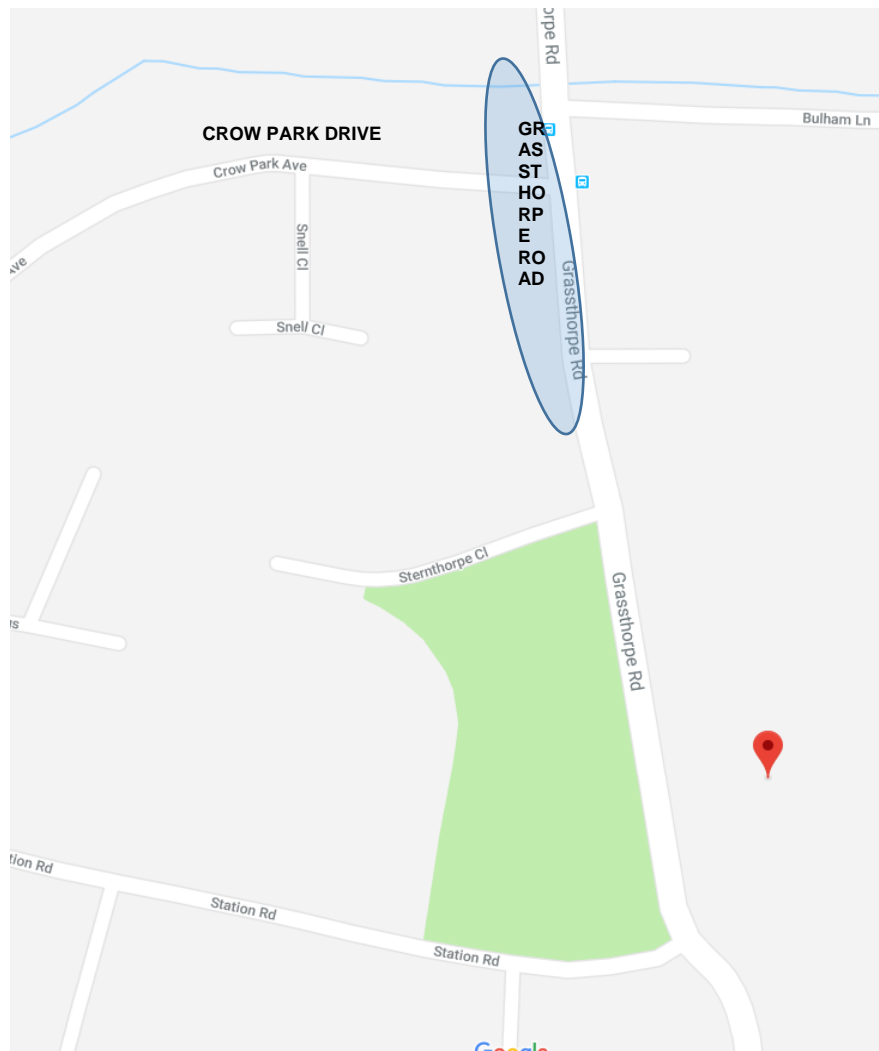
**Figure 3. Area affected by internal flooding on Grassthorne Rd / Crow Park Drive**

7. The rainfall event resulted in 32 properties and businesses experiencing significant internal flooding. Figures 2 and 3 highlight in more detail the areas affected by internal flooding.

Flooding in the Grassthorpe Road / Crow Park Avenue area is believed to be due to the outfall from the highway drainage system to the Bulham Lane drain being submerged and therefore ineffective. Photo 8 below shows the highway drainage outfall. This situation is being further investigated to both confirm the operation and identify if any alterations can be made to reduce the future risk of flooding.

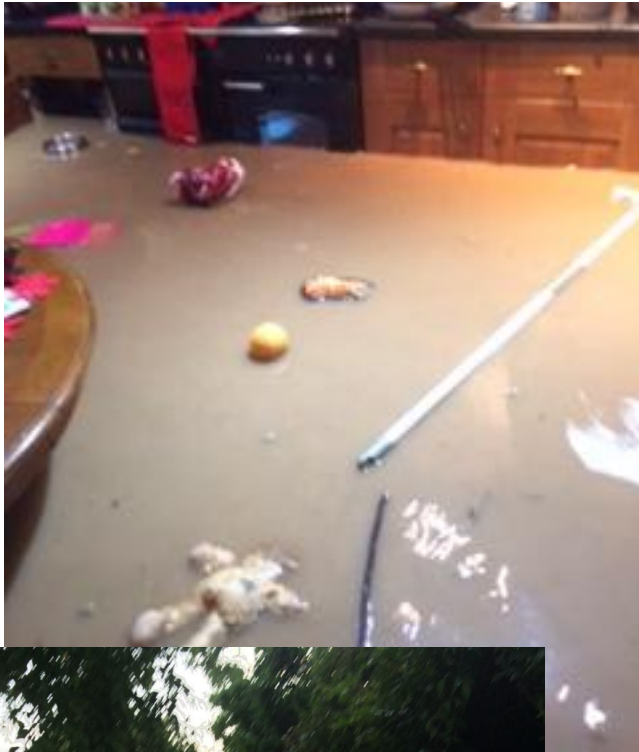
**Photo 4 – Internal Flooding on  
Old Great North Road**

The water then flowed out onto the Old Great North Road and surrounding areas where the natural topography resulted in the water being directed towards properties and businesses resulting in significant internal flooding. Photos 4-7 give examples of the devastation experienced.
