# **West Bridgford – Hostile Vehicle Mitigation Measures**

**Road Safety Audit  
Stage 1 - Completion of Preliminary Design**

SA2185A  
May 2018

Stage 1 Road Safety Audit

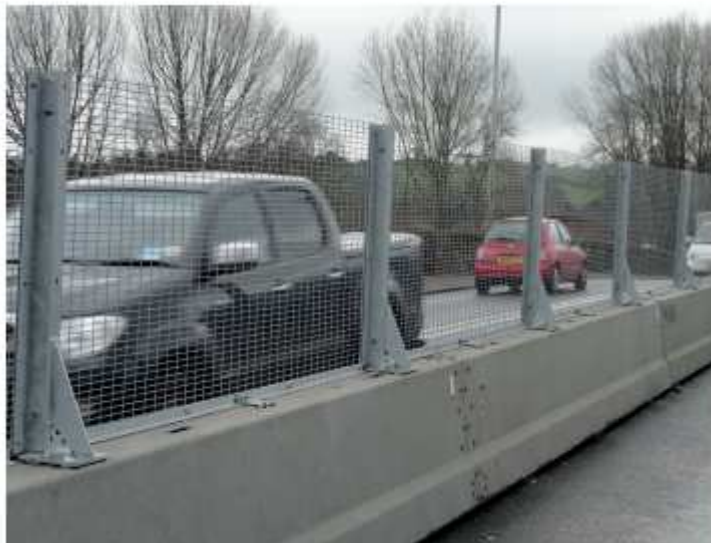
The Barriers are 800mm high. These have been installed on Trent bridge where pedestrians are unlikely to cross the 6 lanes of traffic and it has barrier both sides. On Radcliffe Road and Bridgford Road pedestrians cross regularly, especially during cricket matches and are likely to continue doing this by climbing over the barrier to get to amenities on the other side where there is no barrier. A pedestrian could trip over into live traffic and a collision occur likely resulting in serious or fatal injury.

Fences should be added to deter pedestrians from climbing over the barrier and to use the pedestrian crossing points.
