APPENDIX A

SECTION 19 REPORT – SUTTON ON TRENT – 2 JUNE 2018

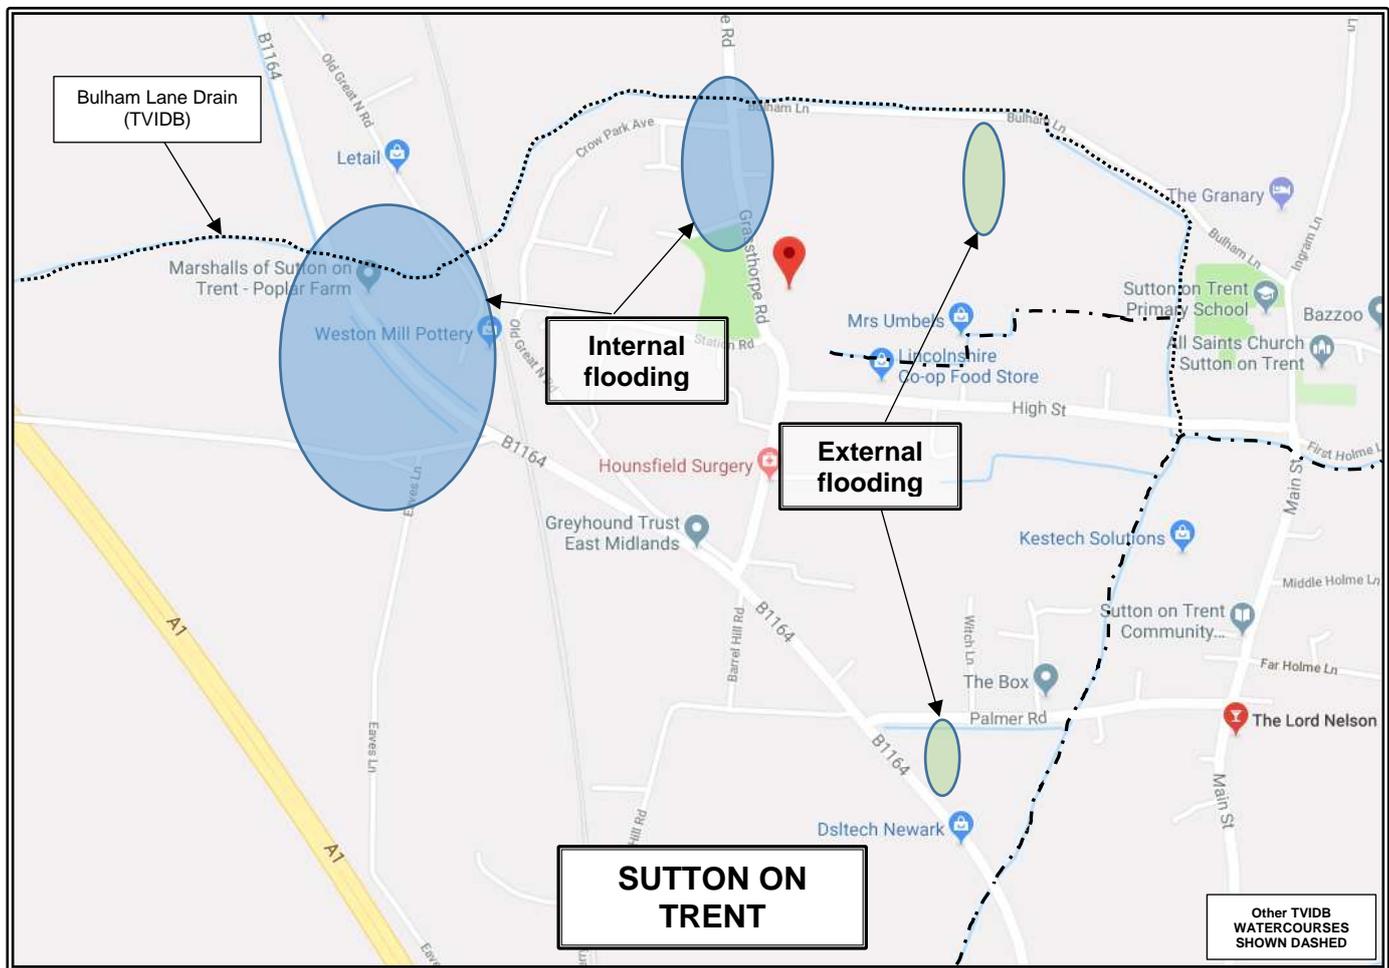
Figure 1. Sutton on Trent Catchment, flooding locations and TVIDB watercourses

On 2nd June 2018 the village of Sutton-on-Trent was subjected to two pulses of torrential rain; the first at 10am and the second at around 5pm centred to the west of the catchment resulting in significant flooding to 32 properties and businesses. Figure 1 shows the catchment, areas affected by the flooding and the TVIDB watercourses.

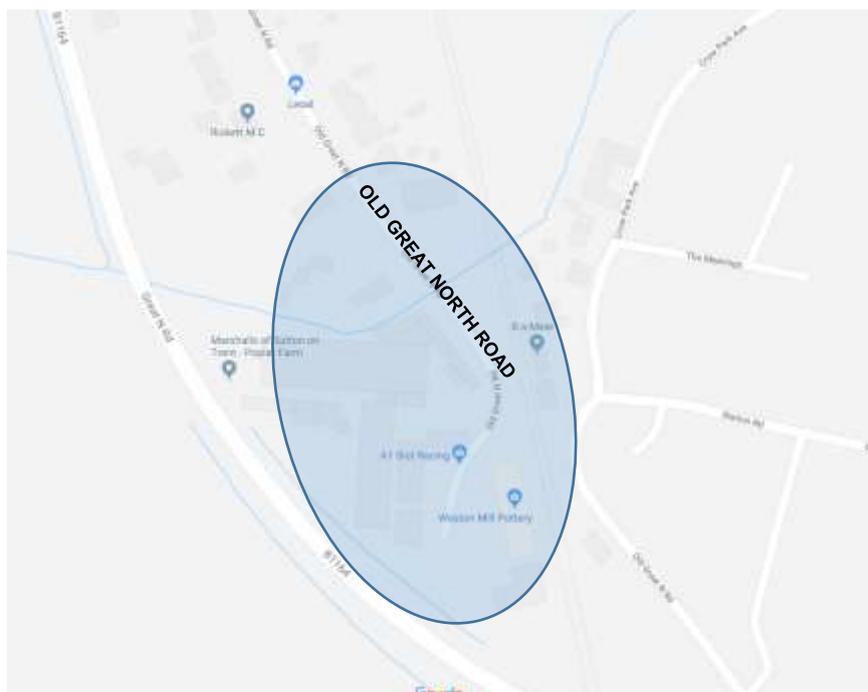
Figure 2. Area affected by internal flooding on Old Great North Road

7. The rainfall event resulted in 32 properties and businesses experiencing significant internal flooding. Figures 2 and 3 highlight in more detail the areas affected by internal flooding.

Investigations have shown that the flooding in the Old Great North Road area was a result of the Bulham Lane Drain (BLD) overtopping in a number of locations. The initial understanding is that these locations relate to sections of the BLD that have been culverted and have highlighted the need to carry out further detailed hydraulic assessments of the watercourse in order to fully understand how it performed during the event. This work has already been commissioned by TVIDB and is programmed to be completed by the end of 2018. Photos 1,2 and 3 overleaf show examples of the culverted section of the BLD.

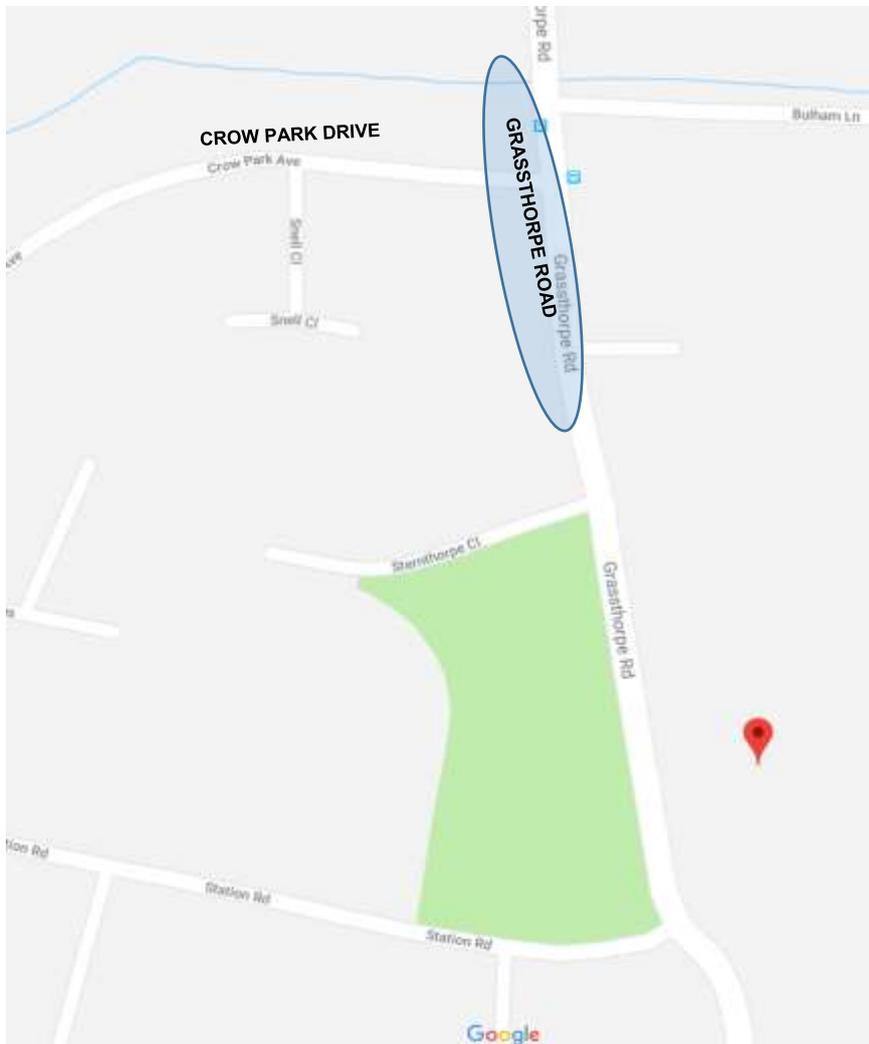
Figure 3. Area affected by internal flooding on Grassthorpe Rd / Crow Park Drive

Flooding in the Grassthorpe Road / Crow Park Avenue area is believed to be due to the outfall from the highway drainage system to the Bulham Lane drain being submerged and therefore ineffective. Photo 8 below shows the highway drainage outfall. This situation is being further investigated to both confirm the operation and identify if any alterations can be made to reduce the future risk of flooding.

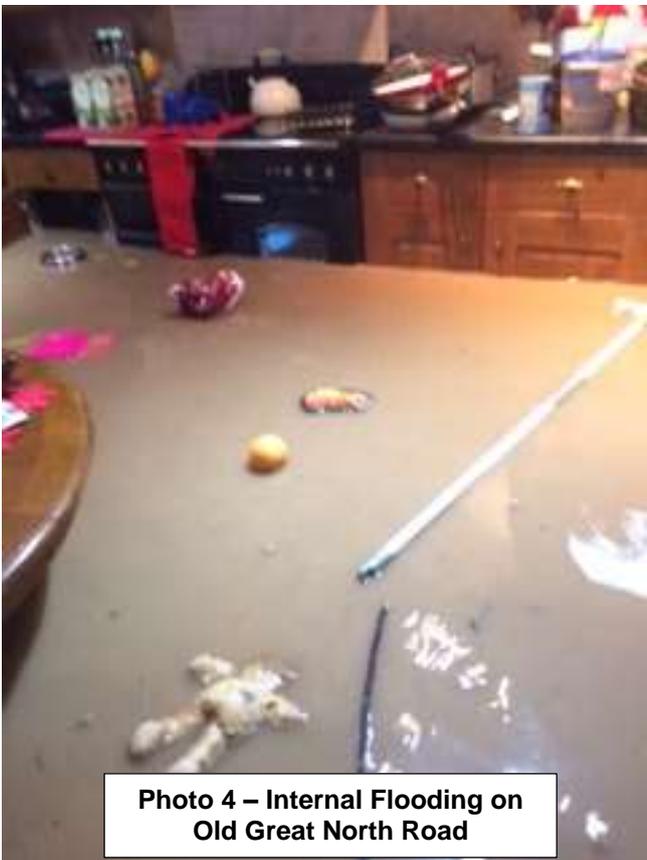
Photo 4 – Internal Flooding on Old Great North Road

The water then flowed out onto the Old Great North Road and surrounding areas where the natural topography resulted in the water being directed towards properties and businesses resulting in significant internal flooding. Photos 4-7 give examples of the devastation experienced.

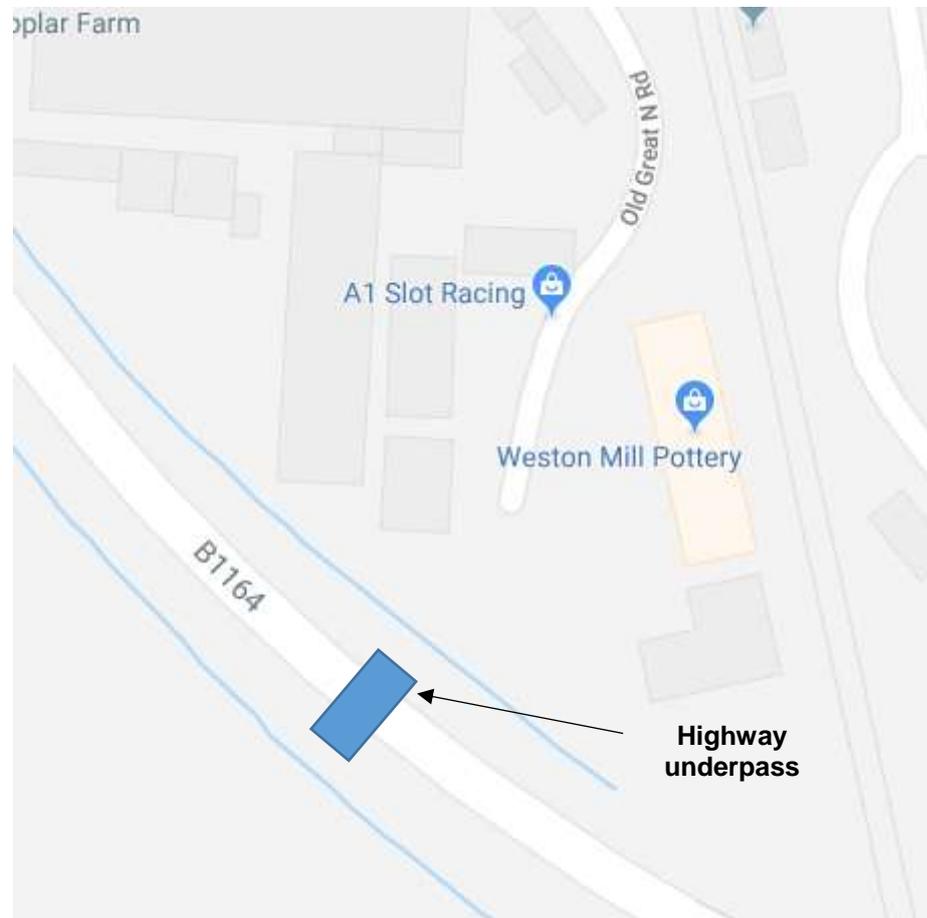
Figure 4. Approximate location of highway underpass under the Great North Road

During early site investigations officers' attention was brought to the fact that a large highway underpass at the bottom of the Old Great North Road hammerhead had been blocked off to be used as a storage facility and this prevented the flood water getting away. The location of this underpass is shown on Figure 4 below.

This issue was followed up and evidence shows the underpass is formally leased to the current user by NCC and has been for some 20 years. The underpass was initially installed as a cattle creep and not as a drainage structure and as such utilising it as a storage facility is legitimate. It is acknowledged that had the underpass been left open the flood depths in this event would likely have been shallower however it must also be acknowledged that if the culvert had been left open it may allow flood water to enter the hammerhead from the other side of the Great North Road.
