APPENDIX 8.1 – NOISE MONITORING DATA LOCATIONS

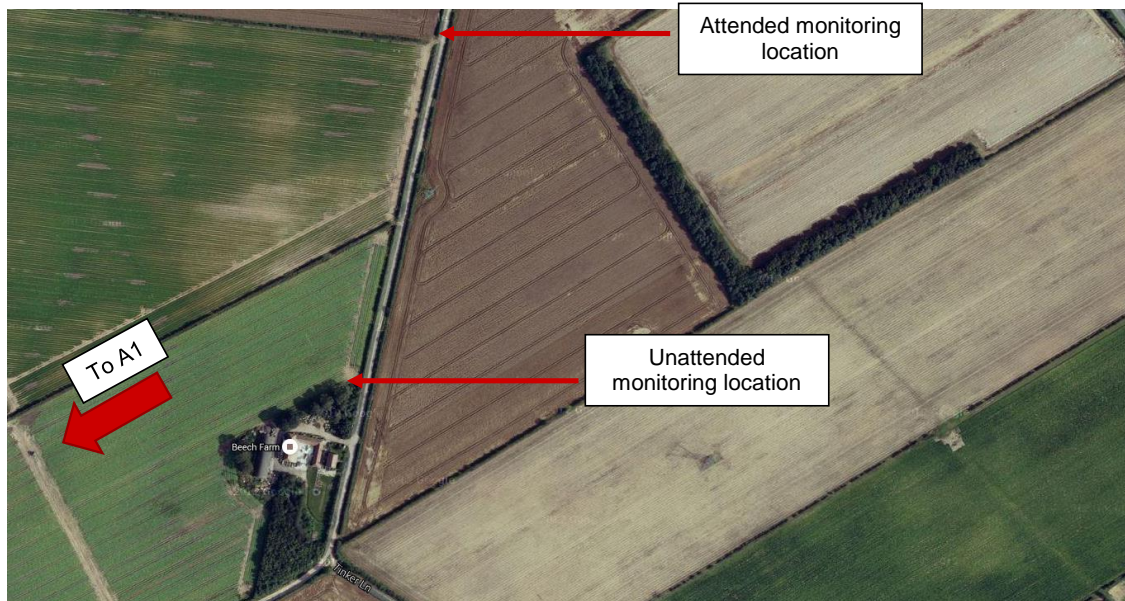
Beech Farm

The unattended monitor was installed in the north-east corner of the property close to the border with the neighbouring farmland. This location was approximately 30 m from the wall of the property itself and 400 m to the north east of the A1. The position of the monitor relative to the property and to the A1 is shown in the photos below, with the A1 highlighted in yellow for clarity.

The attended monitoring location was selected to be some distance away from the property (approx. 300 m from the unattended monitoring position) in order to avoid disturbing dogs located at the property during late night survey work. This monitoring location was 780 m from the A1 at its closest point and located in a field entrance way on Tinker Lane.

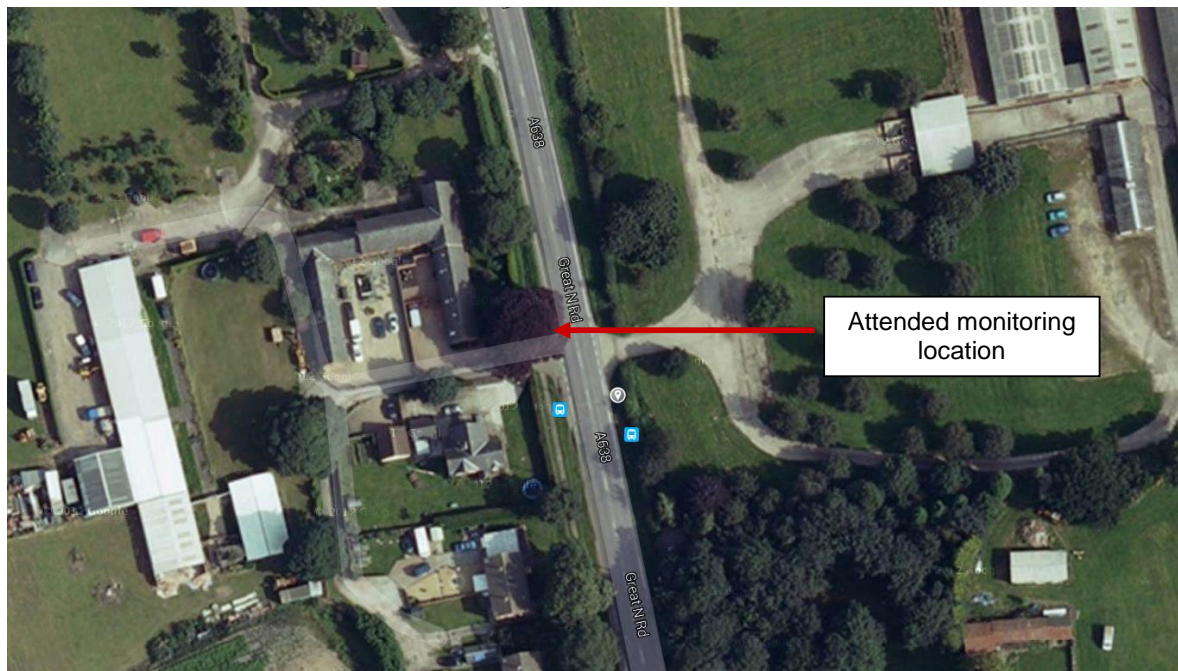
The attended monitoring location at the College Farm site was at the driveway of the nearby properties, approximately 10 m to the east of the nearest property, and approximately 5 m to the west of the A638. The position of the monitor with respect to the nearest properties is shown in the photos below.

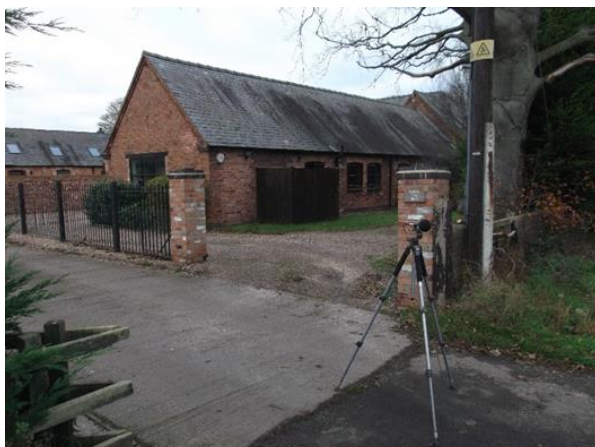
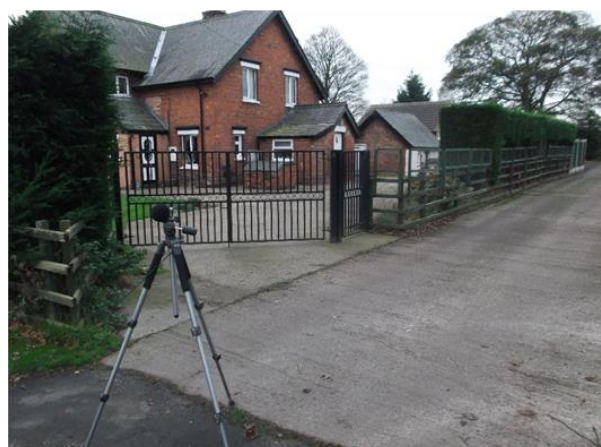
The road close to the property was observed to be very busy during the daytime survey, and conversation with residents suggests that traffic during this period was elevated as a result of a partial closure of the A1.

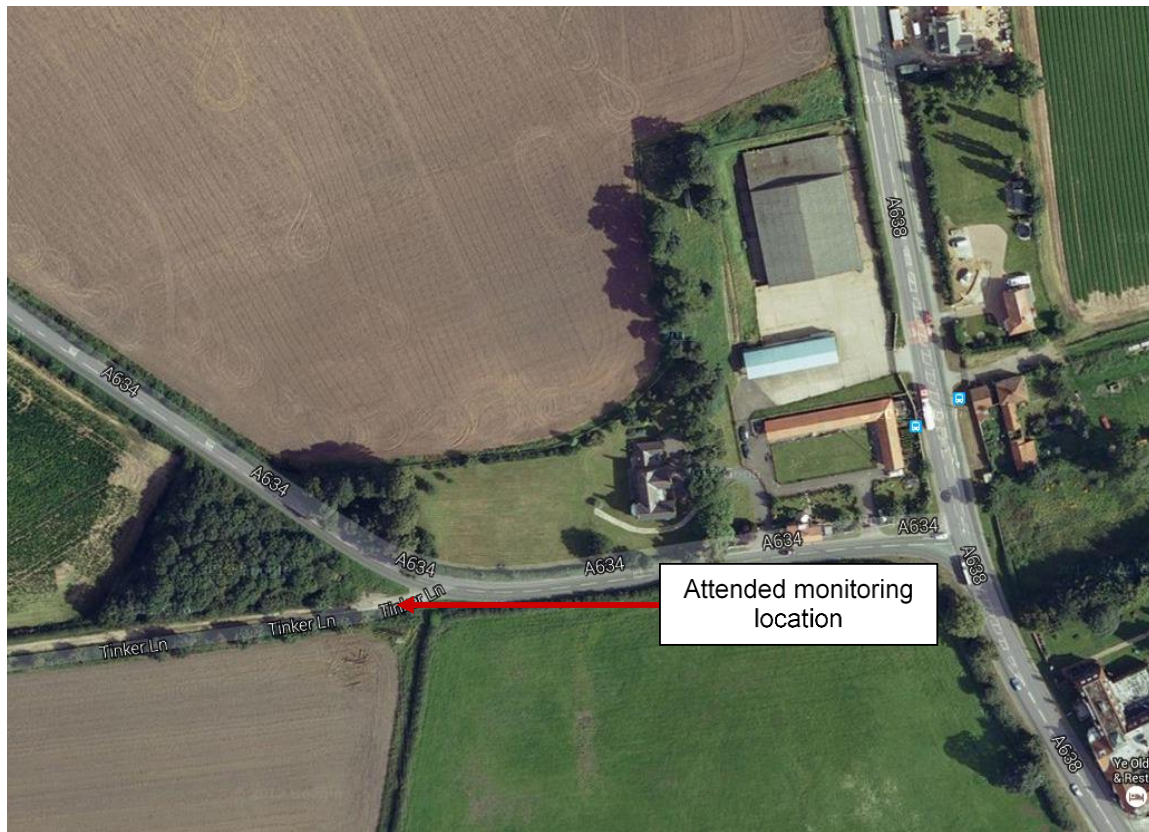
Grange Farm

It was not possible to gain access to the Grange farm property itself, and so a proxy location was selected down Tinker Lane a similar distance away from the A634 road running past the property. Subsequently, the monitor was located approximately 12 m away from the edge of the A364 in a small layby located at the entrance of Tinker Lane, as shown in the photo below.

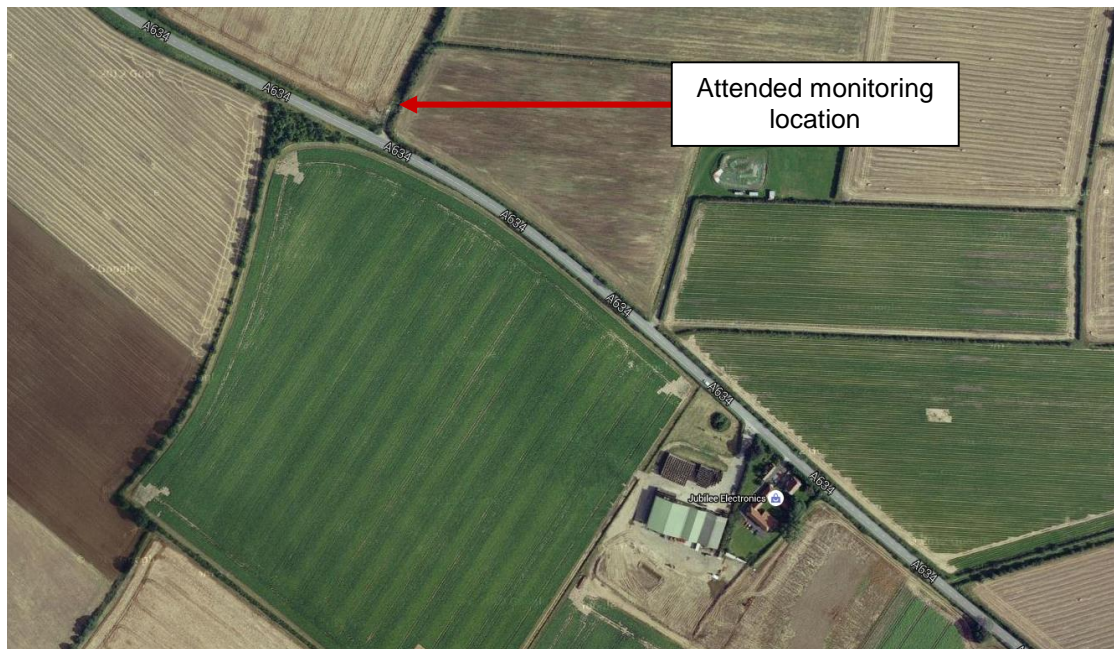
It was not possible to monitor at the Jubilee Farm location, and so a proxy monitoring location was selected to the north west of the site at the entrance to farm land. The monitor was situated a similar distance away from the road to the Jubilee Farm property, and can be seen in relation to the A634 in the photo below.
