APPENDIX A

SECTION 19 REPORT – ARNOLD – JUNE 19

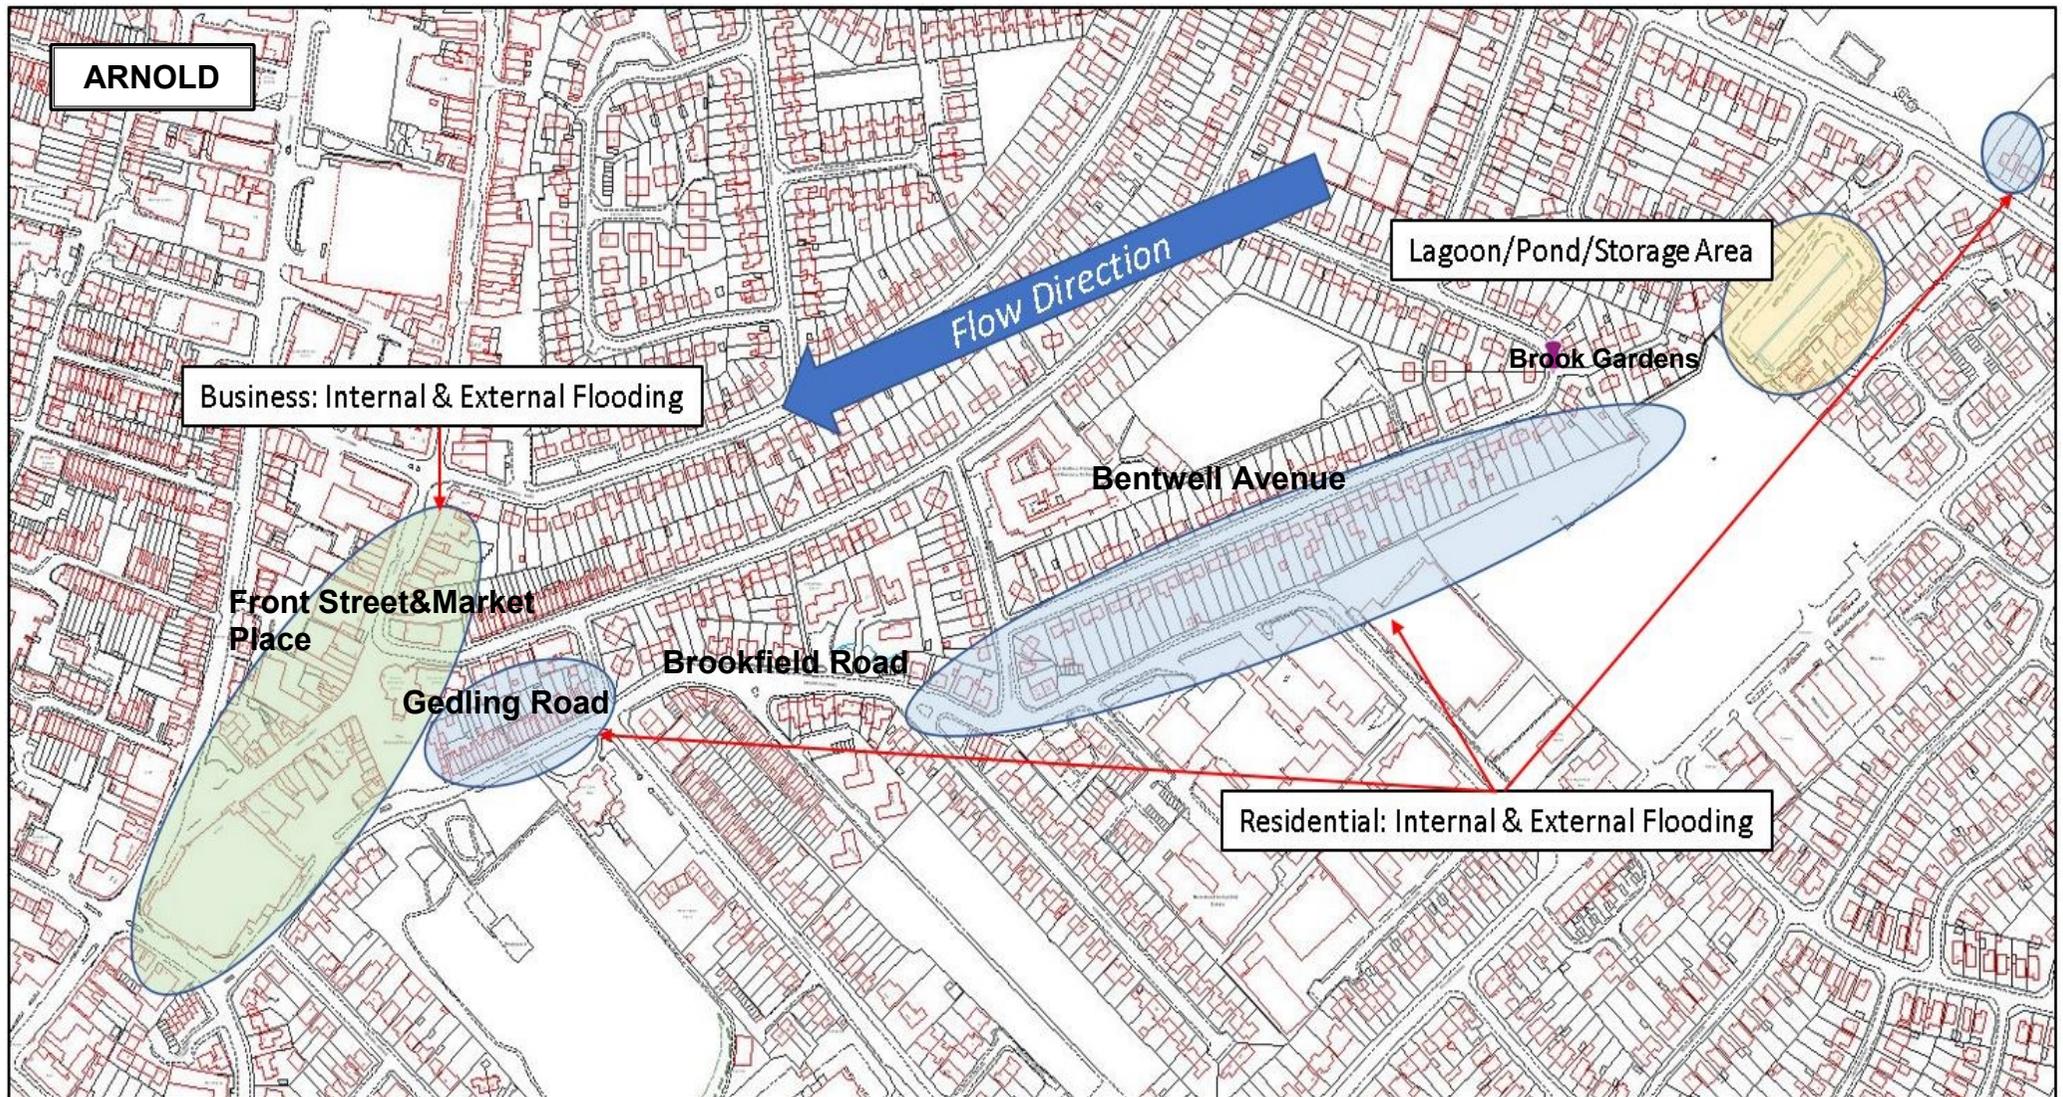
Figure 1. Arnold, sub-catchment of the wider Day Brook Catchment

On the evening of 12th of June 2019 at around 10:30pm and following a prolonged period of heavy rainfall, parts of Arnold suffered a significant flood event. 24 Residential Properties and 20 Businesses were subject to internal flooding with many more suffering flooding to gardens and outbuildings. The areas affected were Hall Drive, Brook Gardens, Bentwell Avenue, Bonnington Drive, Brookfield Road, Gedling Road, Front Street, Market Place and Arnot Hill Road.

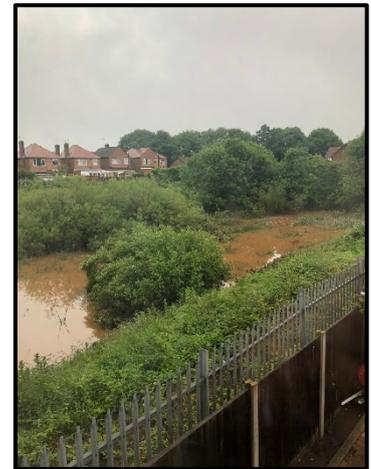
On the evening of the 12th of June, the attenuation area was already at full capacity following the previous days rainfall (see photo adjacent). The storage area then broke its bank allowing the excess surface water to run overland, eventually finding a natural valley along the rear gardens of Bentwell Avenue. This channelled the water downstream at a gradually increasing rate causing extensive damage along its path. The water was following a natural route described on page 4.

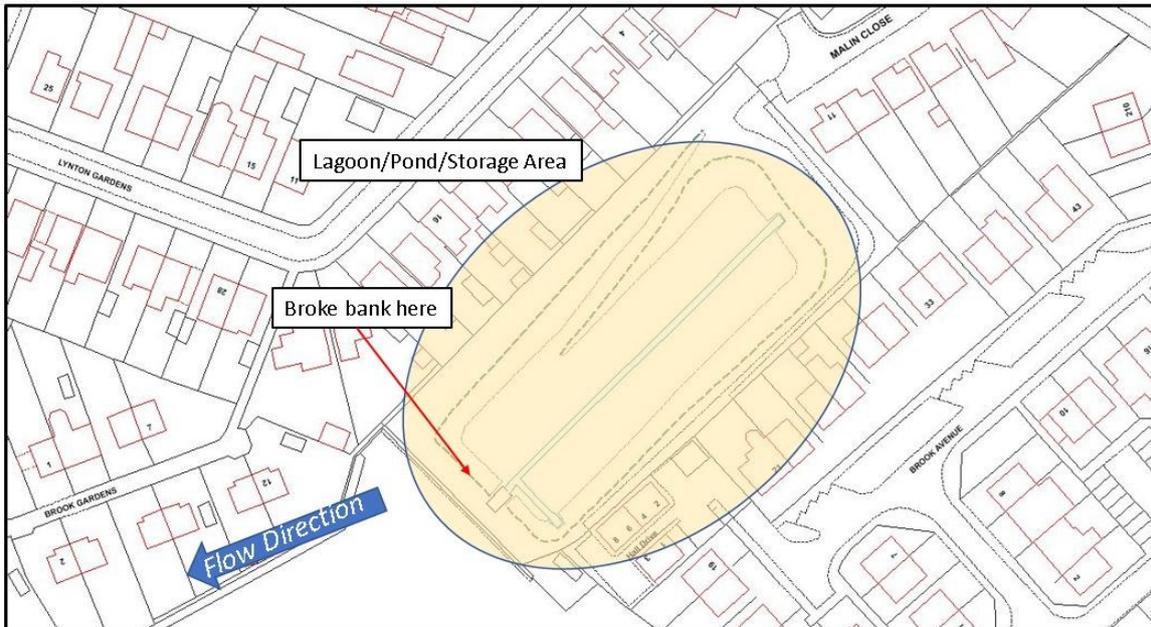
Figure 2. Plan showing location of storage attenuation area

Figure 2 is a plan showing a surface water attenuation area situated between Malin Close to the North East and Brook Gardens to the South West. Immediately to the South of the attenuation area is the Rolleston Drive Highway Depot. The attenuation area is maintained by GBC with a STW surface water sewer permitted to flow into and out of it. When functioning correctly the attenuation area collects water from the STW surface water network upstream and discharges that water back into the STW surface water network downstream but at a controlled rate.

10. GBC and STW will carry out a joint investigation into how the pond operated during the flood event.

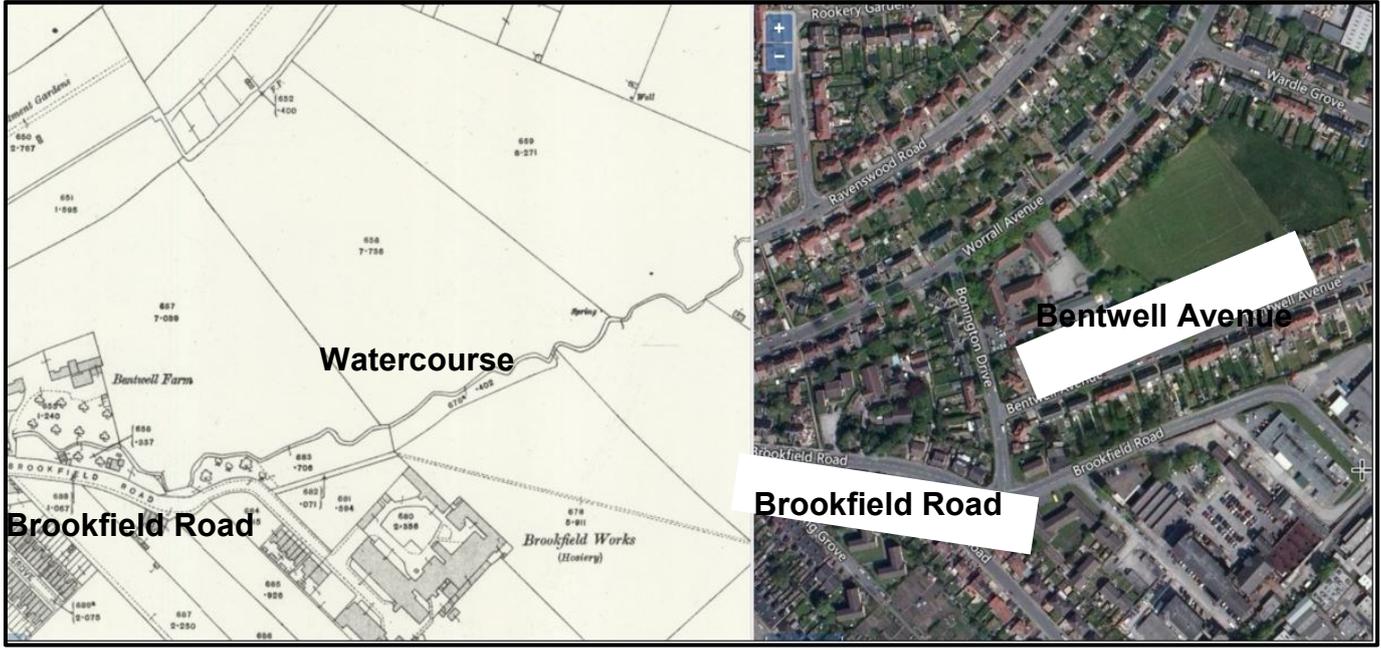
Figure 3. Historic map showing line of original watercourse.

Figure 3 has to the left an historic map which shows the line of the original watercourse meandering towards Brookfield Road, and the aerial photo to the right clearly shows that now Brook Gardens and Bentwell Avenue are on that historic route. This area of Arnold has flooded along this route on a number of occasions with previous documented events in 1998, 1999, 2006, 2010 and 2013.

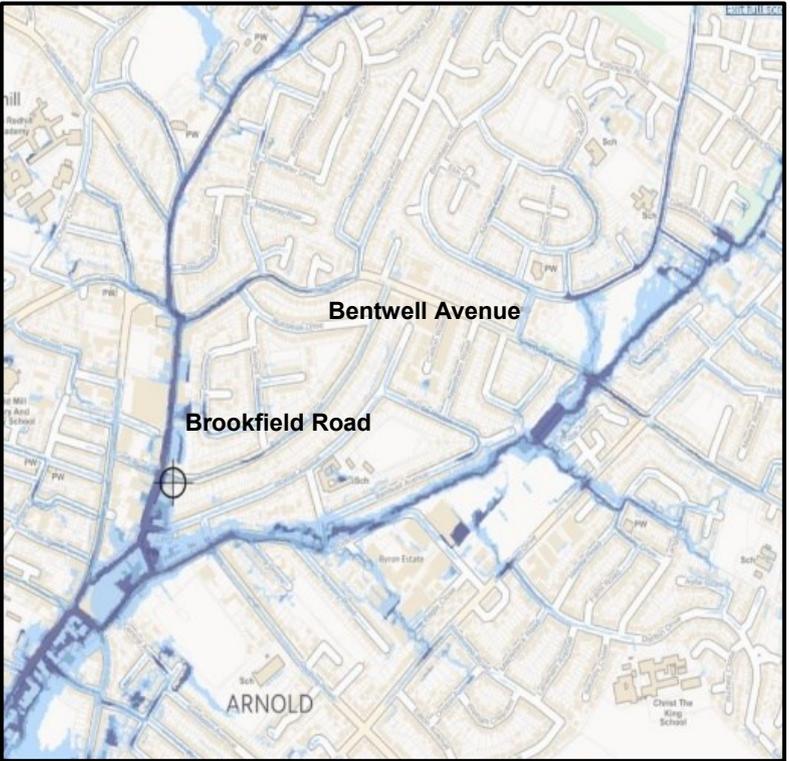
Figure 4. Surface Water Flood Map

This observation is illustrated further by Figure 4 the surface water map of the area provided by The Environment Agency which shows predicted flow routes during periods of heavy rain. As you can see the flow route follows the line of the historical water course now Bentwell Avenue and other residential areas.

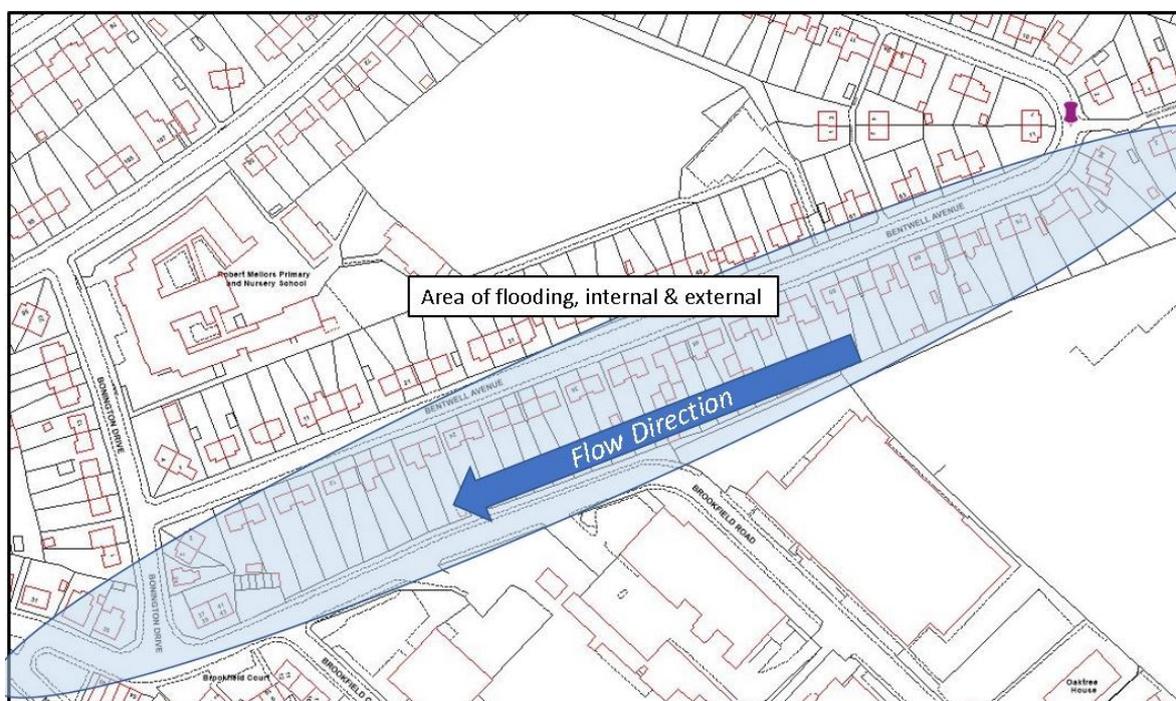
Fig 5. Bentwell Avenue and surrounding area.

Once the water in the storage attenuation area had broken bank it began to flow along the route shown in figure 5, channeling the water through rear gardens and into some houses along Brook Gardens, Bentwell Avenue and Bonnington Drive. At some points the water depth was observed to be up to 4ft in depth.

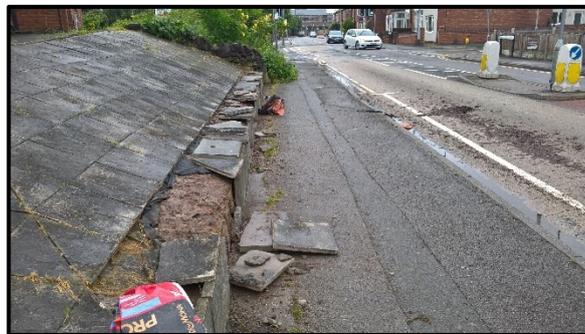
Using Brookfield Road as a channel the water continued to flow along Gedling Road and along the frontages of the terrace houses, shown in figure 6. The water was of sufficient depth at this point to enter some of these houses through the front doors. The photo between Figures 4 and 5 above shows damage to slabs along a raised sloping bank, indicating flow depth.

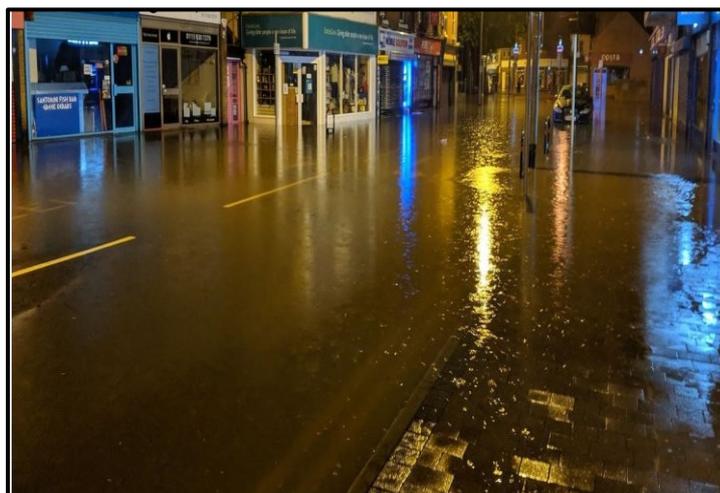
The lower end of Front Street and the Market Place are at the bottom of an urbanised natural valley, so flood water flowed to this point, ponded and flooded a number of businesses. The adjacent photo looks down at the flooding on Lower Front Street and the Market Place.

Evidence suggests that surface water flowed from upper Front Street using the road as a channel, the road was closed to traffic over night for safety.

The flow route mentioned previously also channeled water towards the Market Place where it collected with water from Front Street adding to the flooded area.

The Highway Drainage at this low point is not designed to cope with this amount of water so was simply overwhelmed and could not drain to the Surface Water Sewer quickly enough. The water simply had nowhere to go until the rain began to subside, it was then observed to clear quite quickly.

NCC and STW will look at how the Highway Drainage system works with the Public Sewer system at the Front Street and Market Place area.
