APPENDIX M

SECTION 19 REPORT – HUCKNALL – STORM BABET, OCTOBER 2023

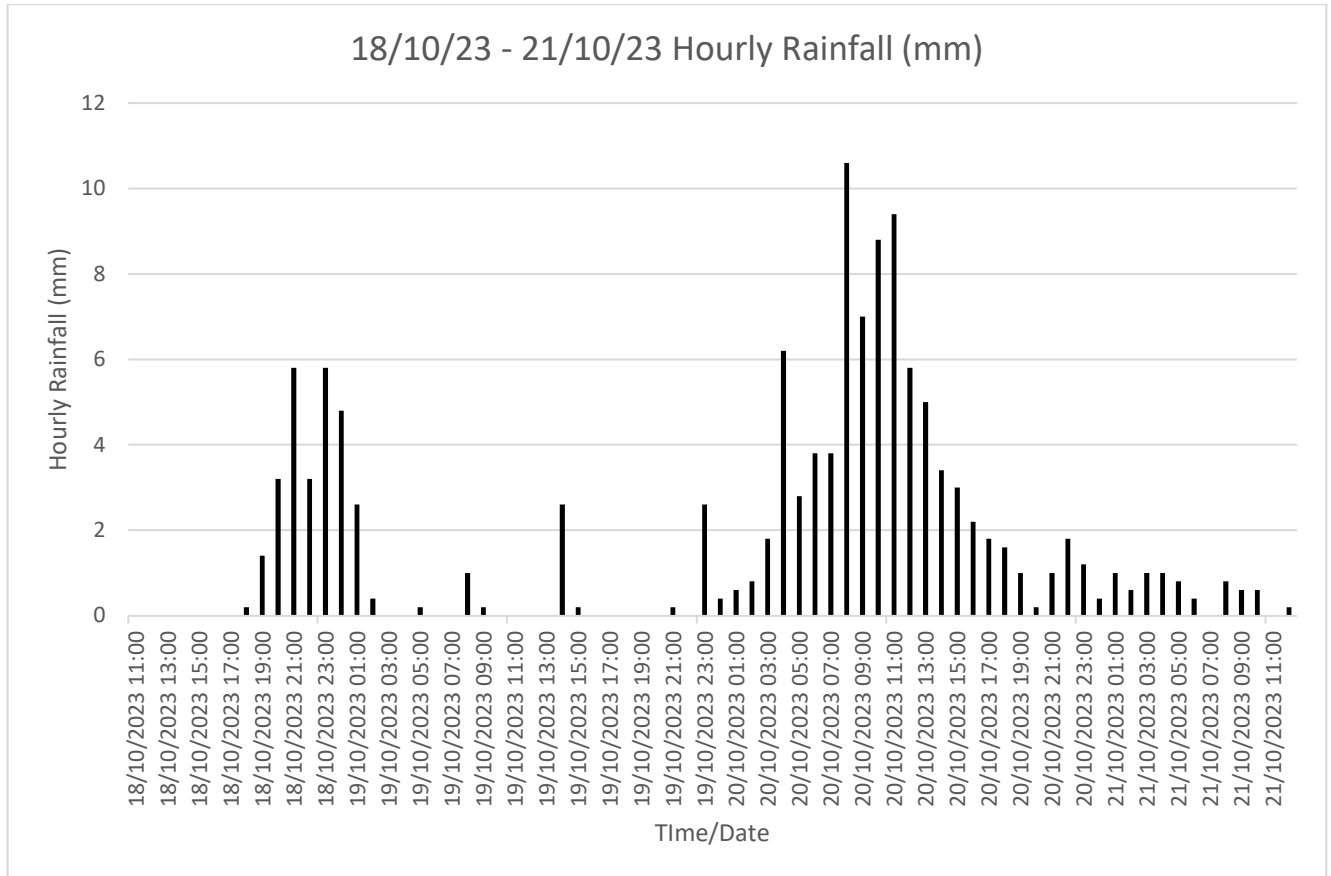
Figure 1. Sutton in Ashfield Hourly Rainfall from 12:00 18 to 23:00 20 October 2023. Data supplied by the Environment Agency.

6. Hucknall is market town located approximately 13km to the north of Nottingham. Hucknall is surrounded on the north, east and west by rural / agricultural land. A number of watercourses run from west to east through the town discharging into the River Leen.
7. The watercourses are a mix of riparian owned and main river (EA managed) Figure 2 shows how the watercourses pass through the town.
8. Between 12:00 noon on 18 and 23:00 on 20 October, 125.8mm of rainfall was recorded at the Sutton in Ashfield rain gauge, which is approximately 9km from Hucknall (Figure 1).

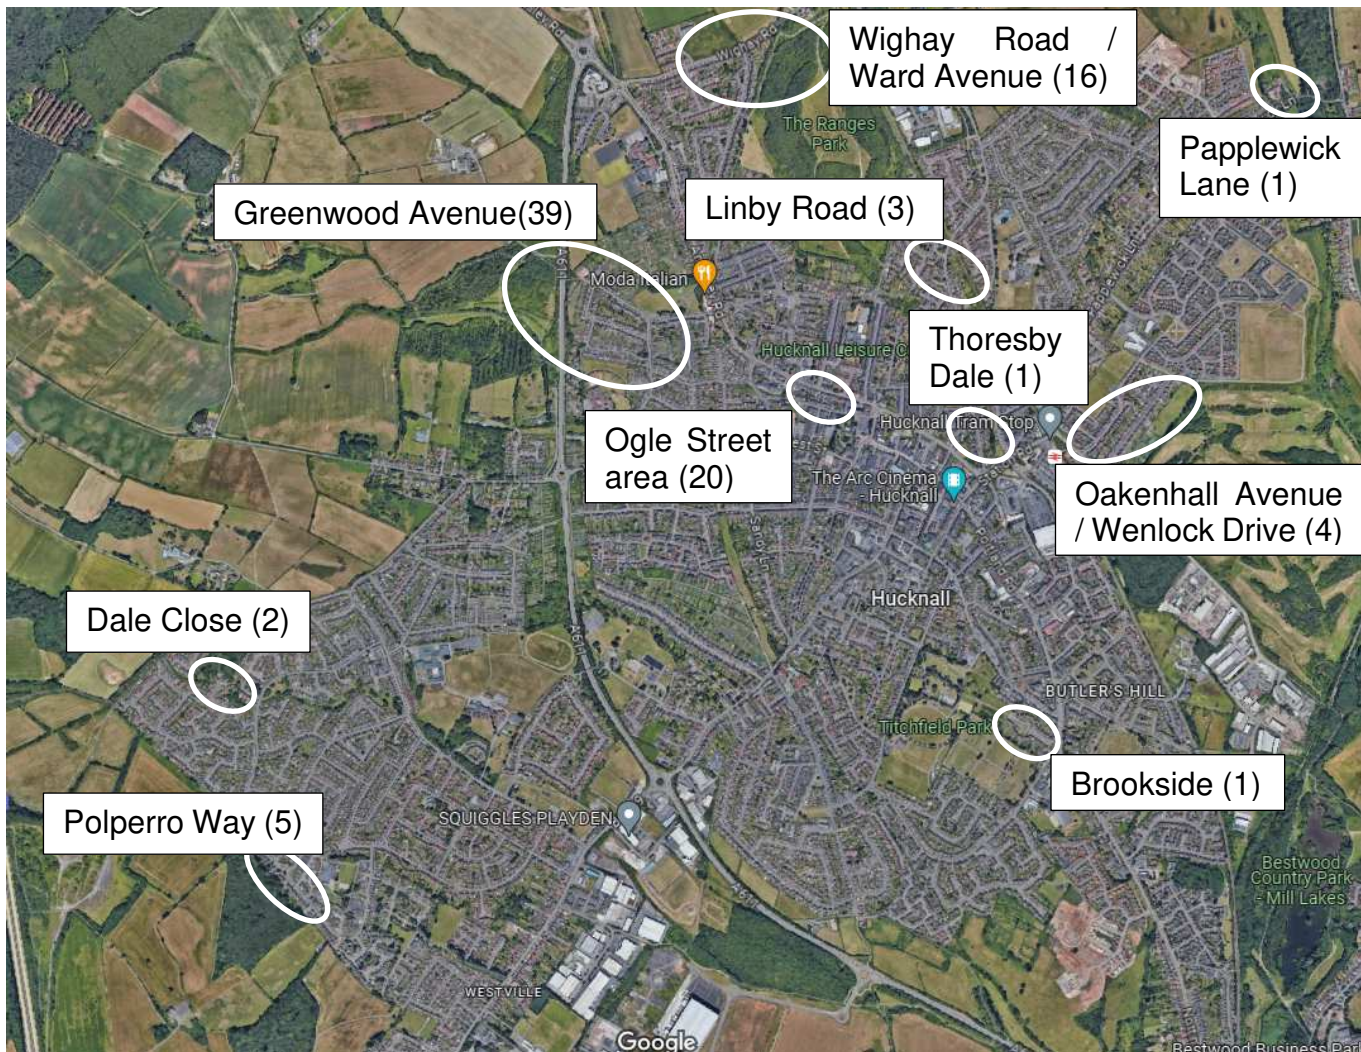
Figure 3. View of Hucknall highlighting areas affected by internal flooding (number of affected properties shown in brackets).

11. The flooding in Hucknall was widespread and affected a number of different areas across the town. Figure 3 highlights the areas where internal flooding was recorded.

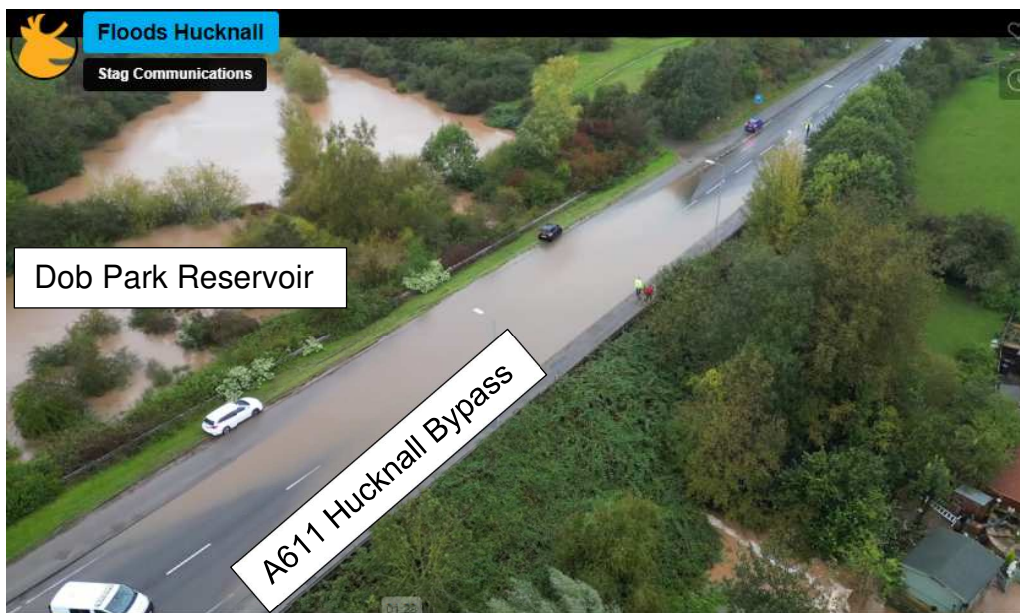
18. Dob Park reservoir discharge rate is hydraulically controlled by the diameter of the outgoing pipe. This pipe is protected from blocking by a steel grille / trash screen. There are no sluices on this structure. Following the flood event this trash screen was checked and debris that had accumulated was cleared. There was no evidence of any blockages and the trash screen was working effectively.
19. Drone footage of the flooding was provided by a resident local to the flooding and Figure 8 is a still taken from this footage. Stag Communications have given permission for the use of their images in this report. The still shows Dob Park reservoir storing water and surface water pooling in the low point of the A611 Hucknall Bypass.

Figure 8. Drone footage of Dob Park Reservoir and A611 after the flooding (picture courtesy of Stag Communications)

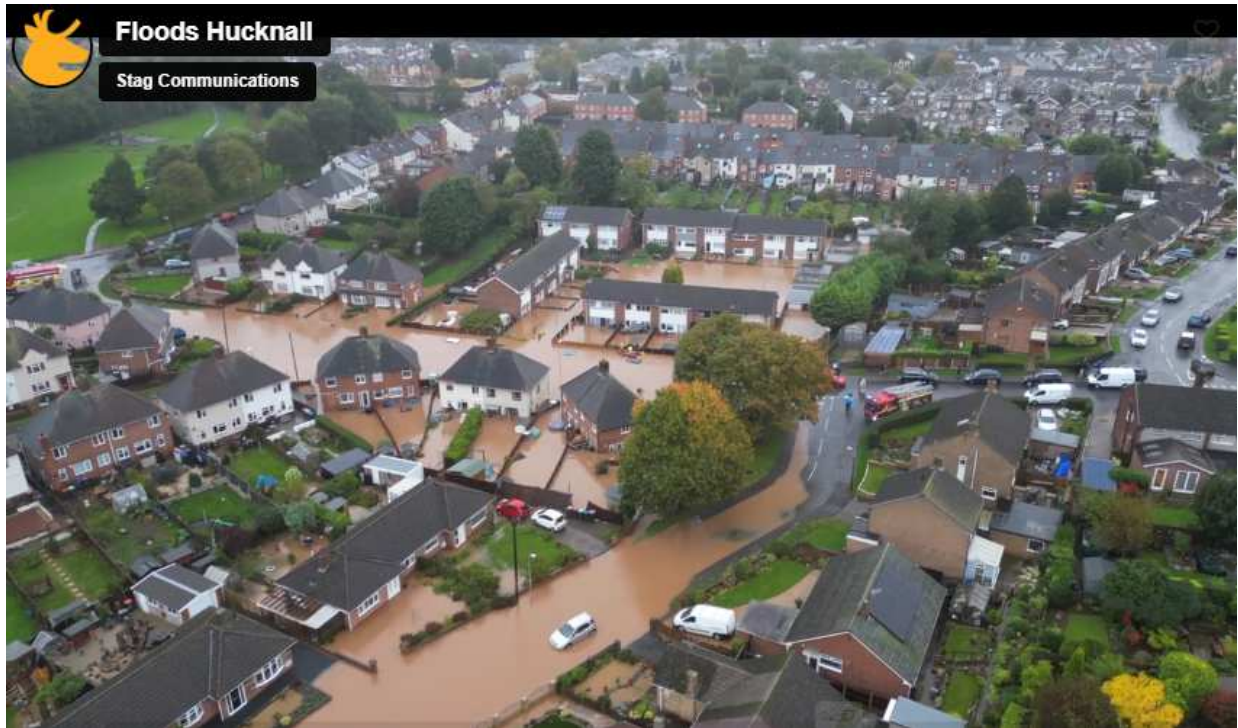
20. Witnesses report significant volumes of water flowing down Greenwood Vale towards Greenwood Avenue resulting in devastating flooding to many properties. Figure 9 shows the impacts of the flooding.

Figure 9. Flooding to Greenwood Vale / Greenwood Avenue

21. Management of surface water flows in the catchment is quite complex and, whilst there is no evidence of operational failure, it is acknowledged that the capacity of the various existing assets must have been exceeded in places. This exceedance may well be due to the unprecedented amounts of rain delivered during Storm Babet however as part of our response to the flooding we are commissioning a detailed investigation into the current hydraulic performance and interaction of the surface water assets in the area including Dob Park Reservoir. This investigation will help to understand whether the existing assets perform to the required design standards and whether there are any improvements necessary to the system.
