APPENDIX A

SECTION 19 REPORT – EASTWOOD – 18 SEPTEMBER 2023

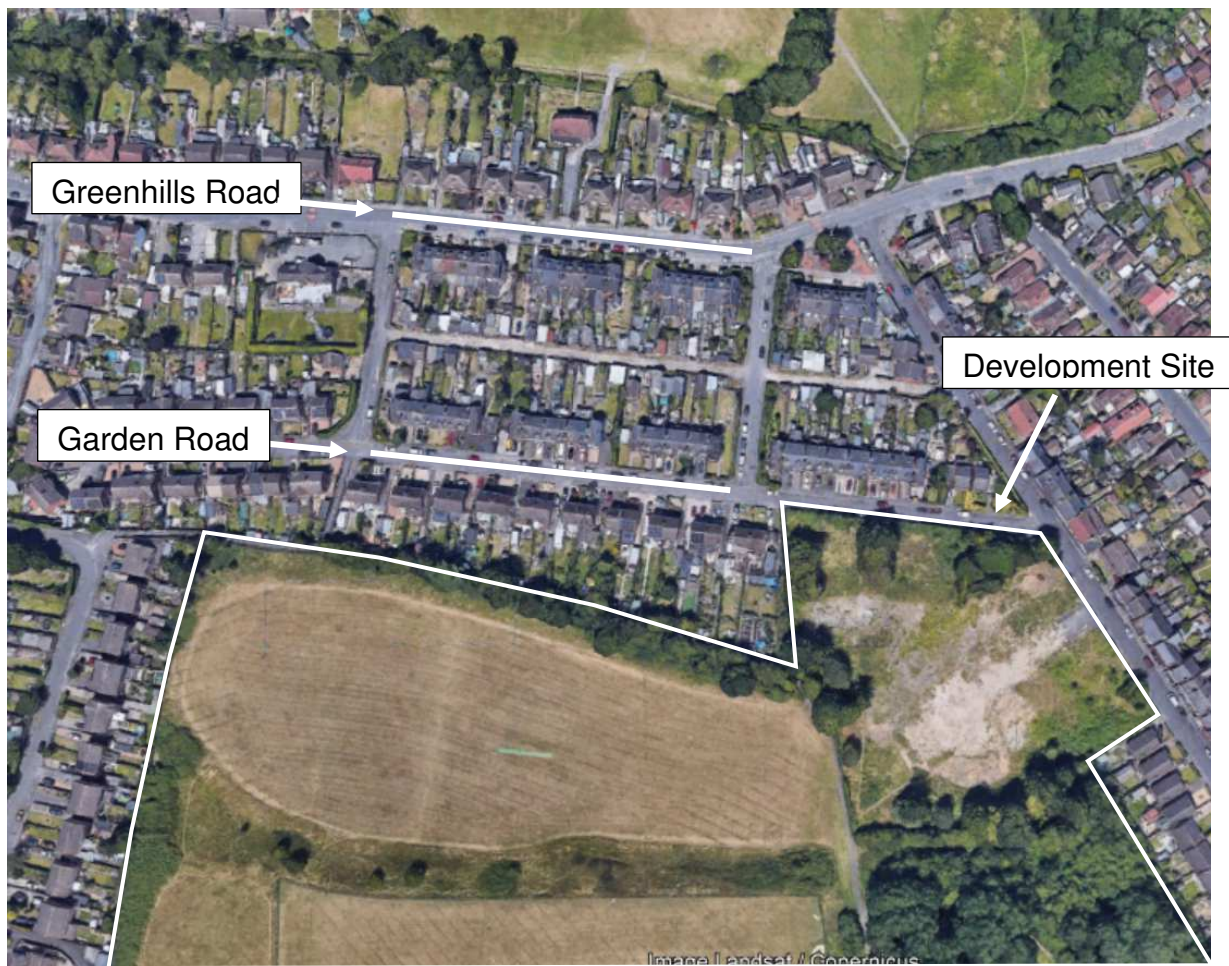
6. During the evening of the 17th September 2023 Nottinghamshire was subjected to heavy localised rainfall with over 35mm of rain falling over the Eastwood area in 3 hours. This rainfall resulted in internal flooding to 5 residential properties and external flooding to gardens and roads. Figure 1 below shows the local area, the areas affected and the development site where the flooding occurred.

Figure 1. Diagram showing local area.

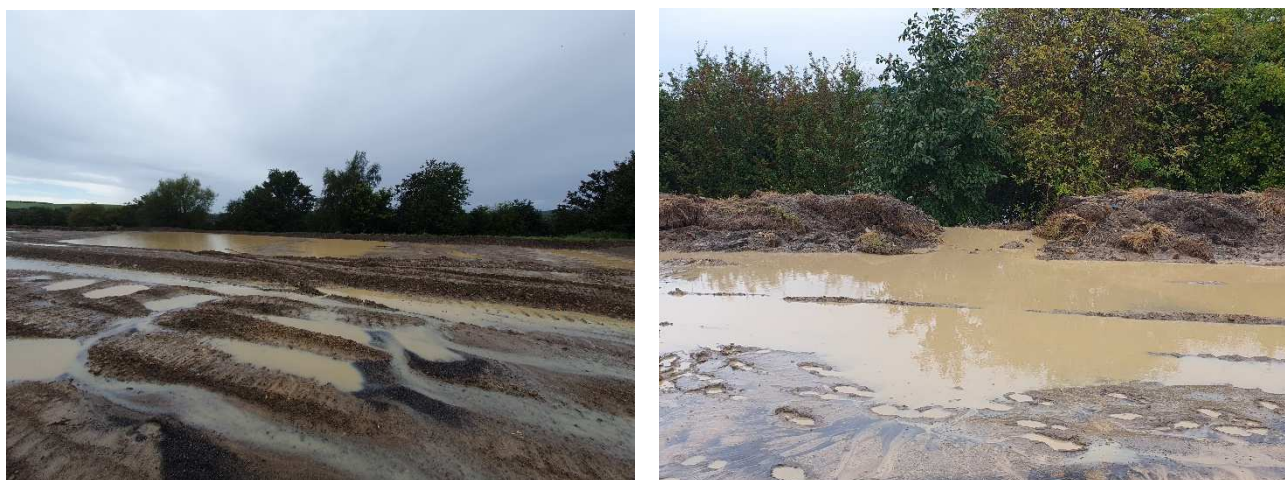
7. The internal flooding was very isolated in nature with 5 residential properties affected. Investigations showed that excessive surface water built up behind earthen bunds on the development site at the rear of the affected properties. These bunds were built to stop excess water flowing off site, following the stripping of the site. After the intense rainfall event this bund failed resulting in the captured water flowing down the banks of one resident's garden and eventually entering the 4 other properties. Figure 2 below shows the bund in question and the area of failure.

Figure 2. Photographs showing banks on development site.

8. Properties on Garden Road suffered flooding from the rear due to the direct breach of the bund, this water subsequently entered the highway, then travelled between properties affecting further residential properties on Greenhills Road. An additional 9 properties in the area suffered external damage to gardens, sheds, garages and outbuildings.

13. This was a very isolated flooding incident and onsite investigations concluded that it was the result of a heavy localised rainfall event falling onto a stripped development, with an ultimate failure of the assets on site with no other obvious contributing factors. There was no evidence or suggestions that any flood water came from the public highway network, sewer network or nearby watercourses.

9. Discussions were undertaken with the development site owners with regards to ensuring additional remedial works were undertaken to reinforce existing bunds on site. As of the 4th of November, these additional measures were complete and included:

- (a) Reinforcing and compacting of the earth bund on the North side of the site,
 - (b) installation of a land drain across the northern boundary, discharging into 2 existing manholes,

- (c) further creation of depressions across site to spread water retention,
 - (d) installation of geo-textile membrane to stop silt build up on new assets.
