APPENDIX AM

SECTION 19 REPORT – WORKSOP – STORM BABET, OCTOBER 2023

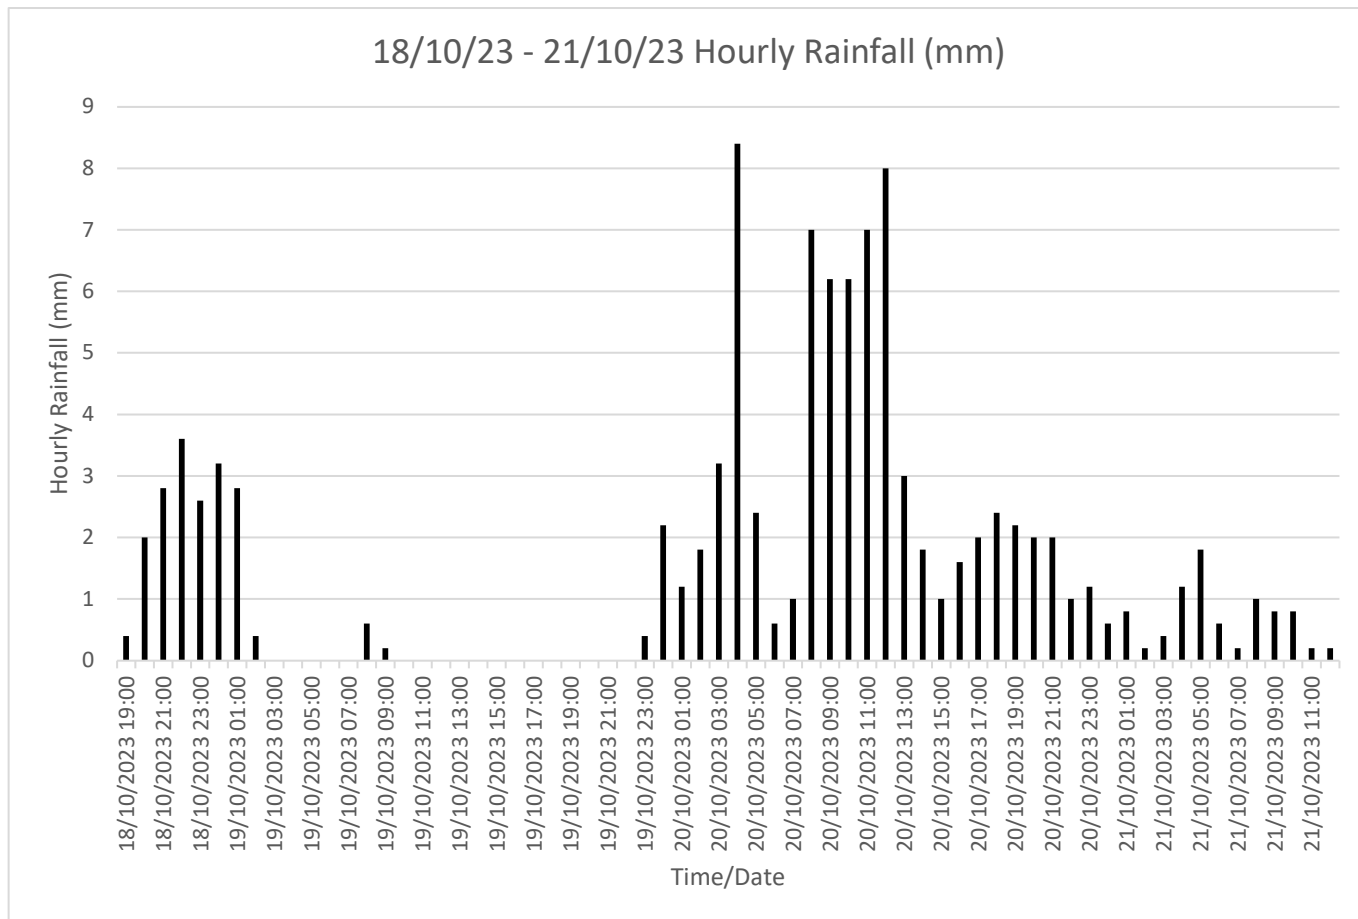
6. Worksop is a town within the District of Bassetlaw, Nottinghamshire. It has a population of approximately 43,439 people according to the 2021 census.
7. The River Ryton (main river) runs through Worksop from West to East, with several bridges and culverts through the town. The Worksop River Level gauge is located near Stubbing Lane, and a rain gauge is present in the Manton area of the town.
8. On the 20th October, during Storm Babet, Worksop suffered a flood event caused by sustained heavy rainfall. 103.2mm of rainfall was recorded at the Worksop rain gauge, with 75.4mm of this on the 20th alone (Figure 1). Consequently, 93 residential properties

Figure 1. Worksop Hourly Rainfall 19:00 18th October – 12:00 21st October 2023. Data supplied by the Environment Agency.

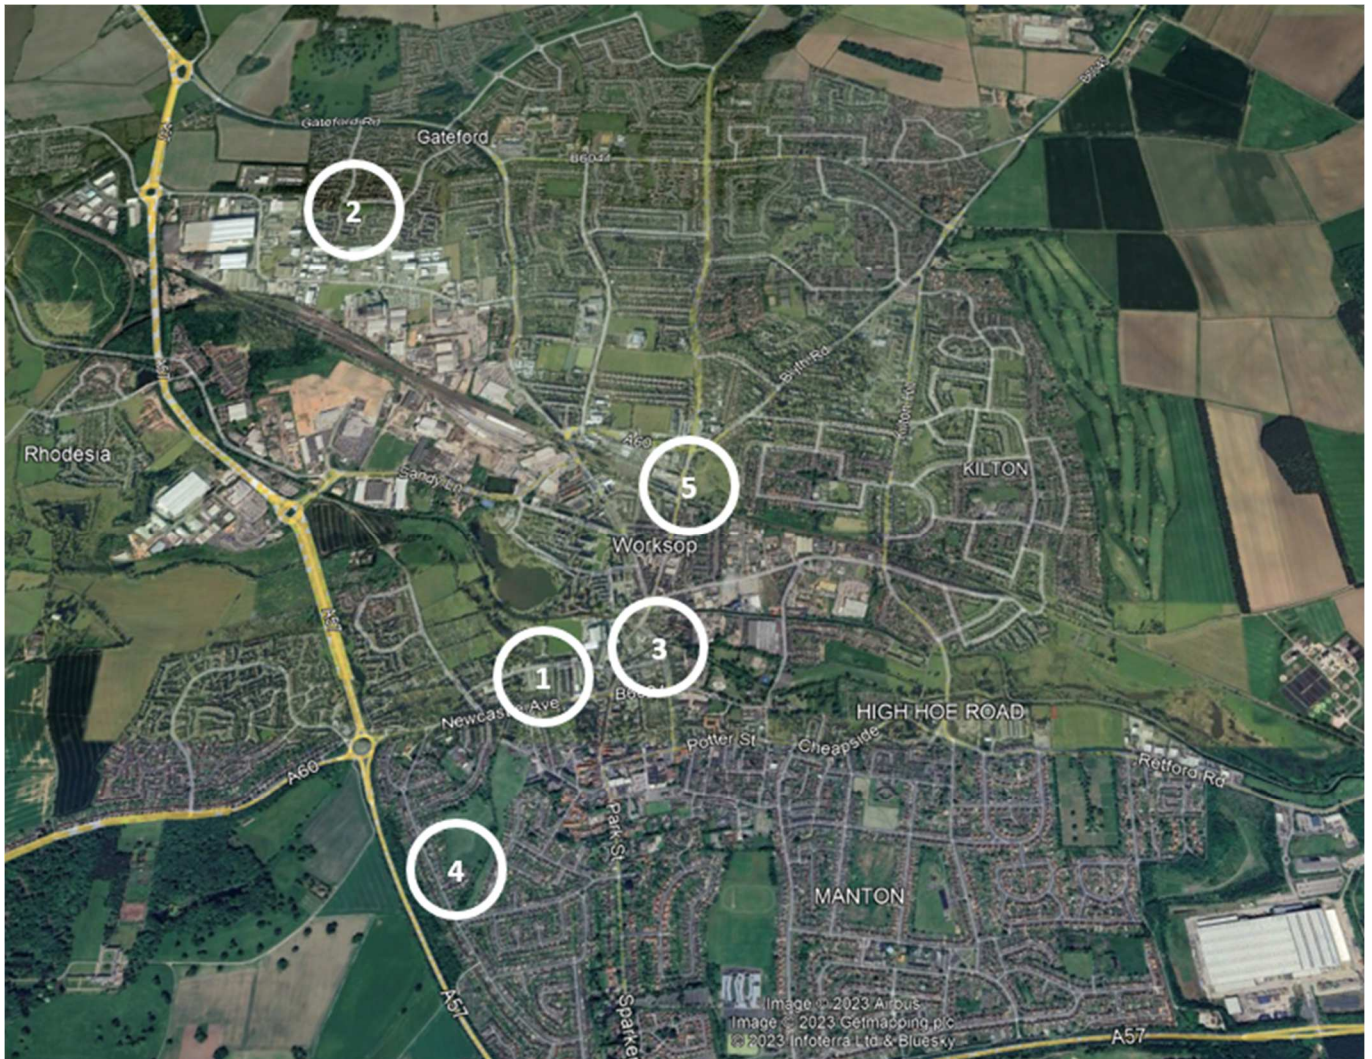
10. A location map of Worksop is shown in Figure 2. The areas affected were: (Internally flooded property numbers given in brackets)

Figure 2. View of Worksop flood affected areas. 1. Allen Street, Central Avenue, Chapel Walk, Hardy Street, King Street, Newcastle Avenue and Stubbing Lane 2. Dunlin Court, Lady Walk and Redwing Close 3. Watson Road 4. Poplar Close 5. Carlton Road

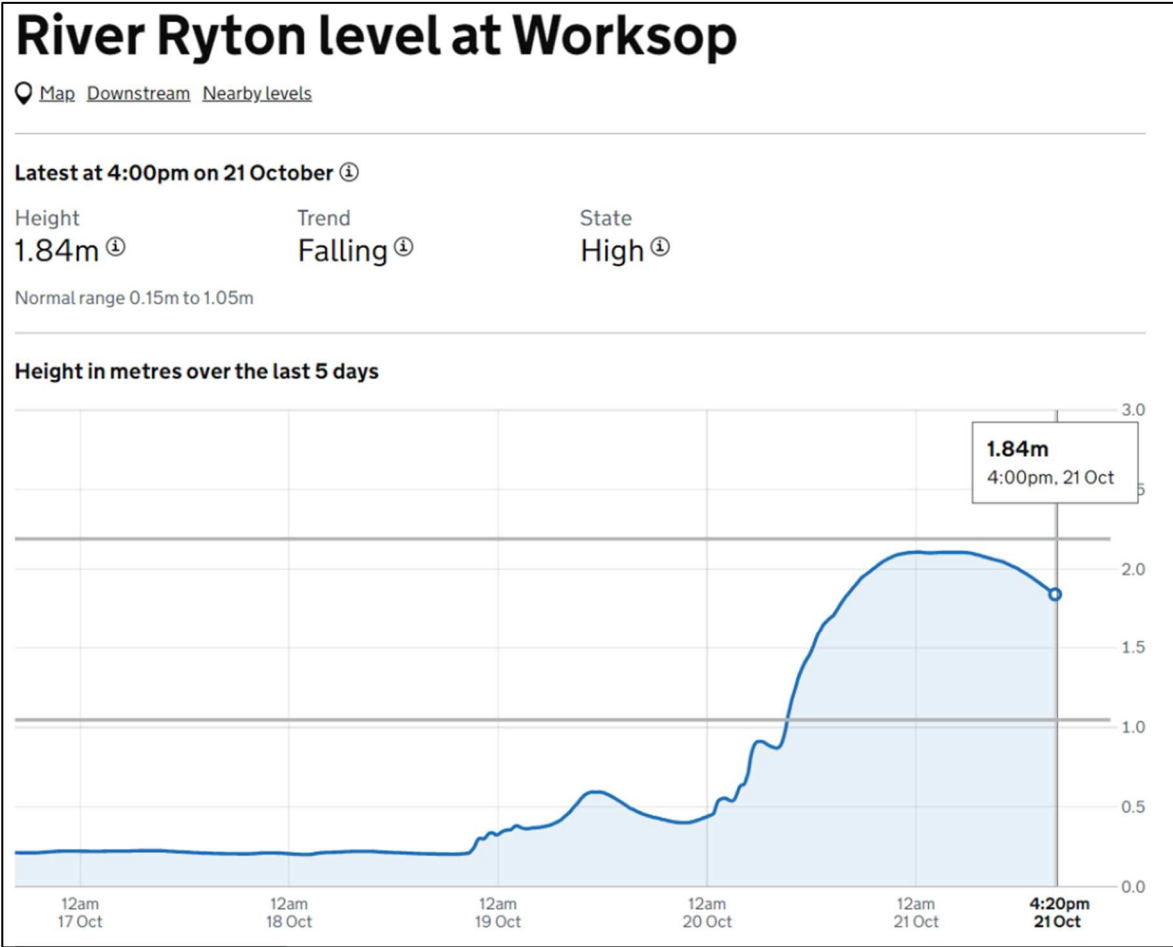
11. Due to the sustained heavy rainfall, the River Ryton which flows through Worksop rose rapidly through the 20th of October, peaking at 2.11m at the Worksop gauge on Stubbing Lane, as shown on Figure 3.
12. Allen Street, Central Avenue, Chapel Walk, Hardy Street, King Street, Newcastle Avenue and The Willows (location plan included as Figure 4.) are located to the south of the River Ryton, which runs from west to east. The Bull Brook (ordinary watercourse) also runs from south to north through the area, out falling into the river Ryton.
13. Accounts from residents note that there was significant flooding off Farr Park and flows of flood water down Brook Terrace, which then caused internal flooding on Newcastle Avenue and King Street. Flooding on all surrounding streets is understood to be a

Figure 3. River Level gauge data for the River Ryton at Worksop.

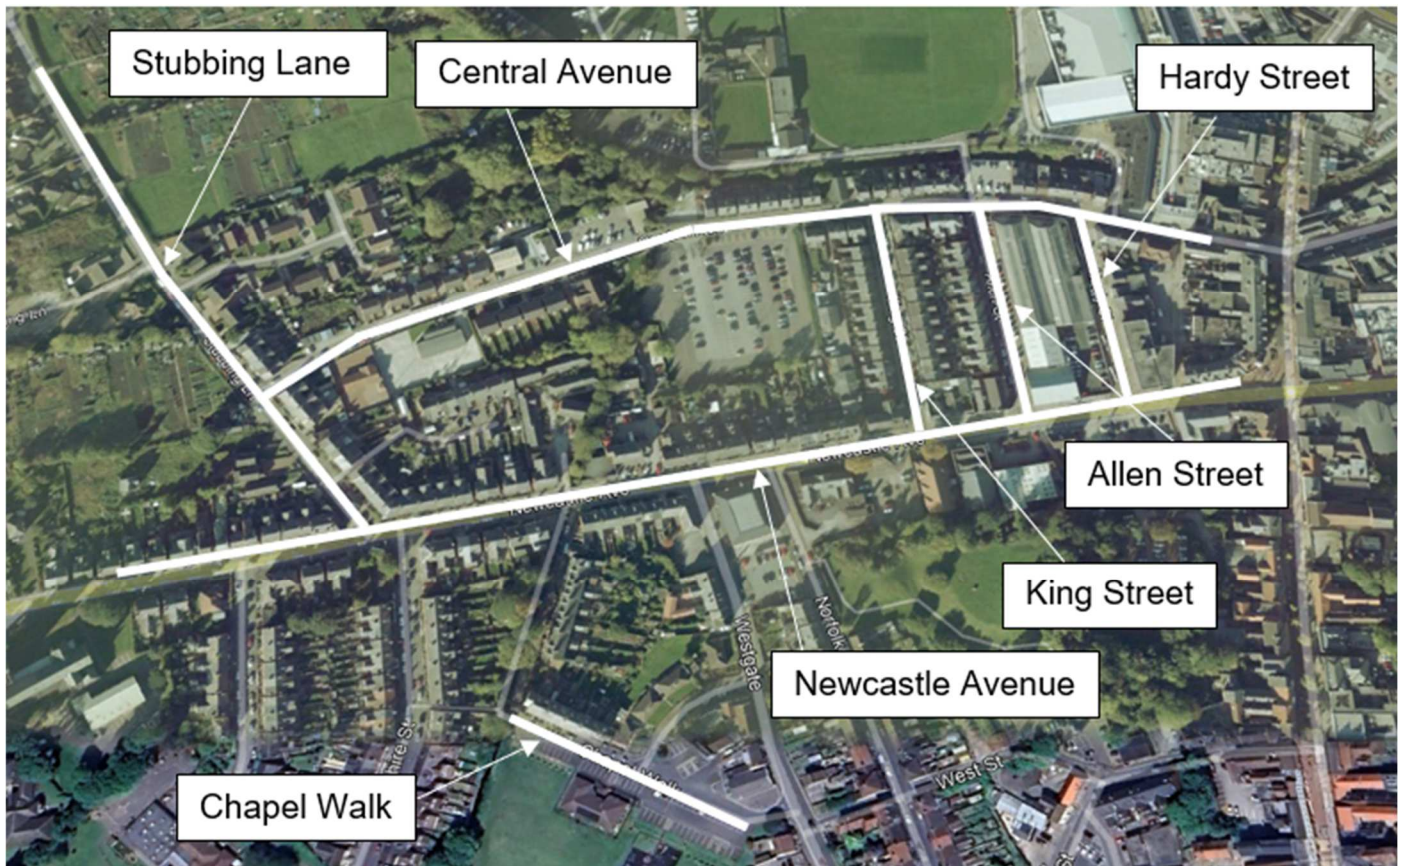
Figure 4. Allen Street, Central Avenue, Chapel Walk, Hardy Street, King Street, Newcastle Avenue, Stubbing Lane

combination of floodwater from the river Ryton, Bull Brook and the local drainage system being unable to effectively discharge into the wider drainage system or river directly.

- 32. All the Risk Management Authorities involved in this event are committed to continuing the investigations into the causes of this incident. Those investigations may identify further actions not listed below.
- 33. As the Lead Local Flood Authority we have witnessed and have experience of how flooding devastates communities. The most vulnerable in the community will be our priority. Nottinghamshire County Council will continue to work closely with partners and communities to identify ways of proactively reducing the risk, likelihood and consequences of future flooding events.
- 34. The LLFA will liaise with all RMA's to further understand the multi-source flooding in the Central Avenue and Newcastle Avenue Area.

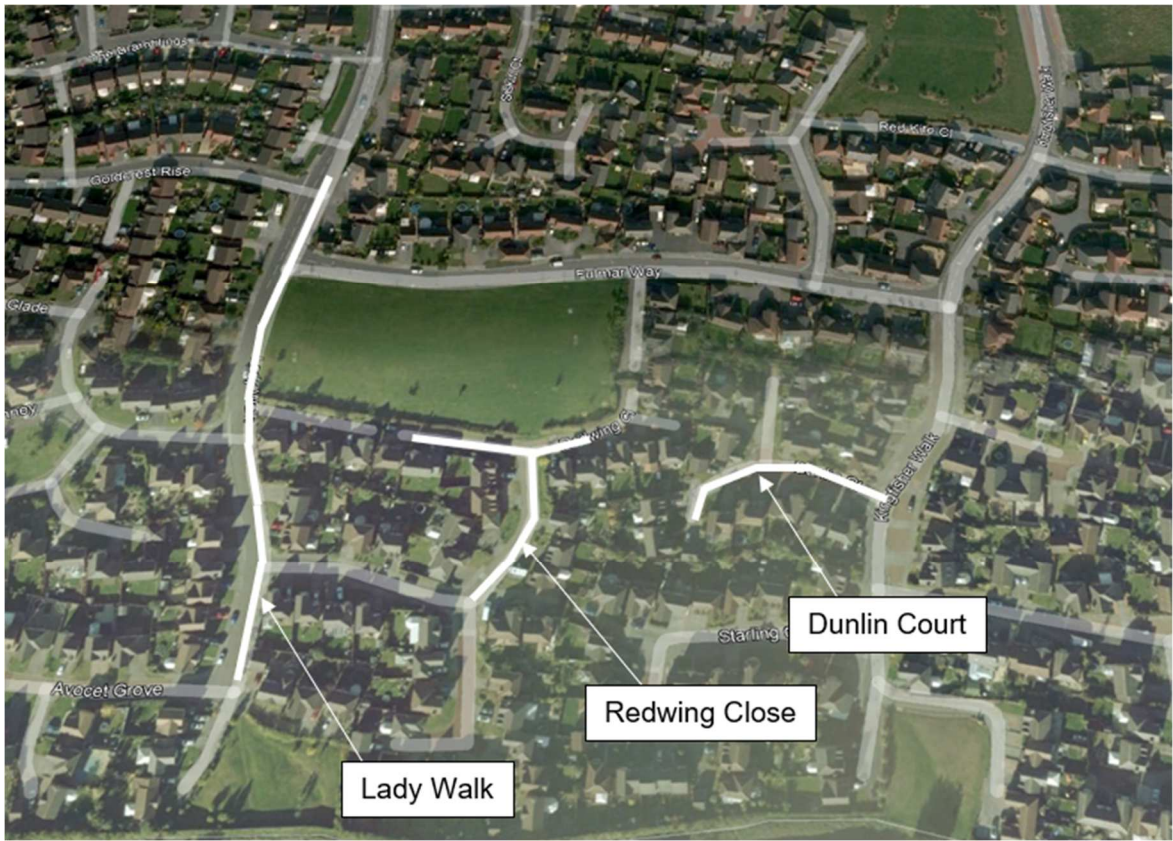
Figure 5. Dunlin Court, Lady Walk, Redwing Close

15. Dunlin Court, Lady Walk and Redwing Close are located in the Gateford Area of Worksop, with locations shown in figure 5. Due to the sustained heavy rainfall during Storm Babet, drainage systems were overwhelmed. As a result, highway flooding began initially, however levels were reached whereby surface water flowed off the highway and into properties. A total of 6 properties suffered internal flooding in this area.
16. This localised surface water flood risk is identified by mapping, shown in figure 6, which correlates with the flooding experienced.

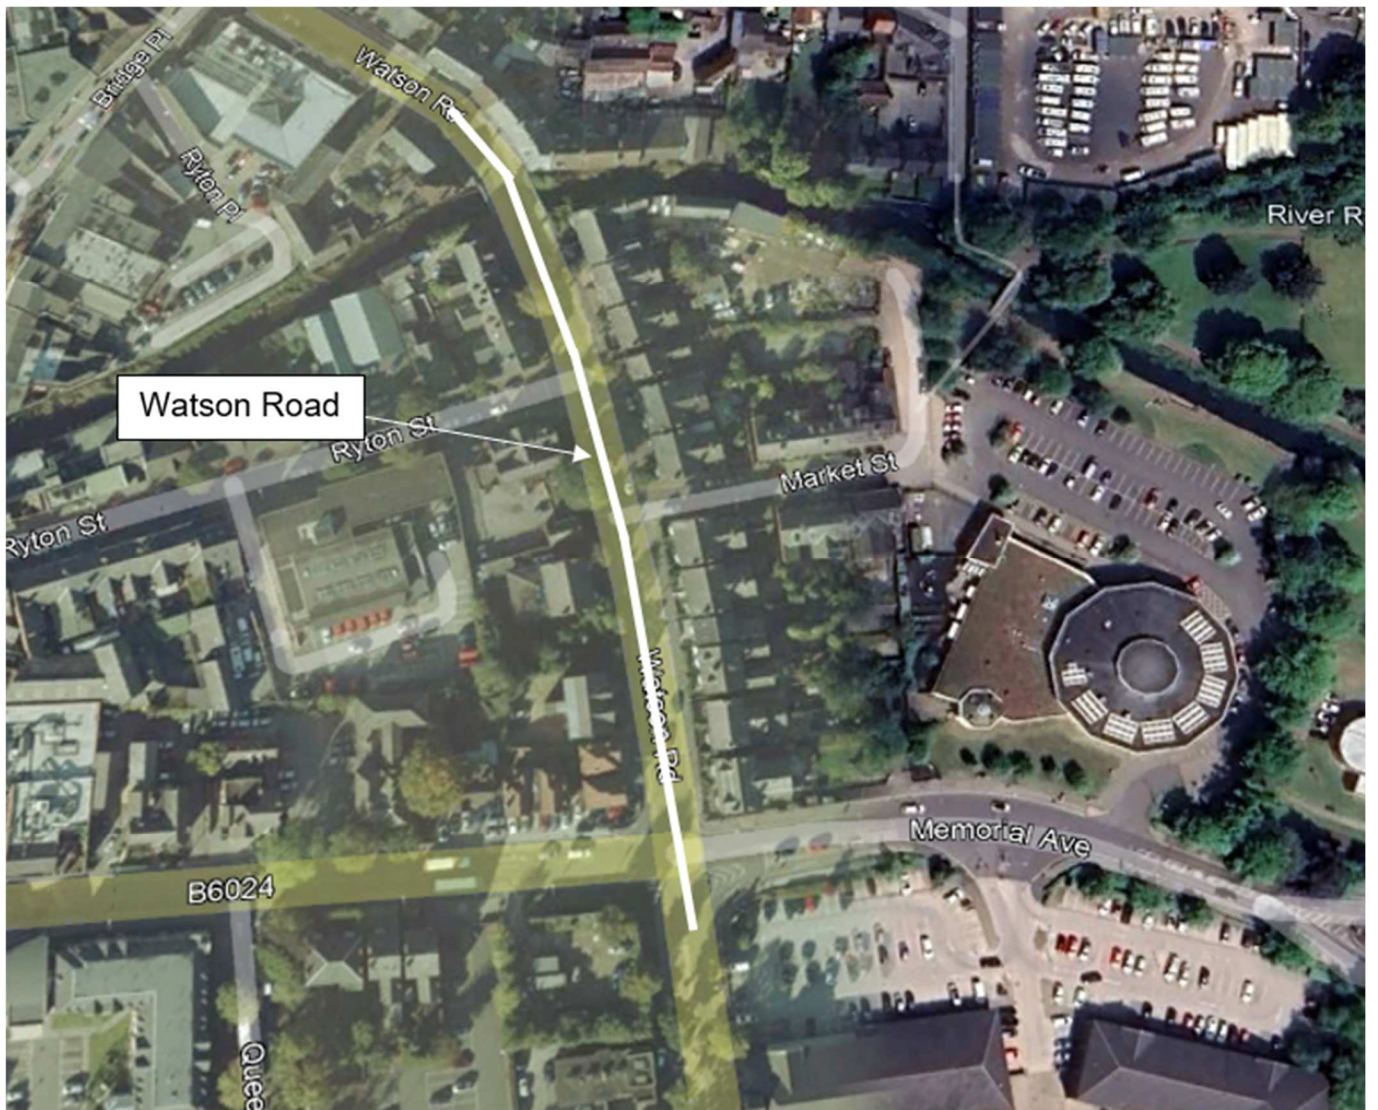
Figure 7. Watson Road

17. At Watson Road one business property was internally flooded. As shown in Figure 7, the road crosses a bridge over the River Ryton, which due to the sustained heavy rainfall had overtopped its banks.
18. As a result, the resultant flood water then followed the surrounding topography and pooled in the low spot causing internal flooding.

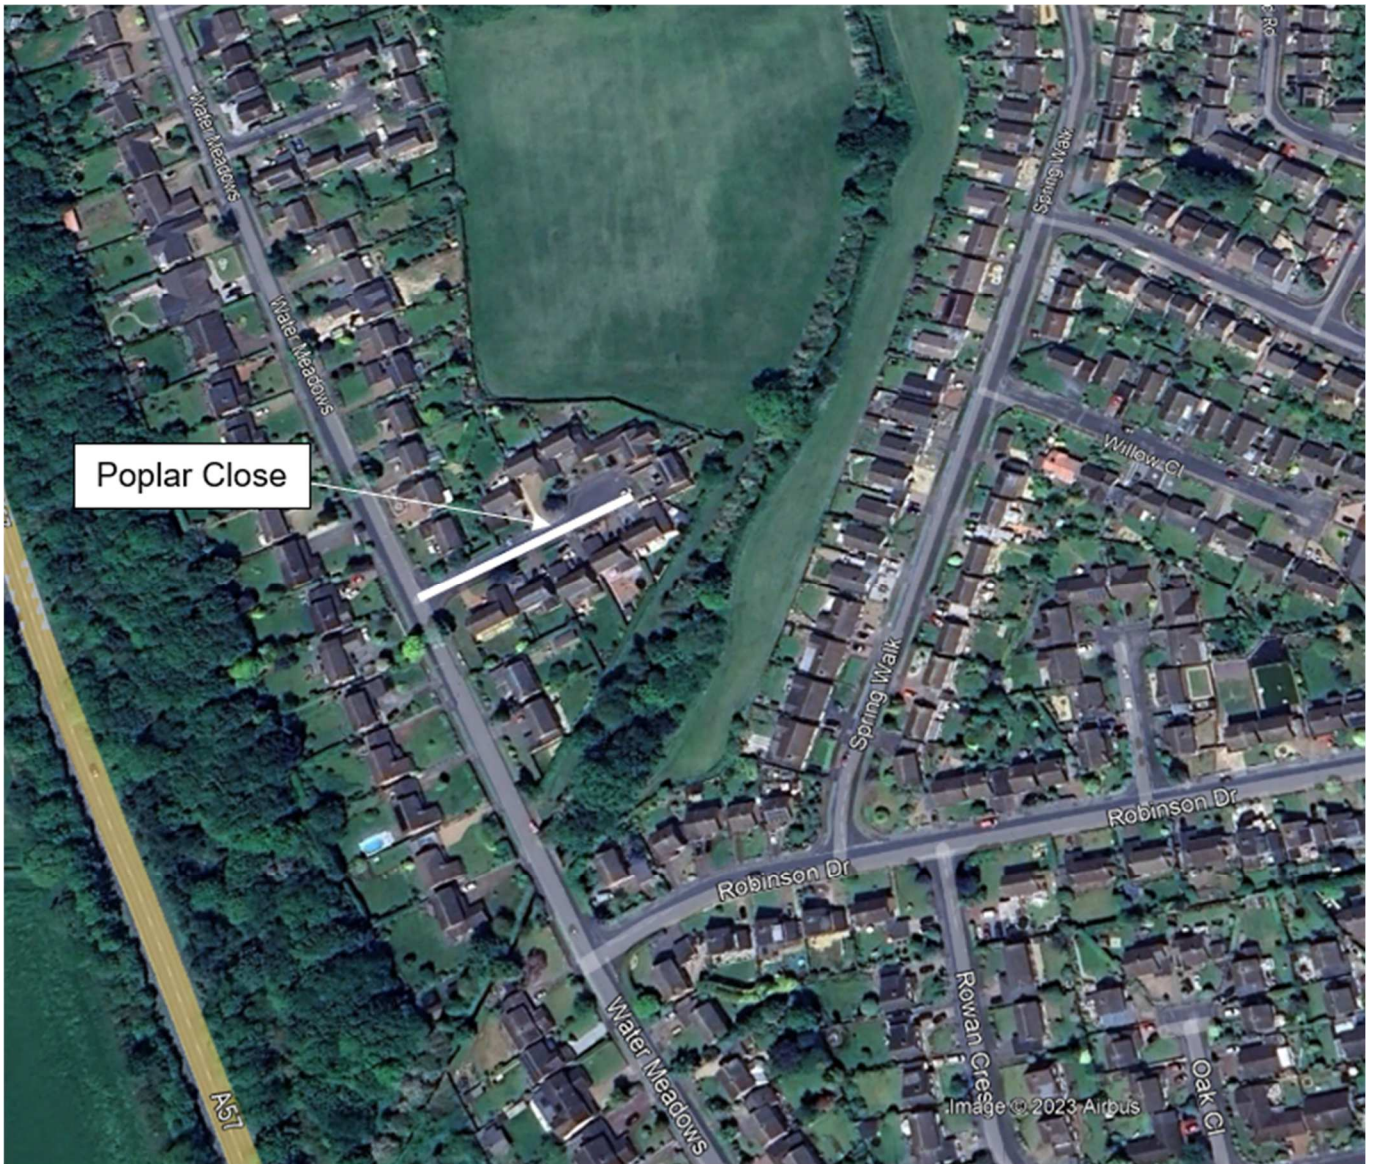
Figure 8. Poplar Close

19. As shown in Figure 8, Poplar Close is located to the south of Farr Park which has the Bull Brook (ordinary watercourse) run through it.
20. Residents accounts note that during Storm Babet areas of Farr Park were subject to flooding to a depth of approximately 1 foot. Surface water flowing down Poplar Close could not outfall effectively into the drainage system which would usually take this to the Bull Brook. As a result, surface water built up and then flowed off the highway, internally flooding two residential properties.
21. Predicted Fluvial Flood Extents as shown in Figure 9. correlate with this observed flooding on Farr Park.

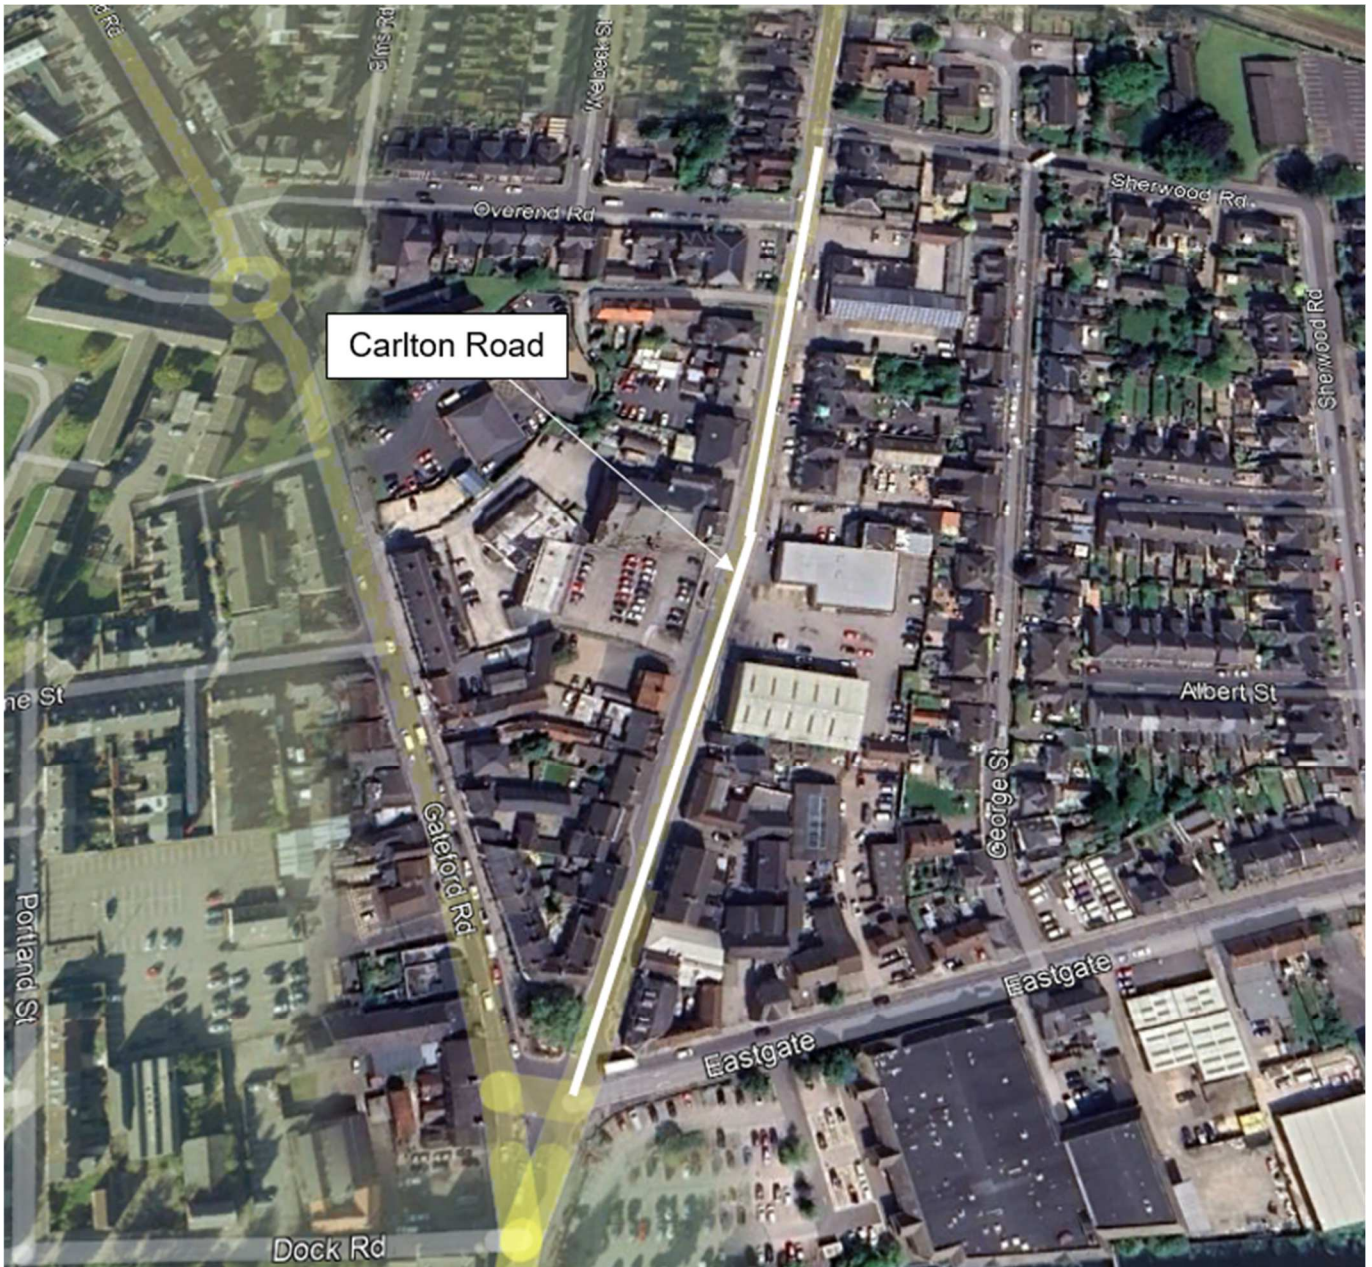
Figure 10. Carlton Road

22. One business property suffered internal flooding on Carlton Road. From accounts from staff it is understood that the flooding came from surface water runoff from the rear yard of the property.
