Appendix C – Photographic Montages

Land at Mill Hill - Photographic Montages

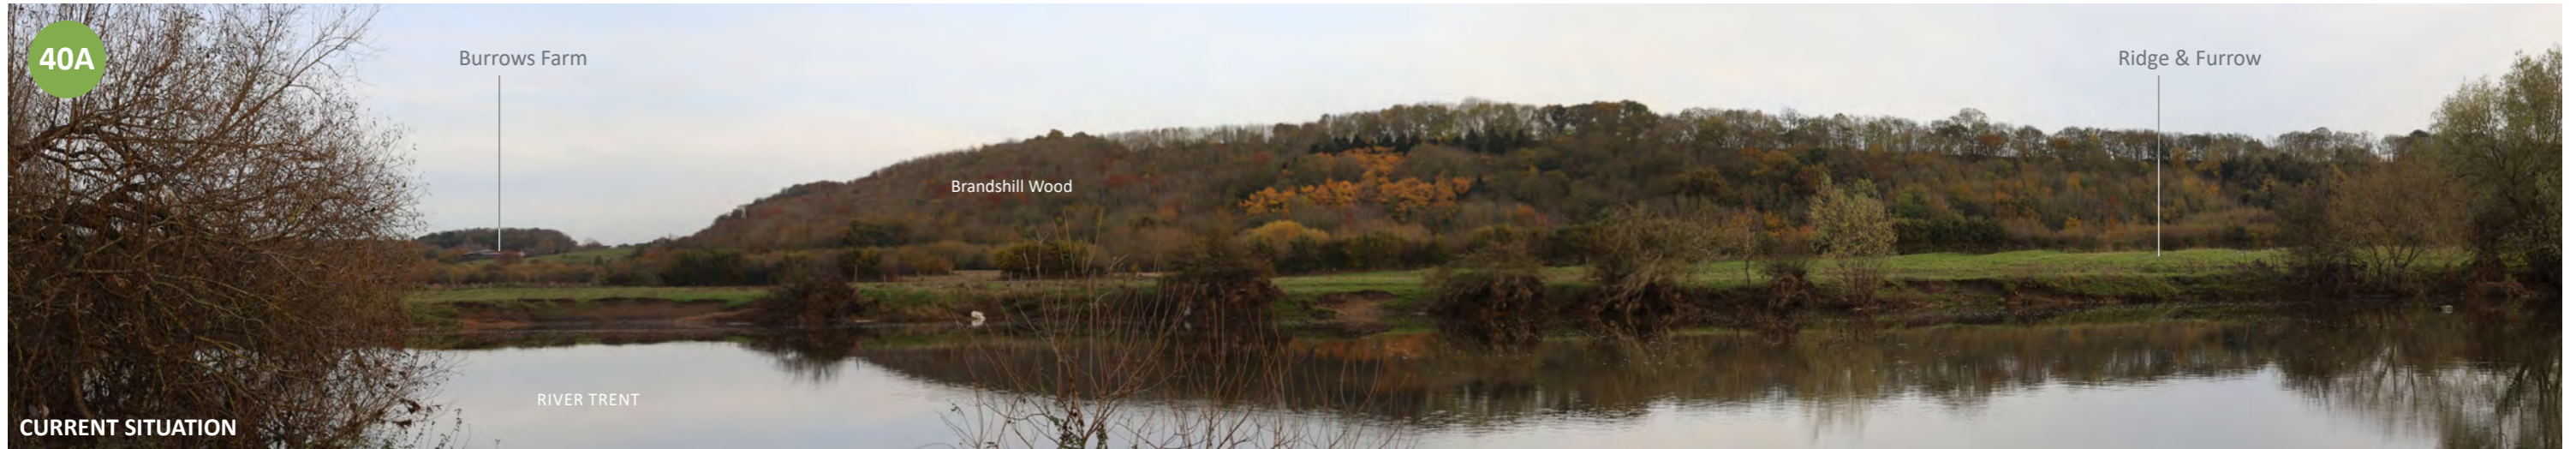
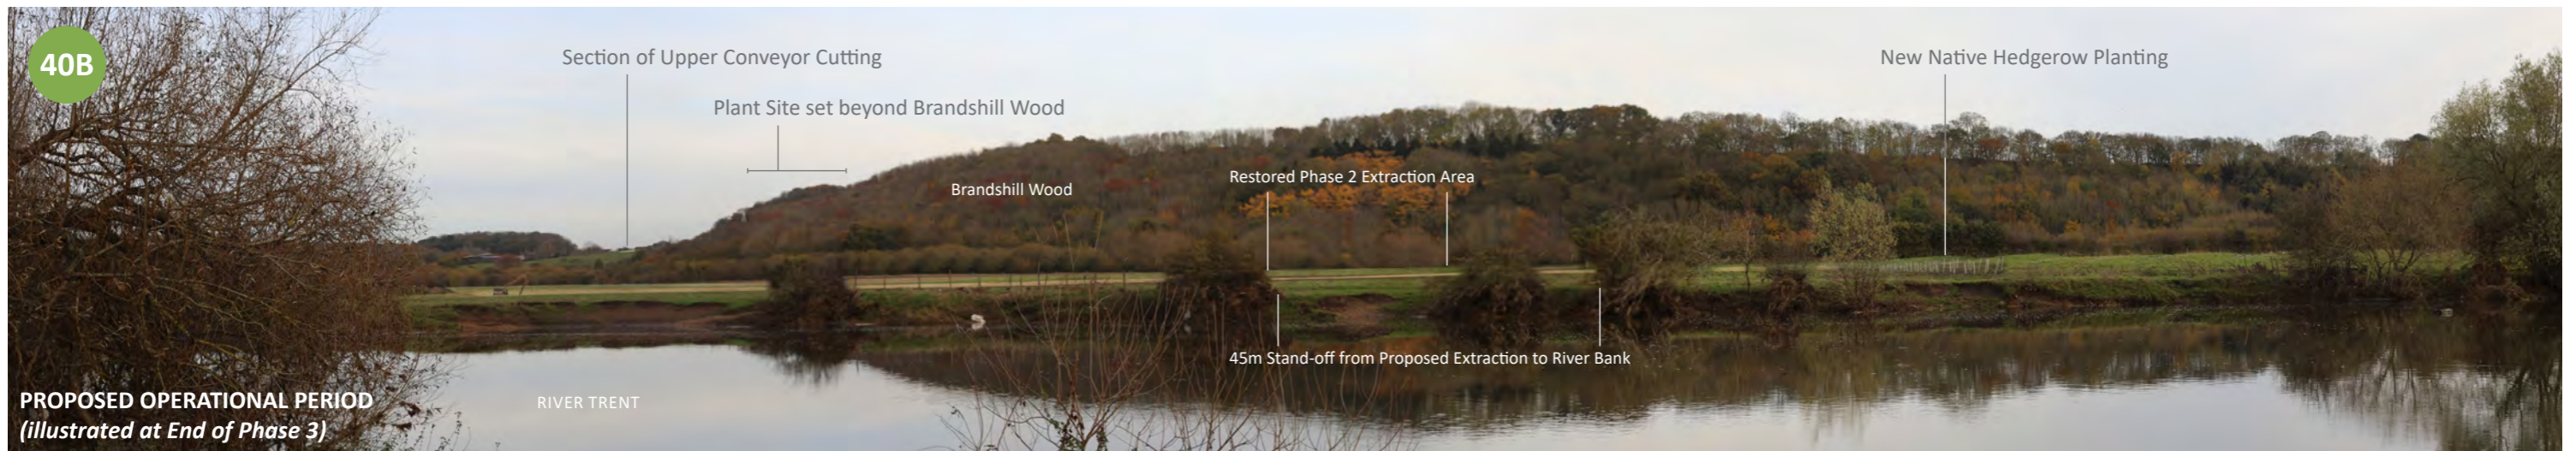
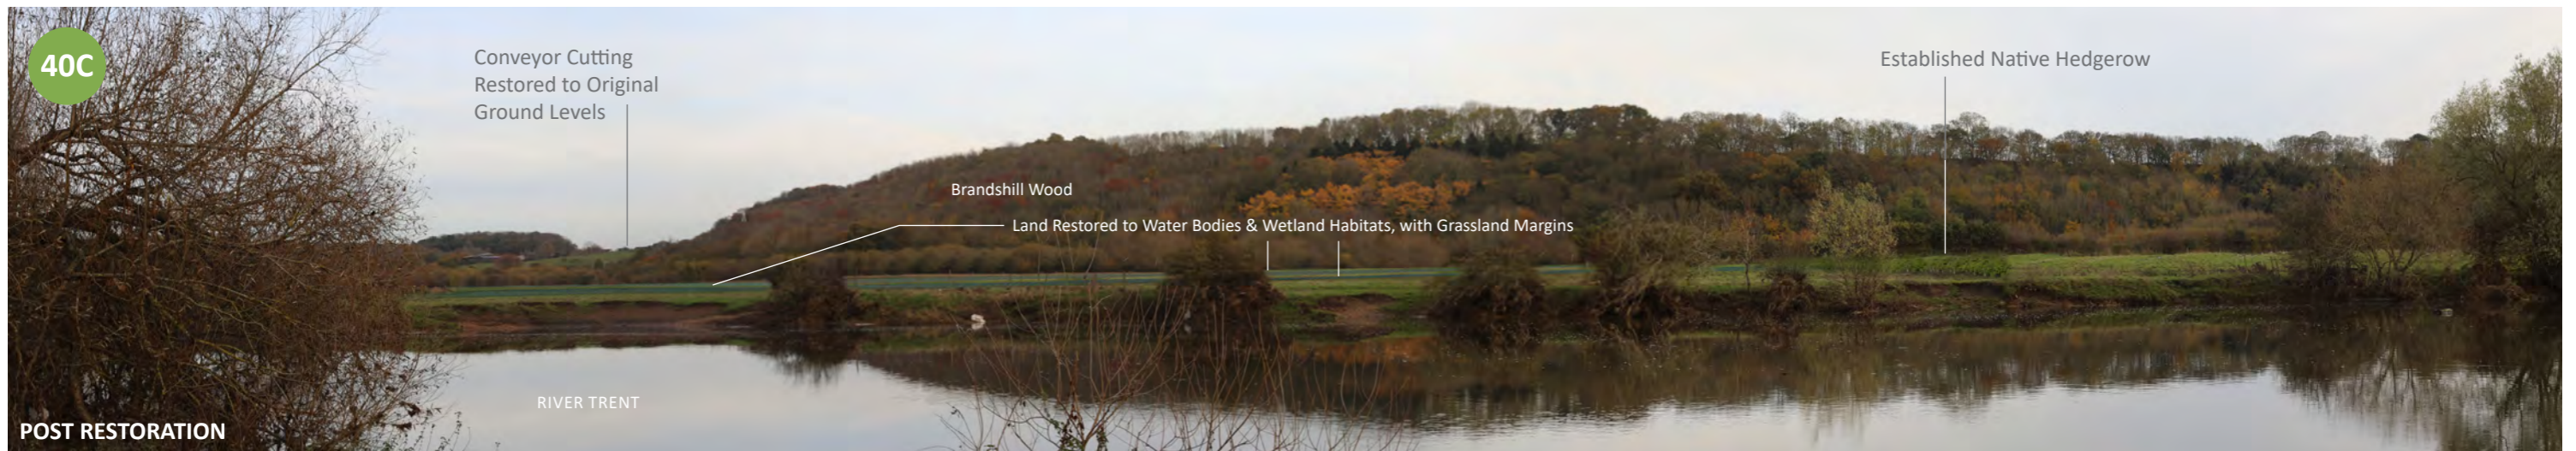
Photomontage Location 40: View Looking from West to East from PROW ref. FP69, Attenborough Nature Reserve

Photomontage Location 40. View looking eastwards towards the Site and Brandshill Wood from PROW ref. FP69, located within the Attenborough Nature Reserve, adjacent to the River Trent. There is a limited vertical angle of view due to the low lying nature of flood plain. Visual change includes the removal of existing vegetation structure within both the fore and mid ground of the view, together with mineral extraction and progressive restoration works throughout the development period.

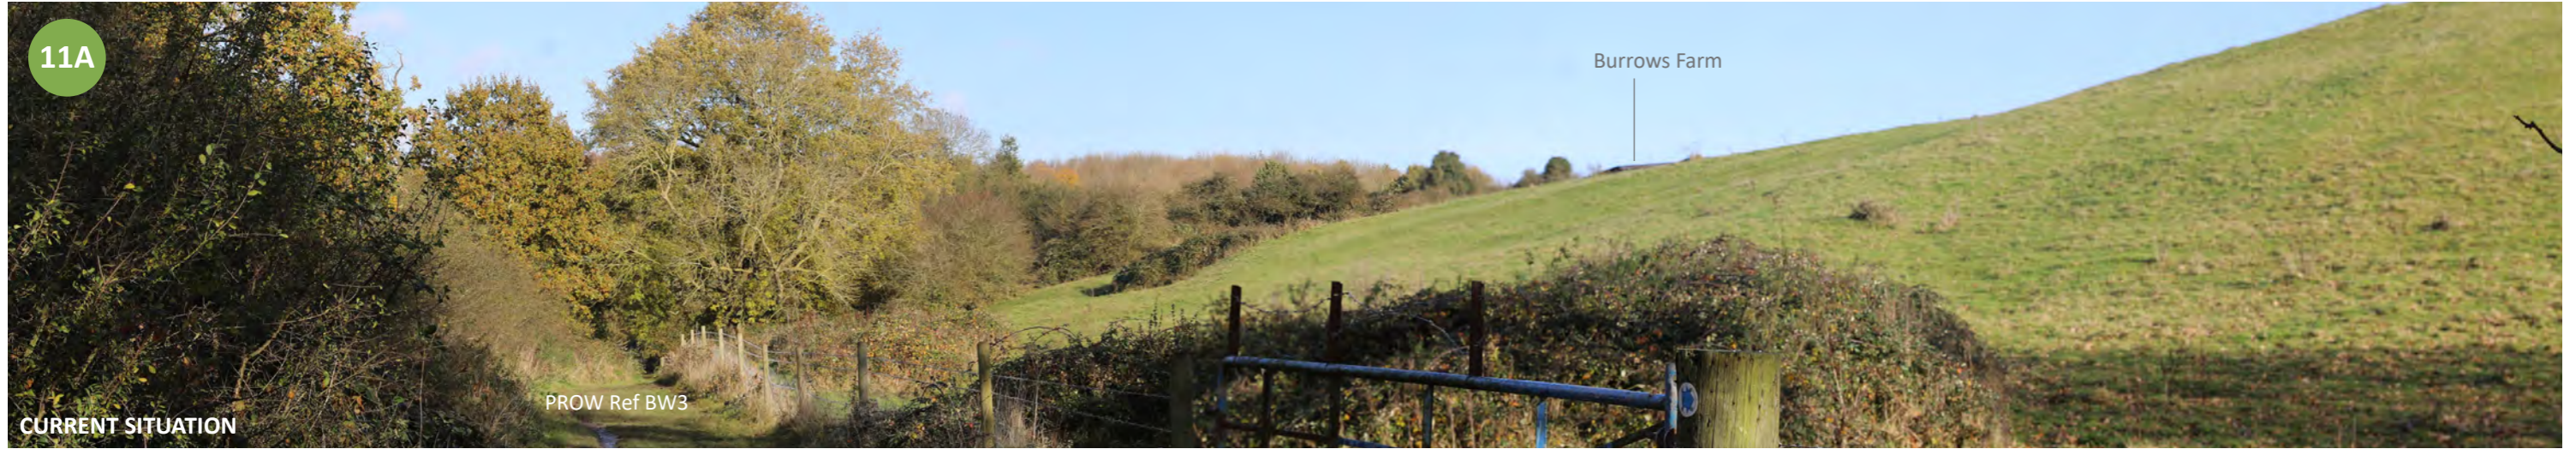
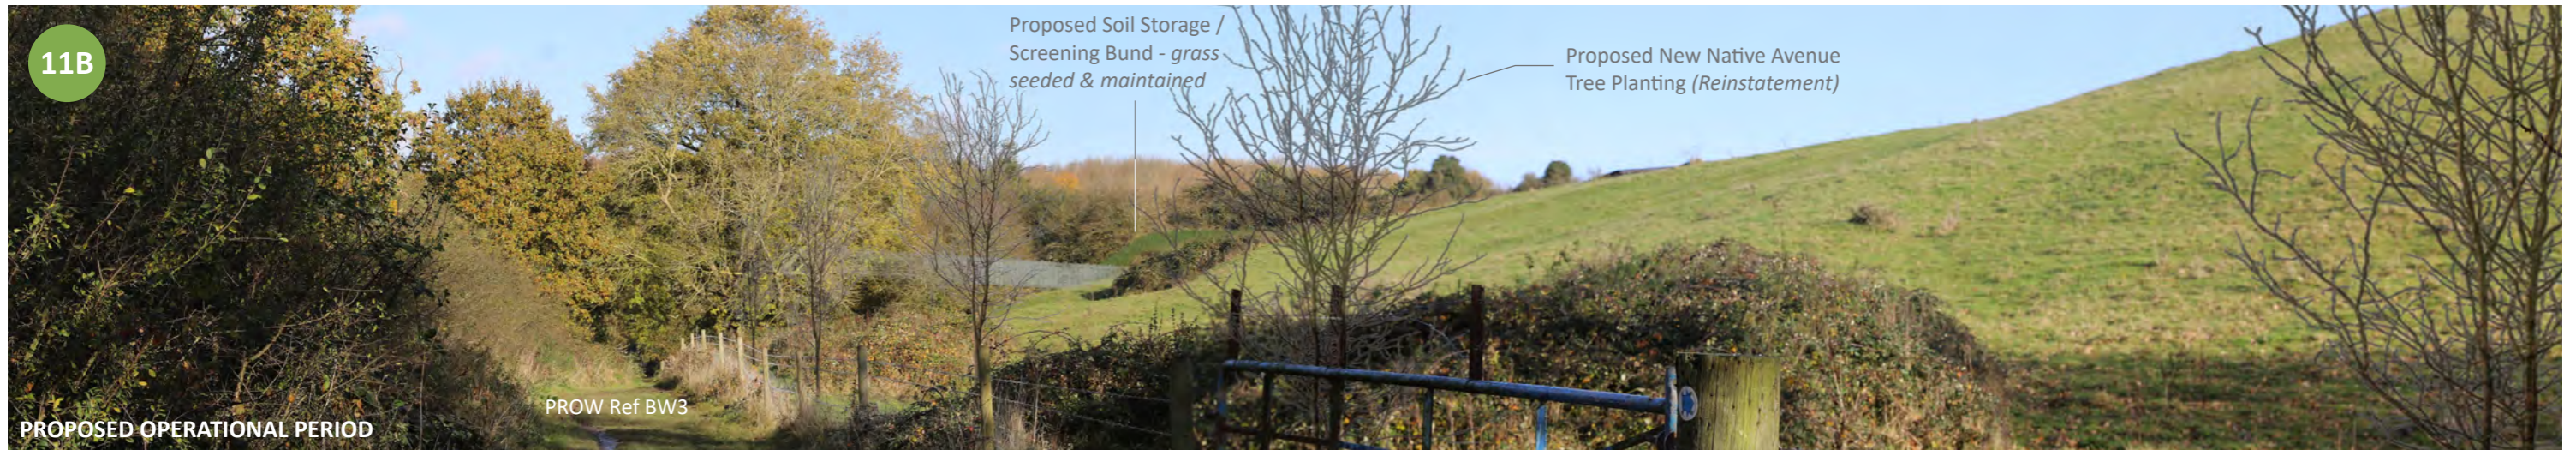
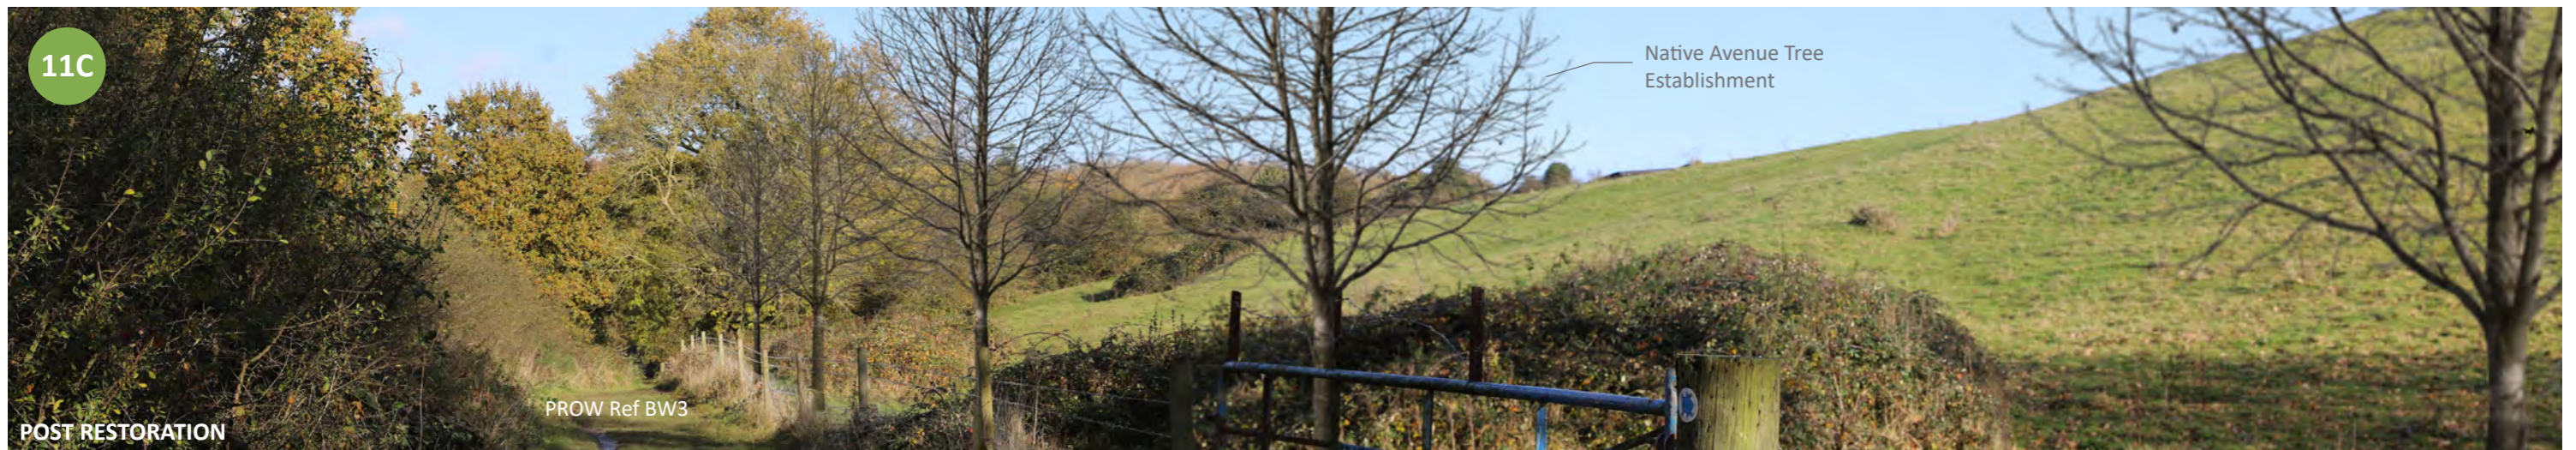
Photomontage Location 11: View Looking from South West to North East from PROW ref. BW3

Photomontage Location 11. View looking northwards from PROW ref. BW3, towards the proposed conveyor corridor and crossing point. Visible change is limited due to the nature of existing landform / topography and the conveyor corridor cutting, together with existing and proposed vegetation structure associated with the PROW route and the proposed reinstated avenue. Partial visibility of soil storage / screening bunding to be established adjacent to Burrows Farm.

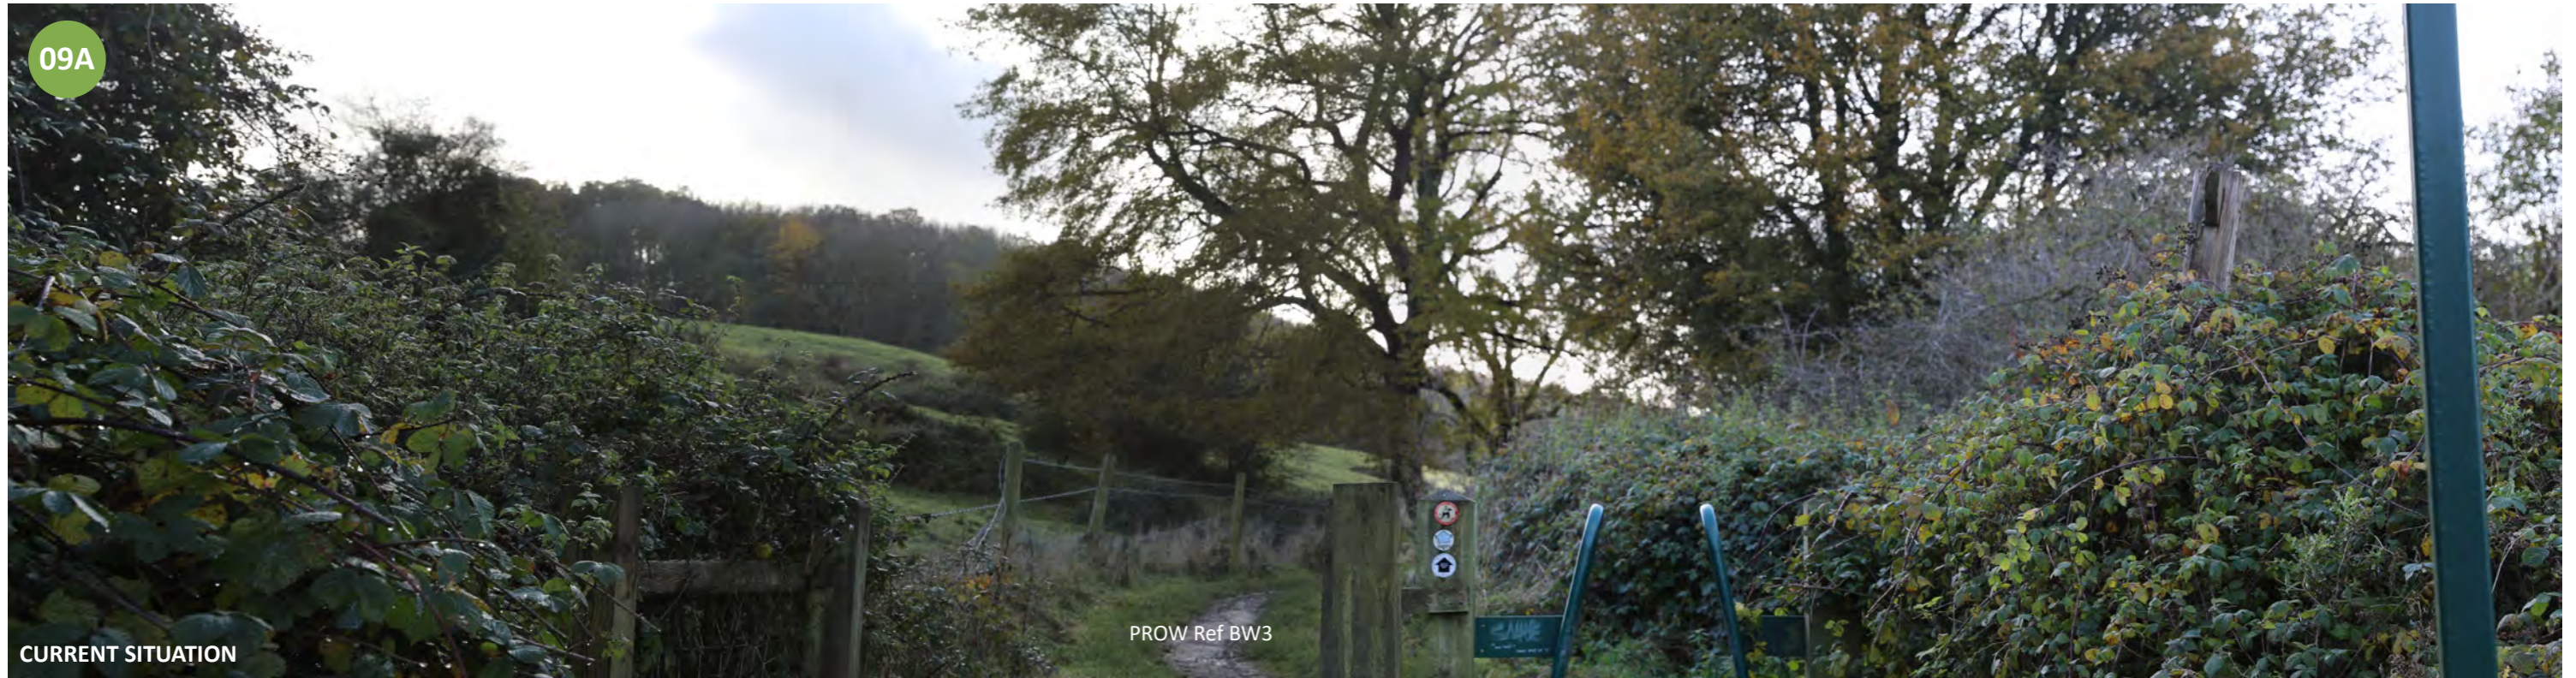
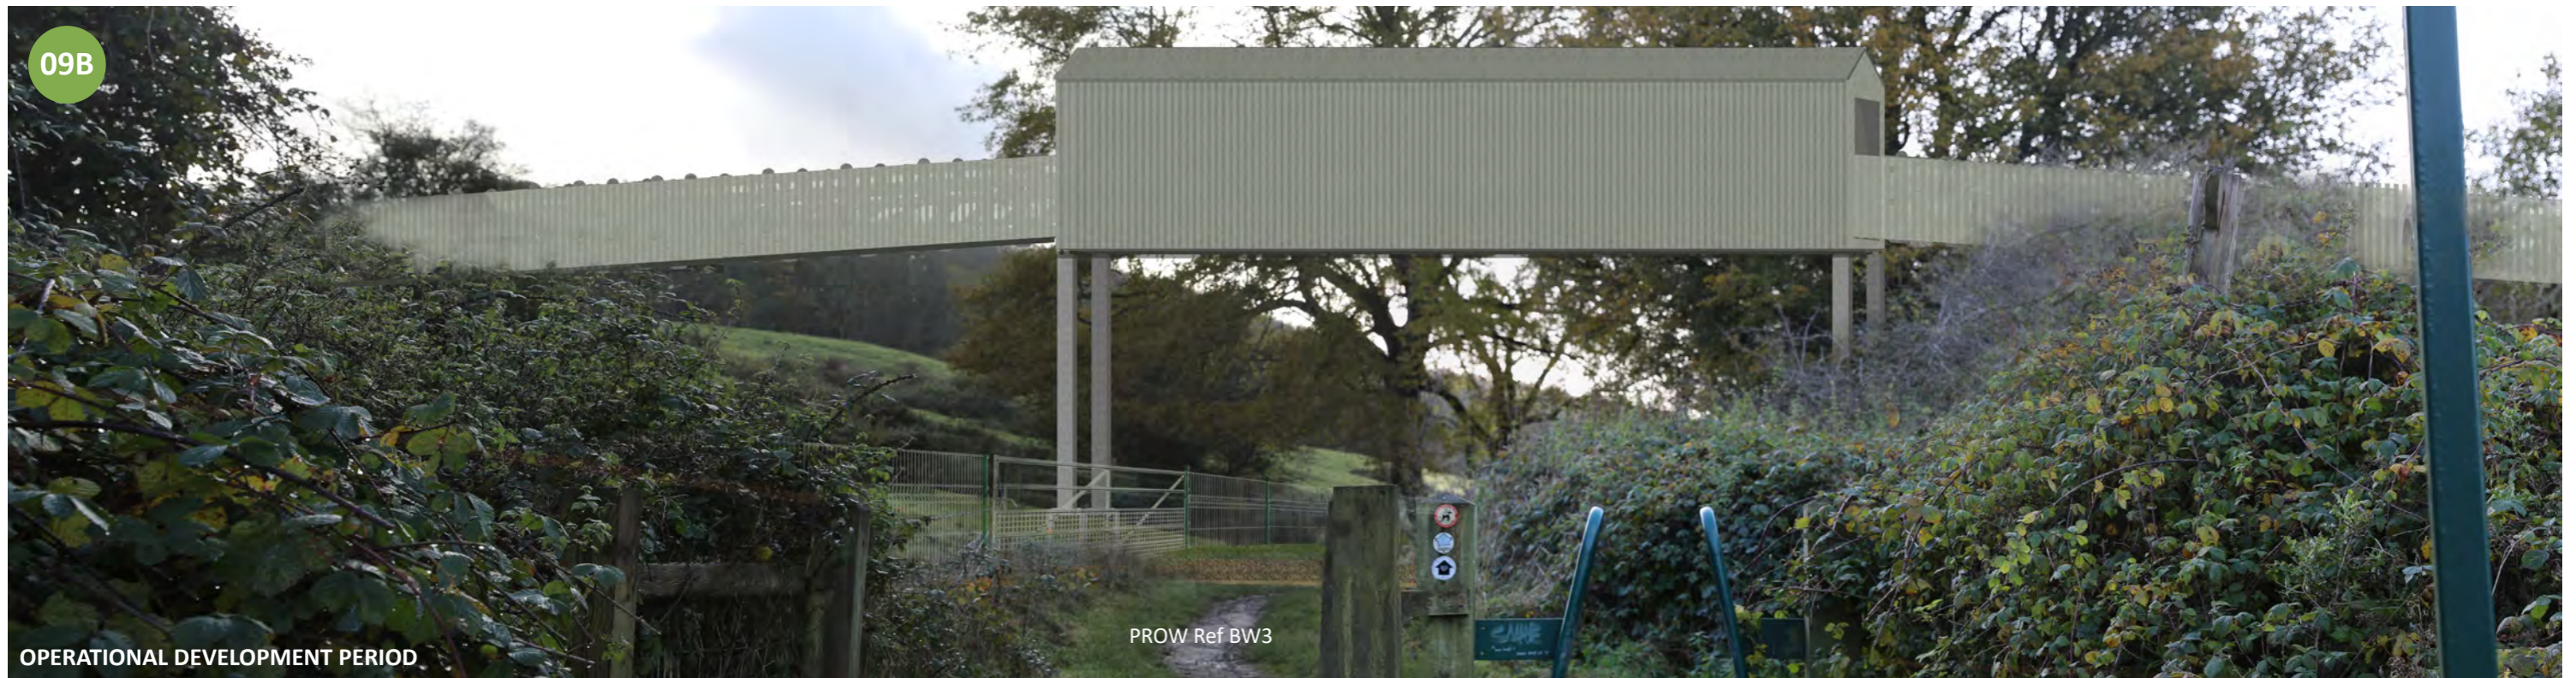
Photomontage Location 09: View Looking from North East to South West from PROW ref. BW3 - Junction with 100/3

Photomontage Location 09. View looking south westwards from PROW ref. BW3, towards the proposed conveyor corridor and crossing point. Short range visibility (transient) of the elevated conveyor crossing point and surface level vehicular crossing. Associated fencing / gates and surfacing changes, with the existing PROW route travelling beneath the conveyor bridge. Native tree planting visible upon restoration, post the removal of the conveyor infrastructure.

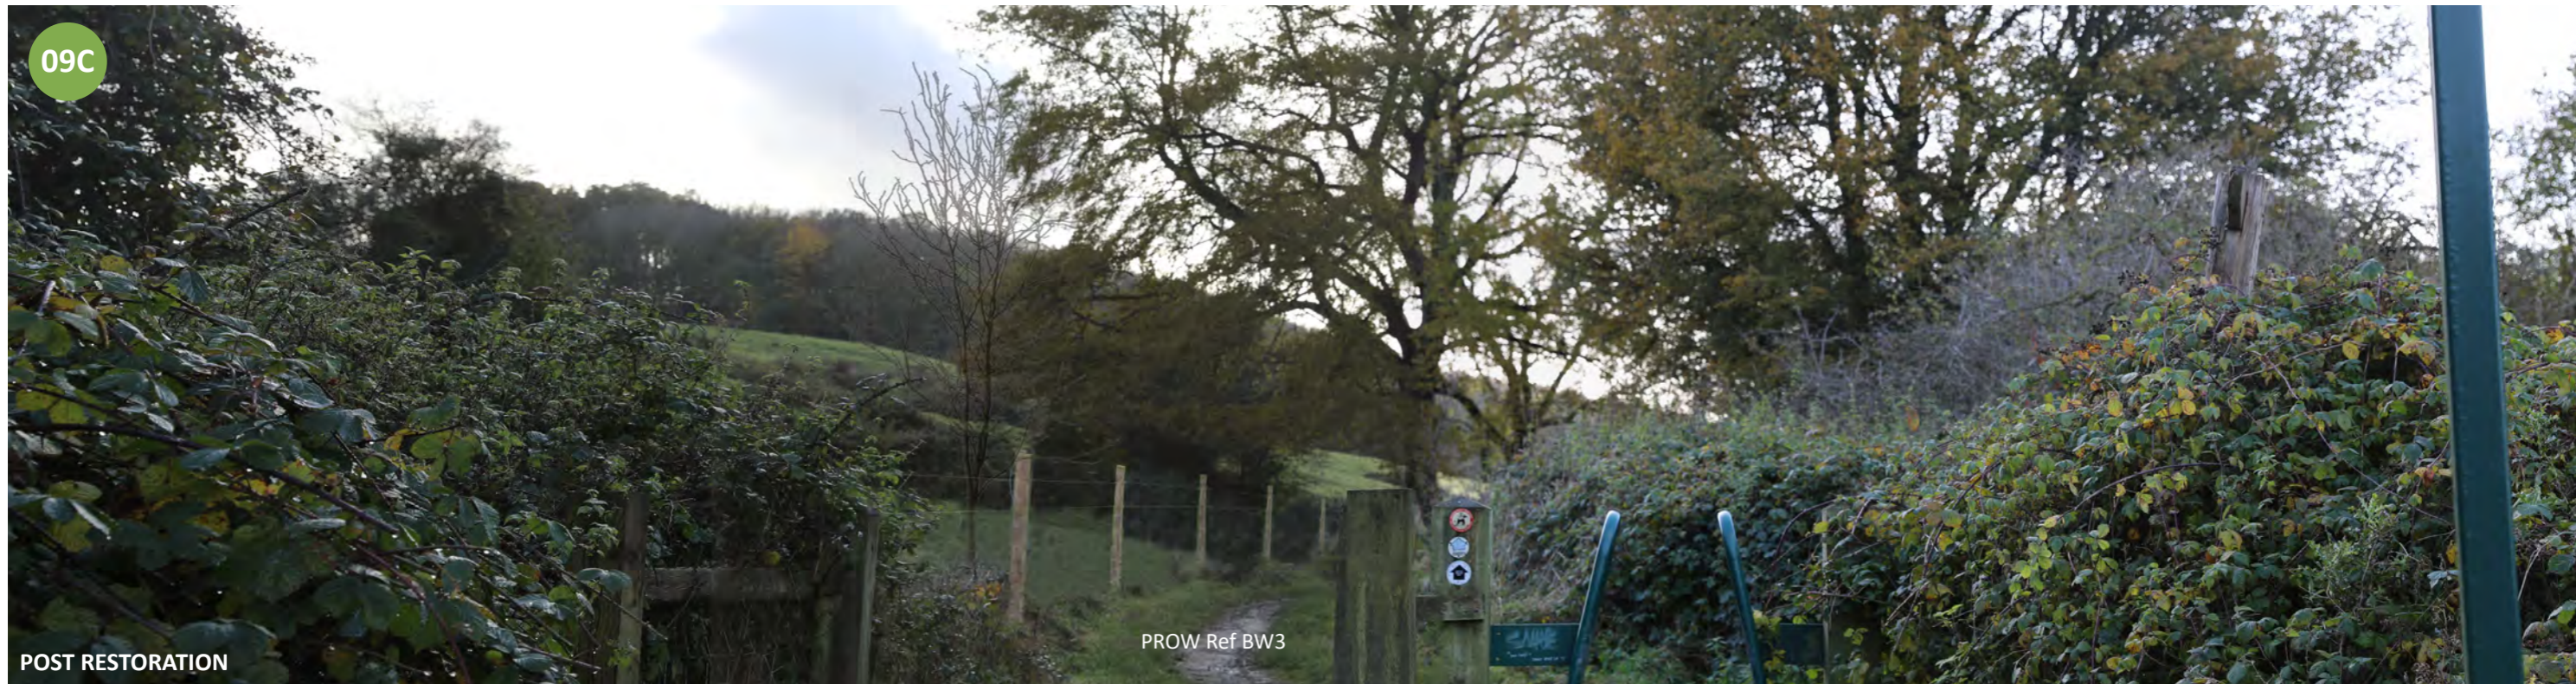
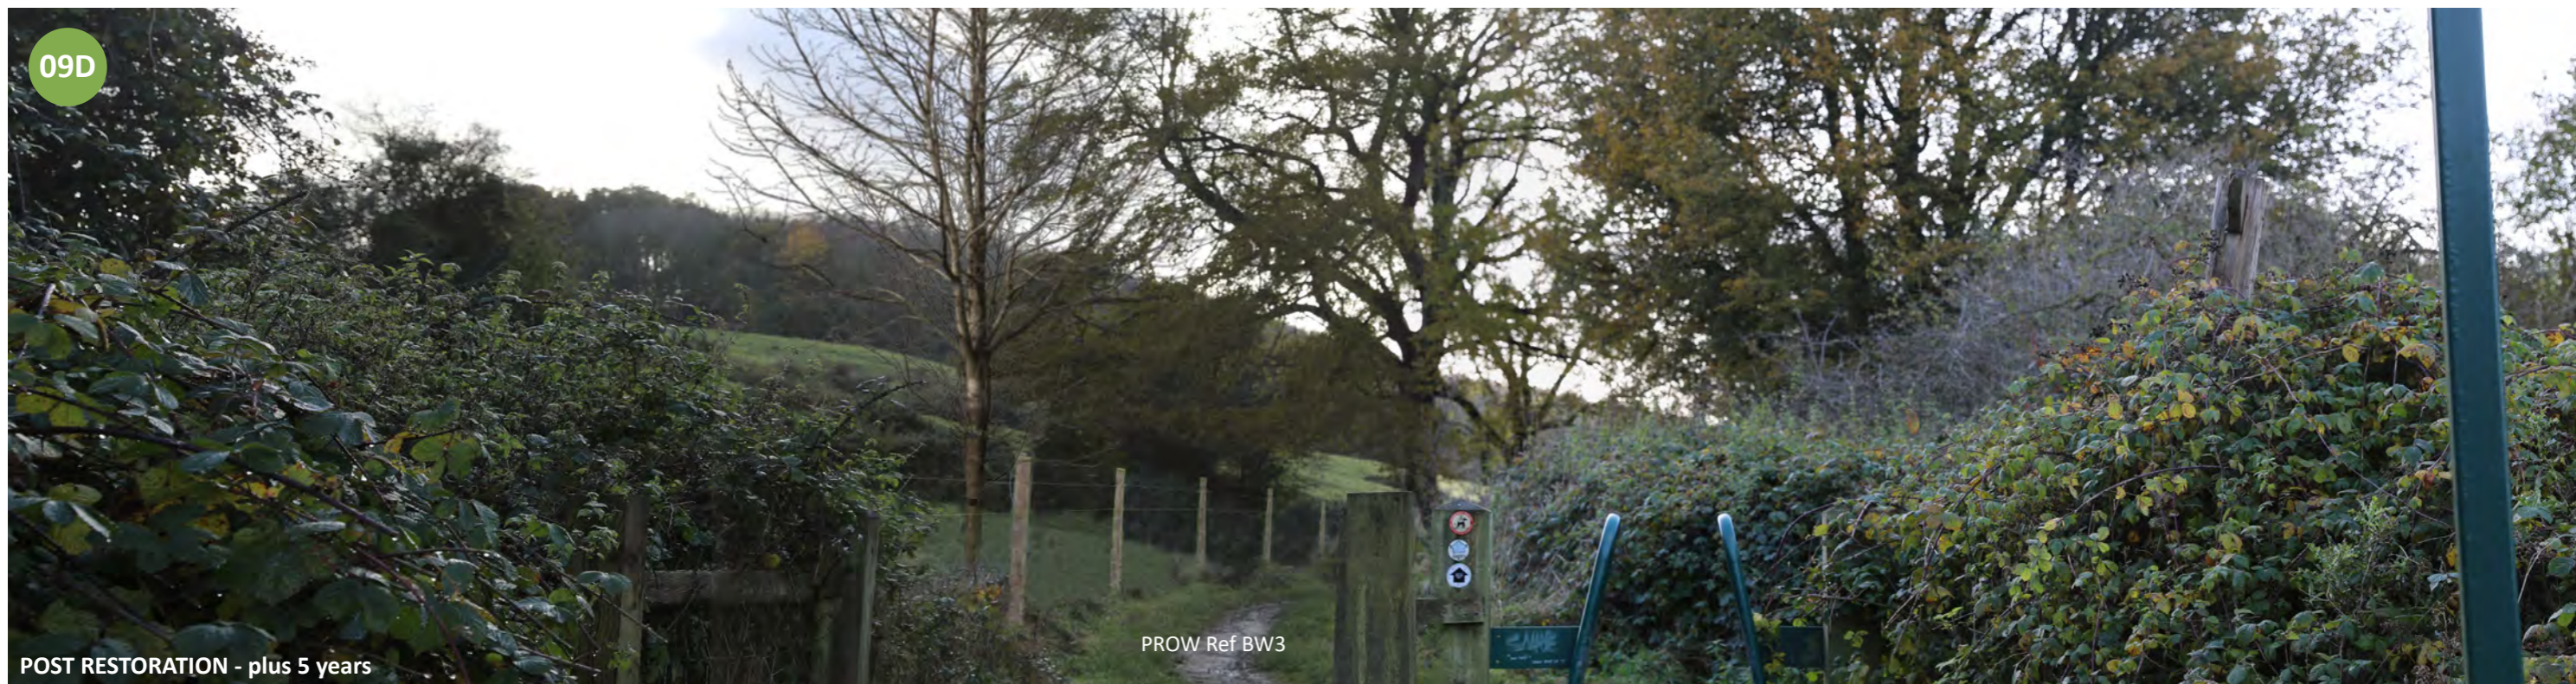
Photomontage Location 09: View Looking from North East to South West from PROW ref. BW3- Junction with 100/3

Photomontage Location 09. View looking south westwards from PROW ref. BW3, towards the proposed conveyor corridor and crossing point. Short range visibility (transient) of the elevated conveyor crossing point and surface level vehicular crossing. Associated fencing / gates and surfacing changes, with the existing PROW route travelling beneath the conveyor bridge. Native tree planting visible upon restoration, post the removal of the conveyor infrastructure.

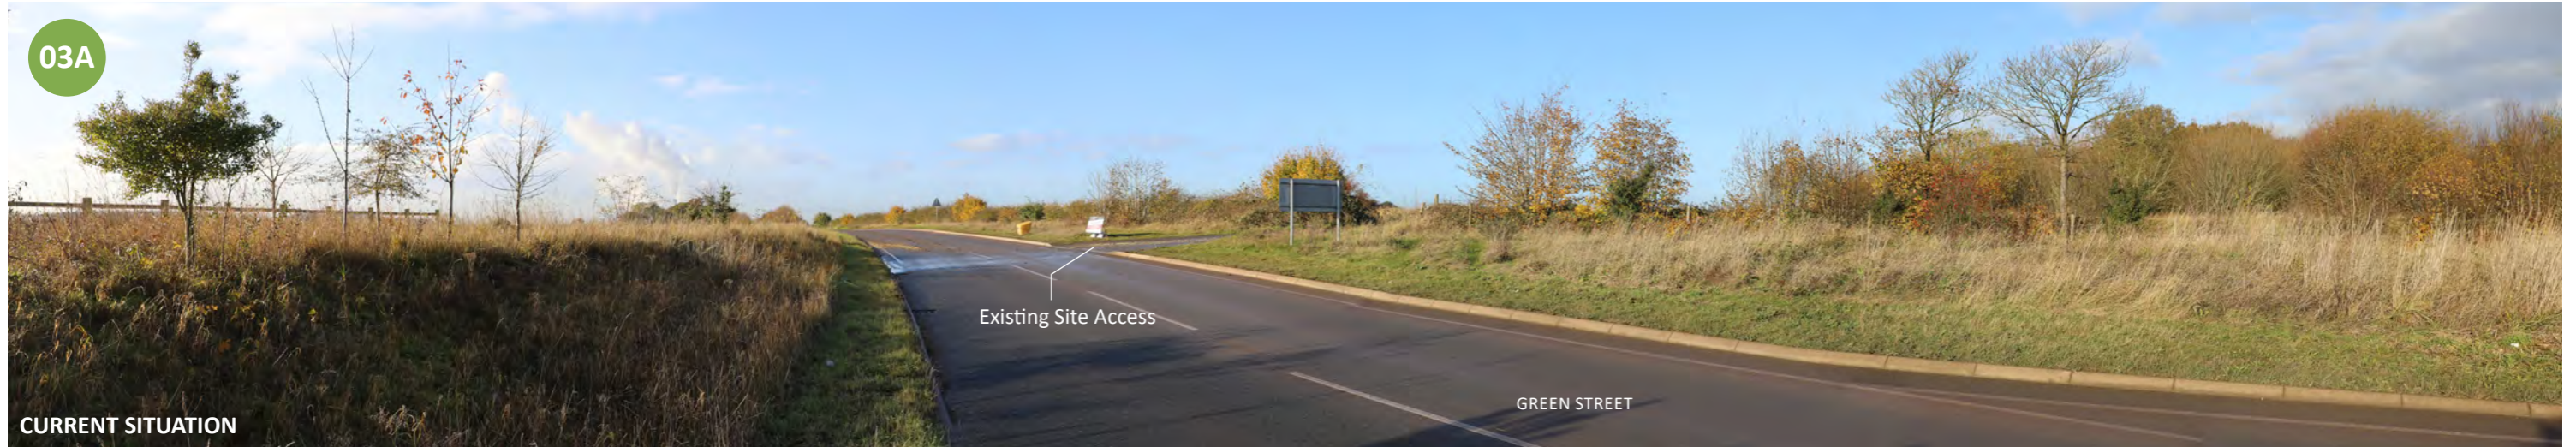
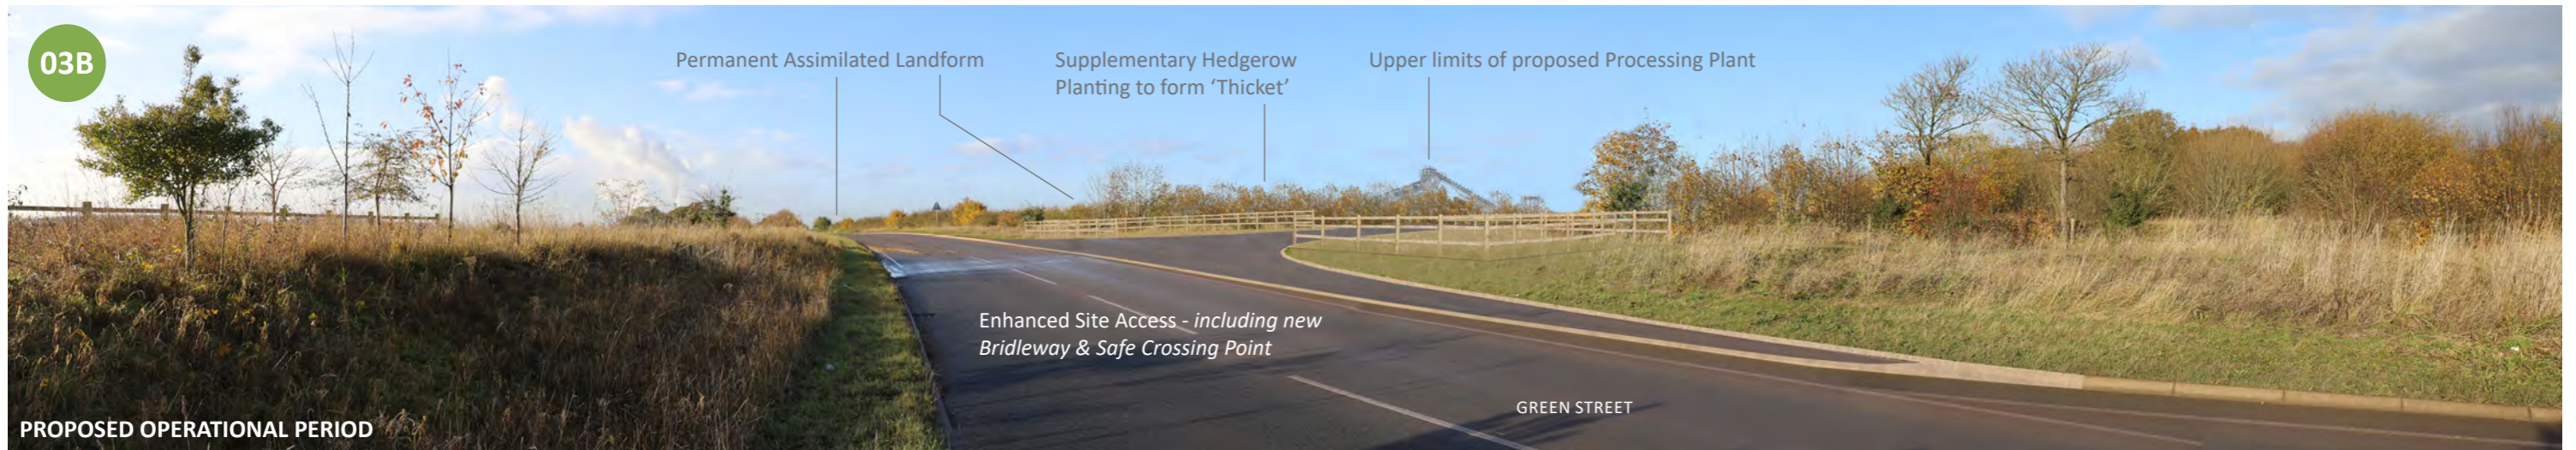
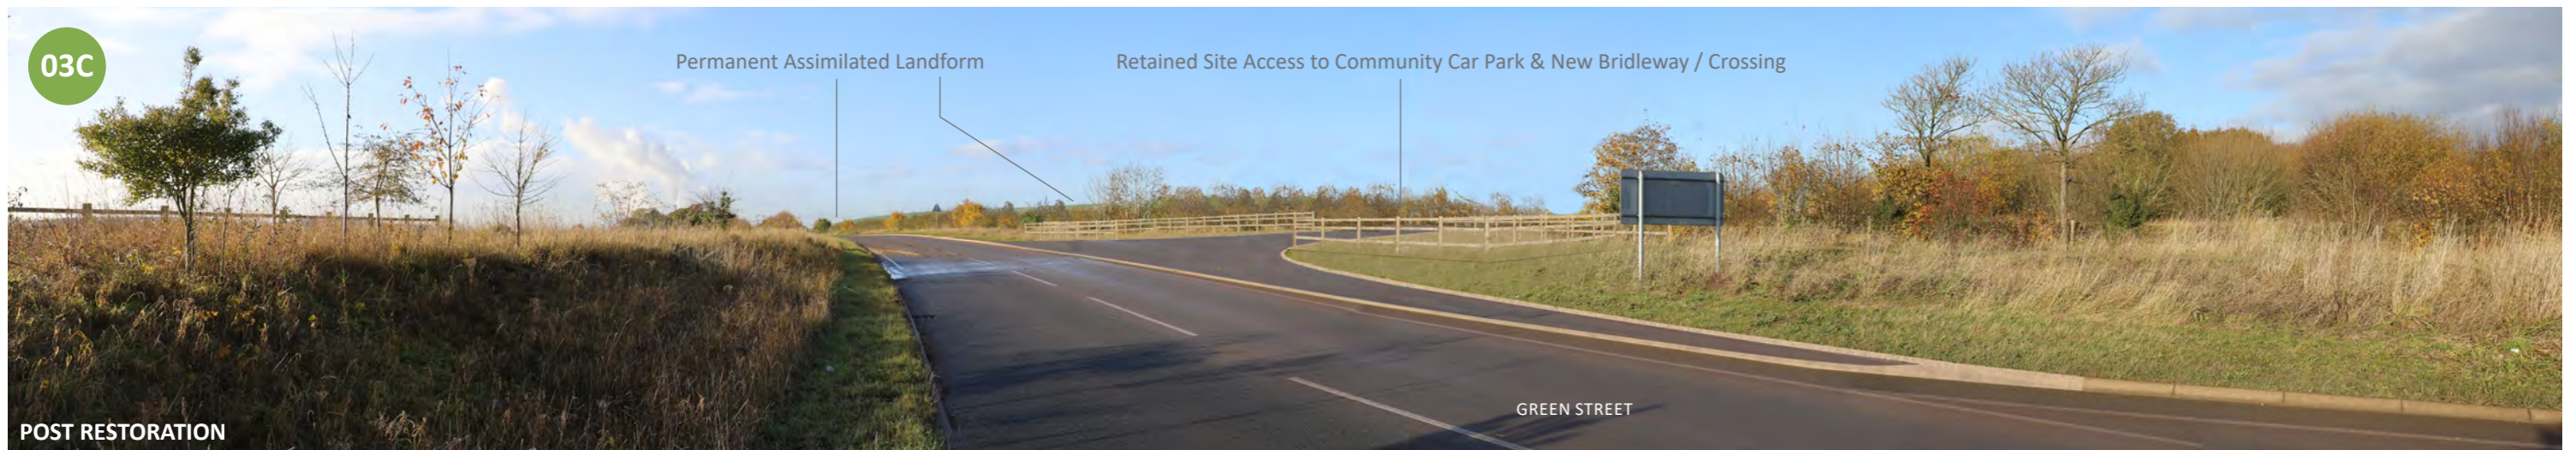
Photomontage Location 03: View looking West from Green Street towards Proposed Plant Site

Photomontage Location 03. View looking west from Green Street, adjacent to the existing Site Access, towards the proposed sunken plant site and assimilated landform beyond. Visibility includes works to hedgerows, including both removal and enhancement to facilitate safe access and new bridleway works, to allow access to both the proposed plant site and community car park. The plant site is set low down beyond. Visibility is limited to the upper limits of the proposed processing plant only, with no visibility of internal movements from this location.

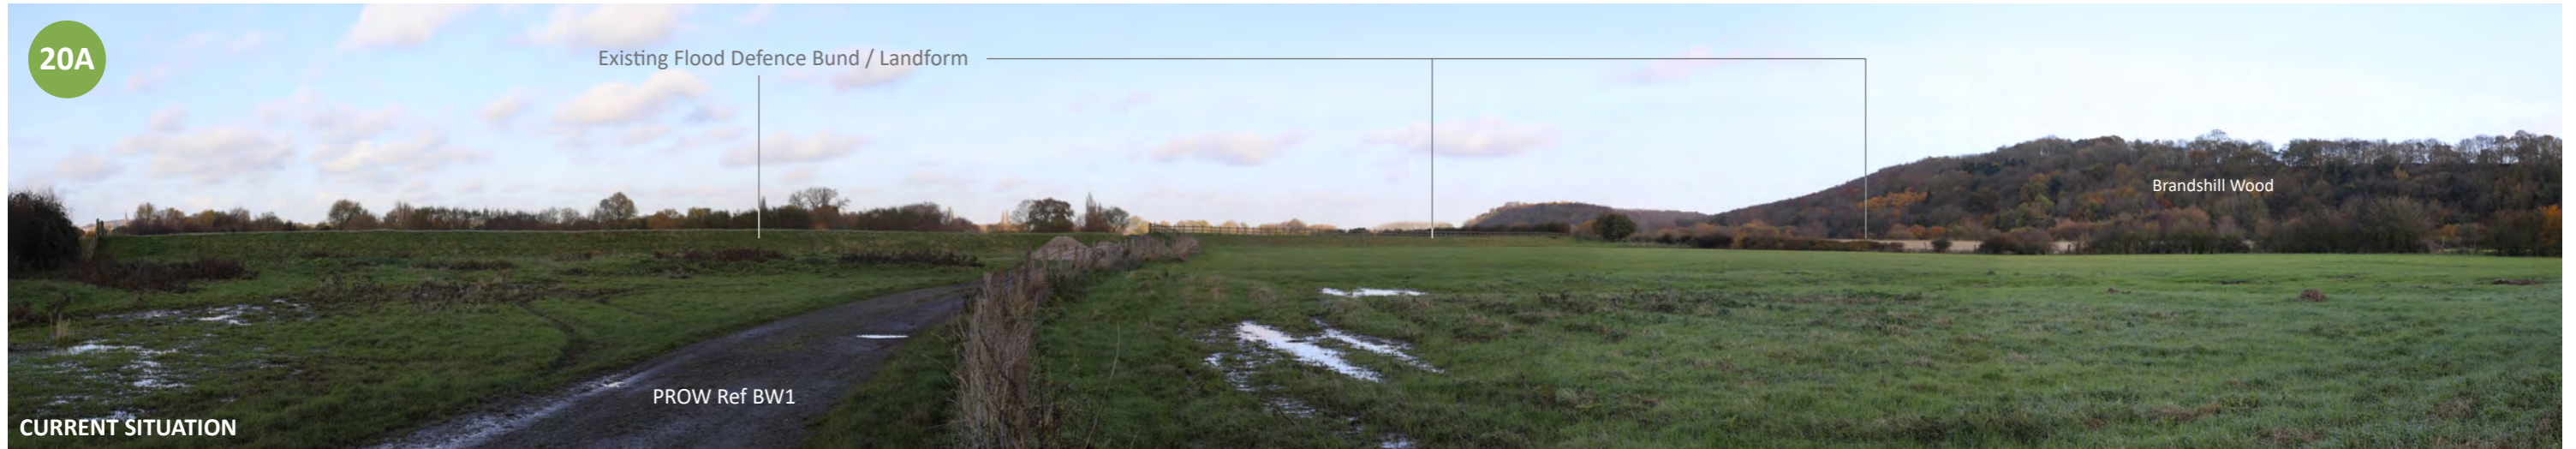
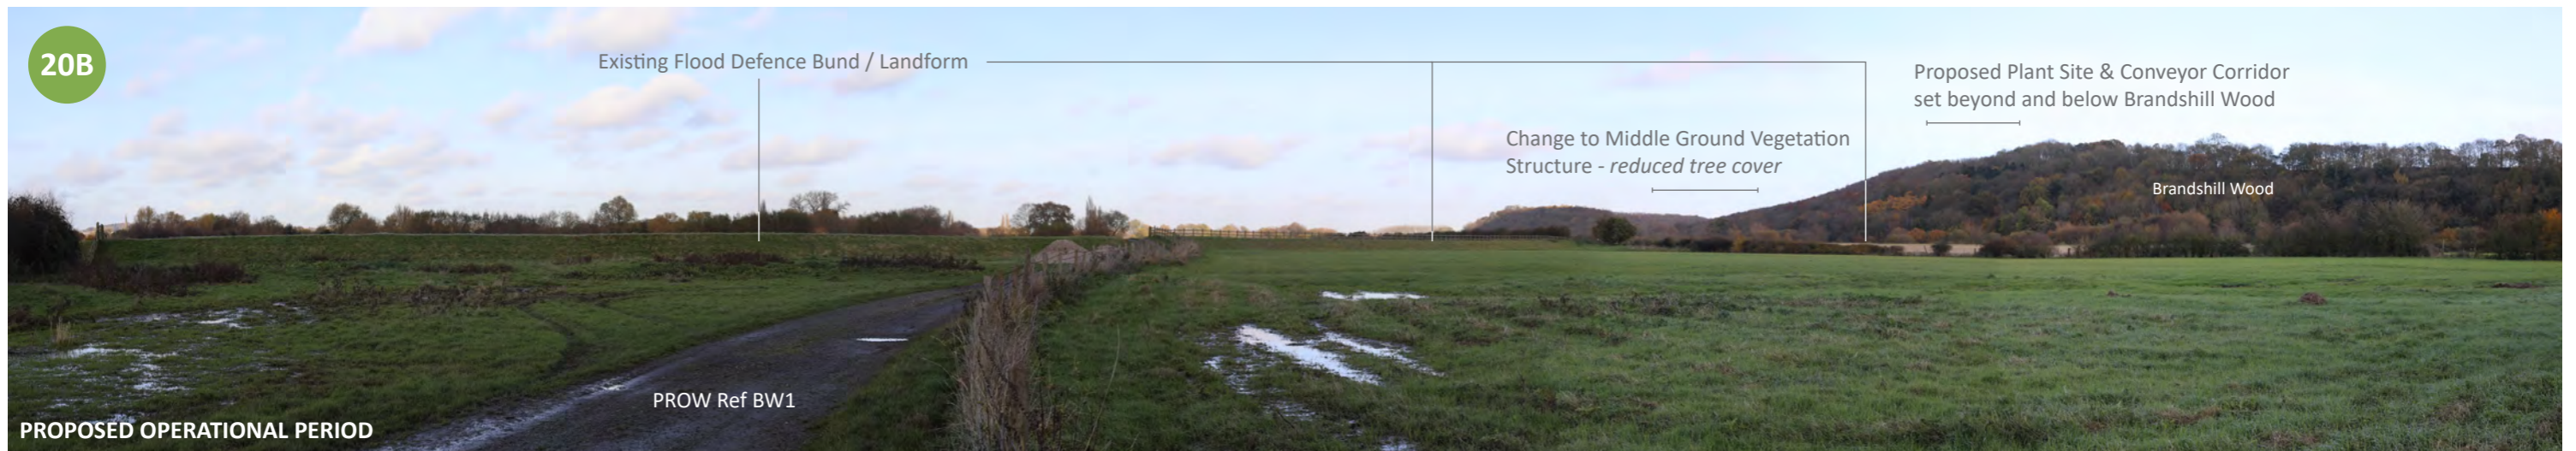
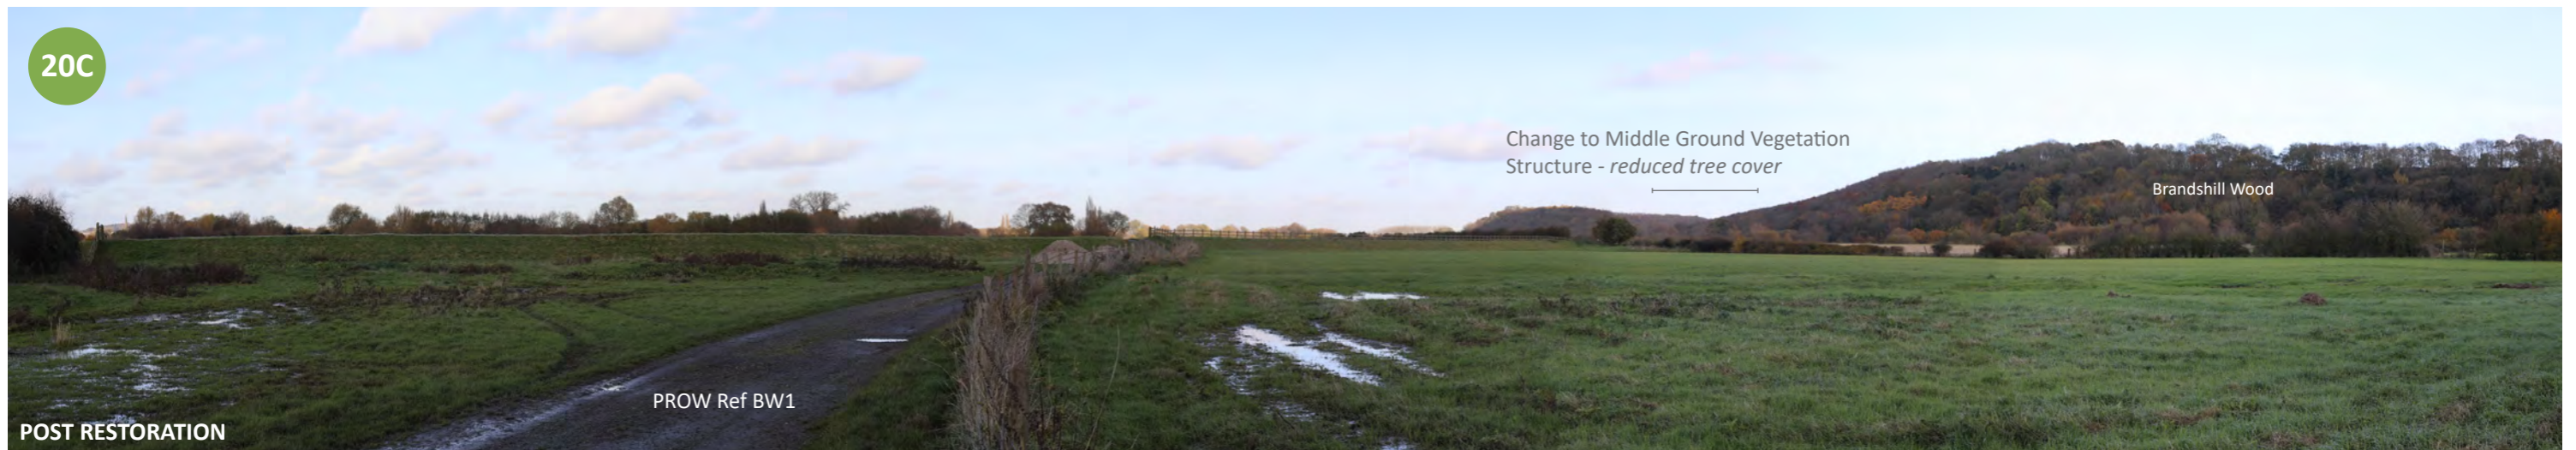
Photomontage Location 20: View looking North to North East from PROW Ref. BW1

Photomontage Location 20. View looking North to North East from PROW Ref. BW1. As illustrated above, due to the presence of the intervening above ground flood defence bund, no direct view of the proposed development can be gained from this location. It is considered that an amount of vegetation loss will be perceived within the middle to background of the view, however due to wider vegetation presence, no skyline change would occur. The proposed mineral extraction areas and associated plant / machinery movements would be set below and beyond the existing bund landform.
