Appendix C – Photographic Montages

Land at Mill Hill - Photographic Montages

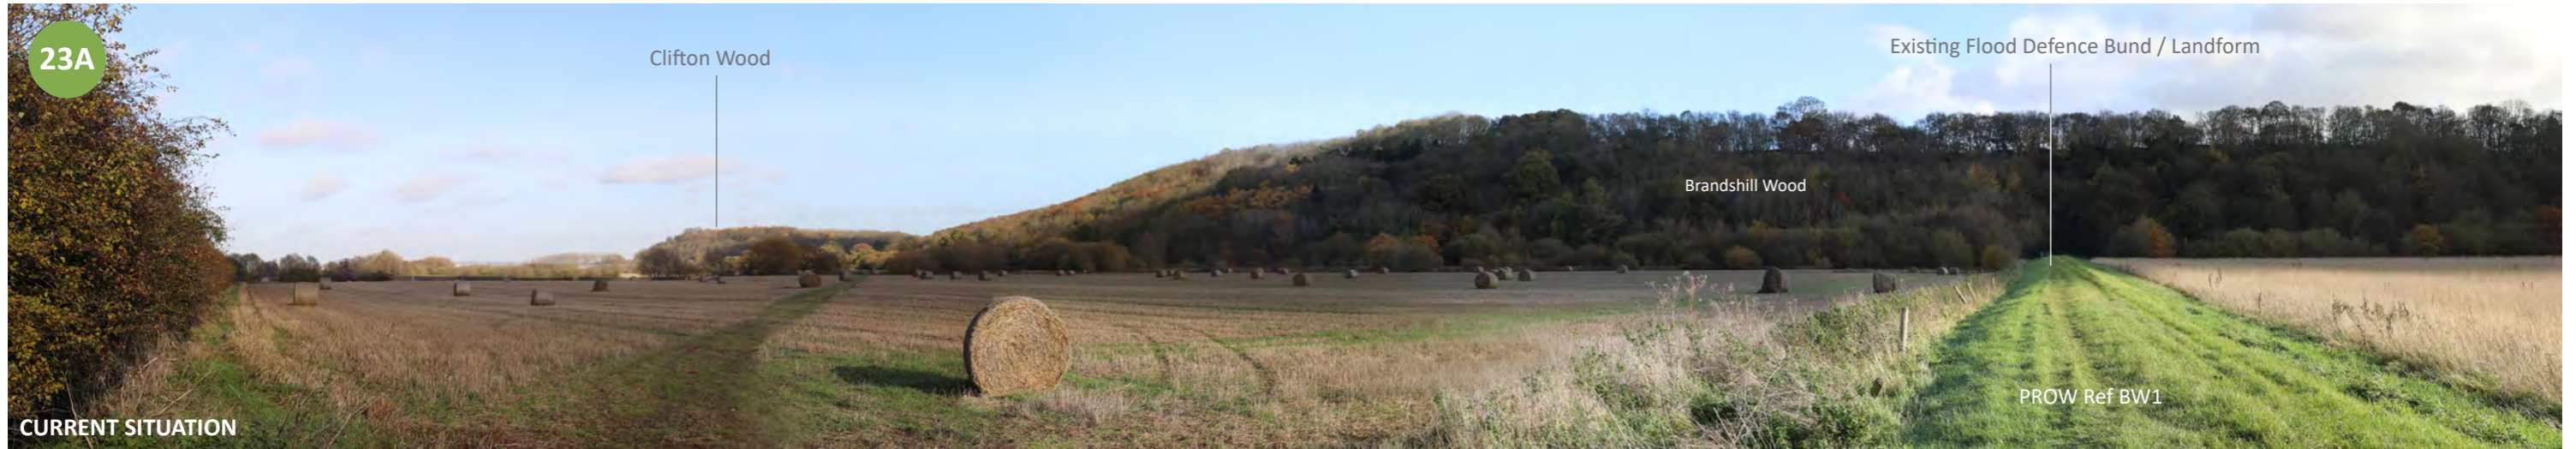
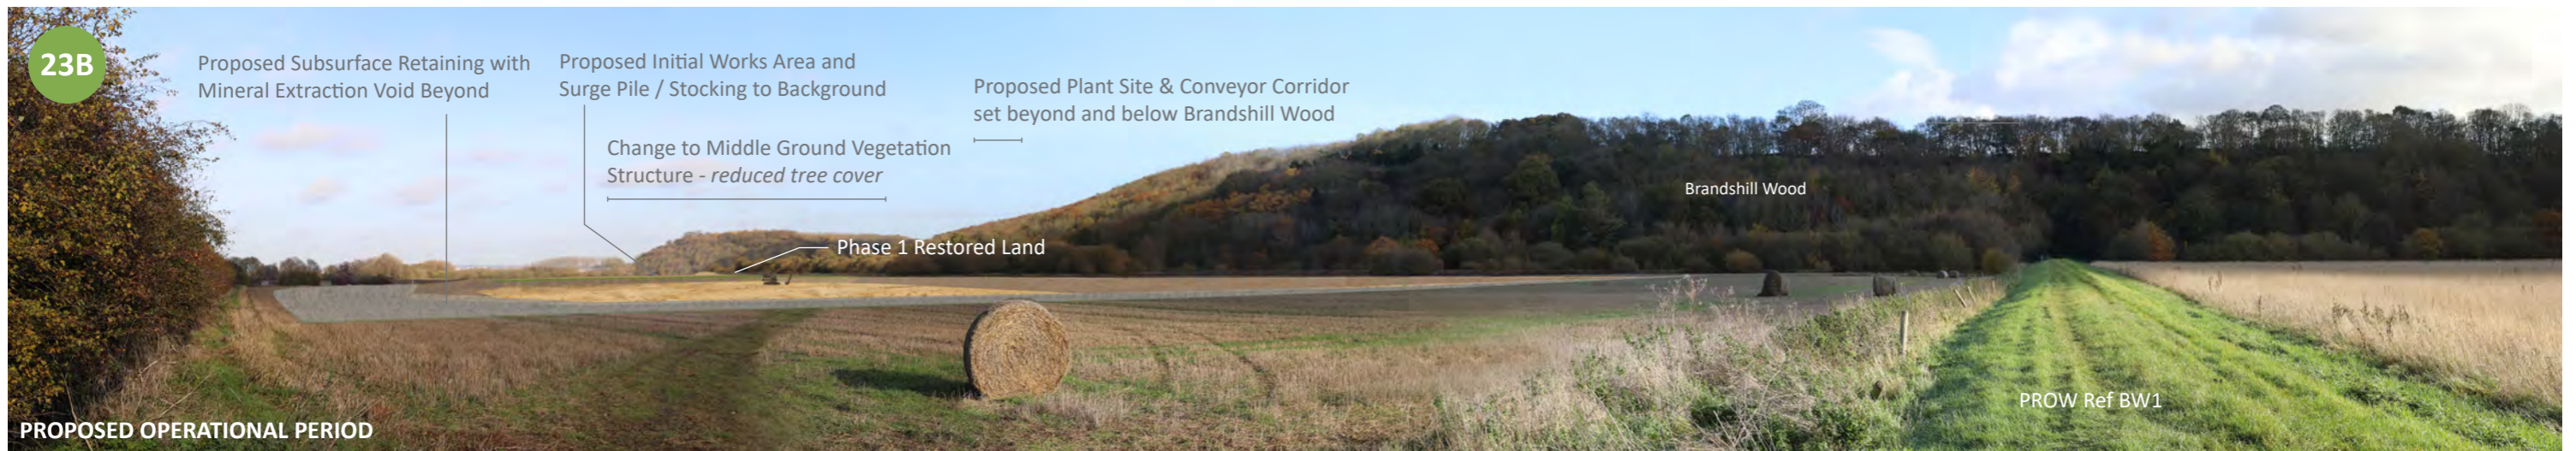
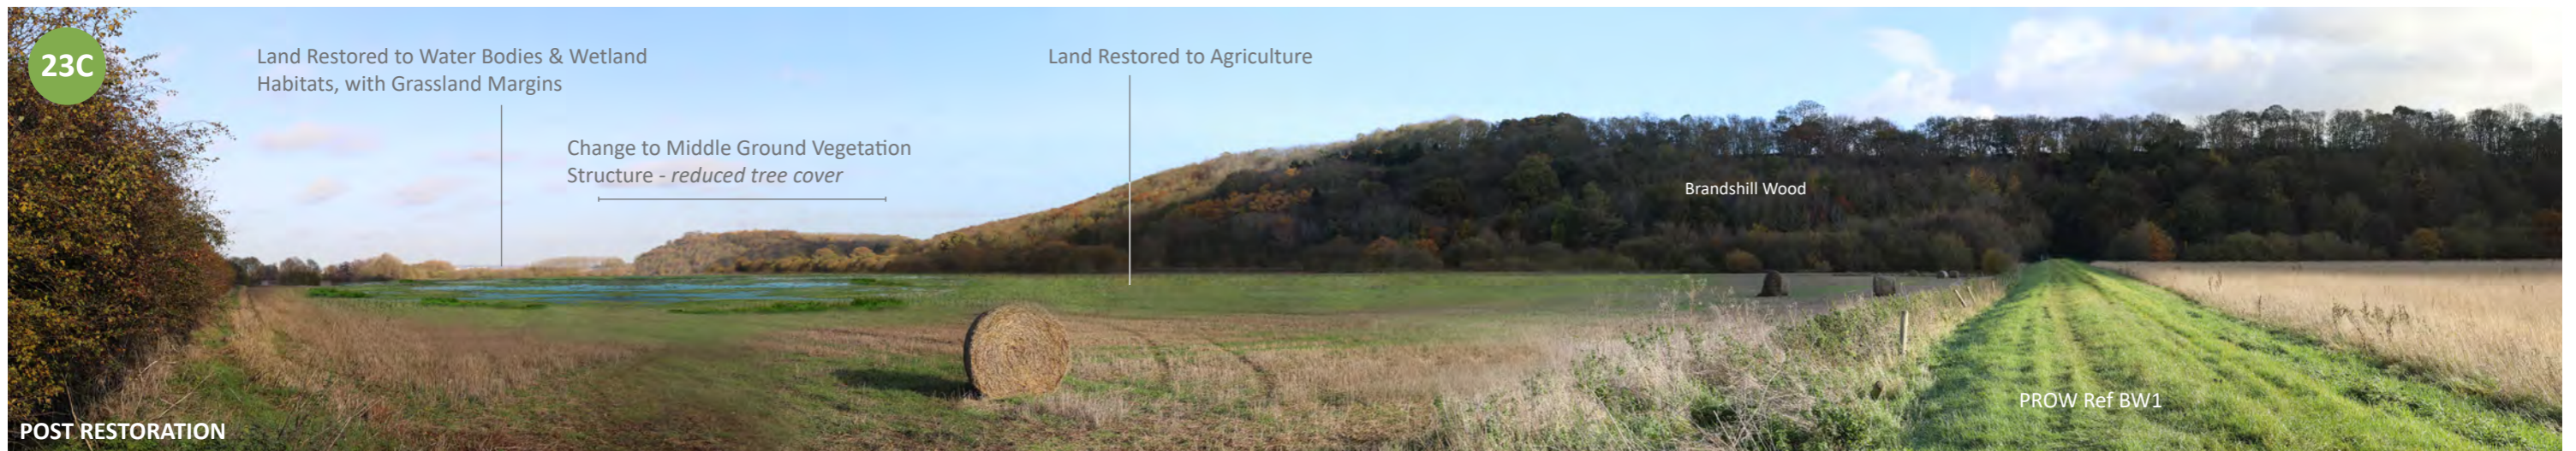
Photomontage Location 23: View looking North to North East from PROW Ref. BW1

Photomontage Location 23. View looking North to North East from PROW Ref. BW1, along the existing Flood Defence Bund. Visibility over the Phase 2 Mineral Extraction Area with Phase 1 and the Initial Works Areas beyond. Temporary, elevated visibility due to the PROW alignment to the top of the existing Flood Defence Bund. A transient view over only a section of the overall PROW.

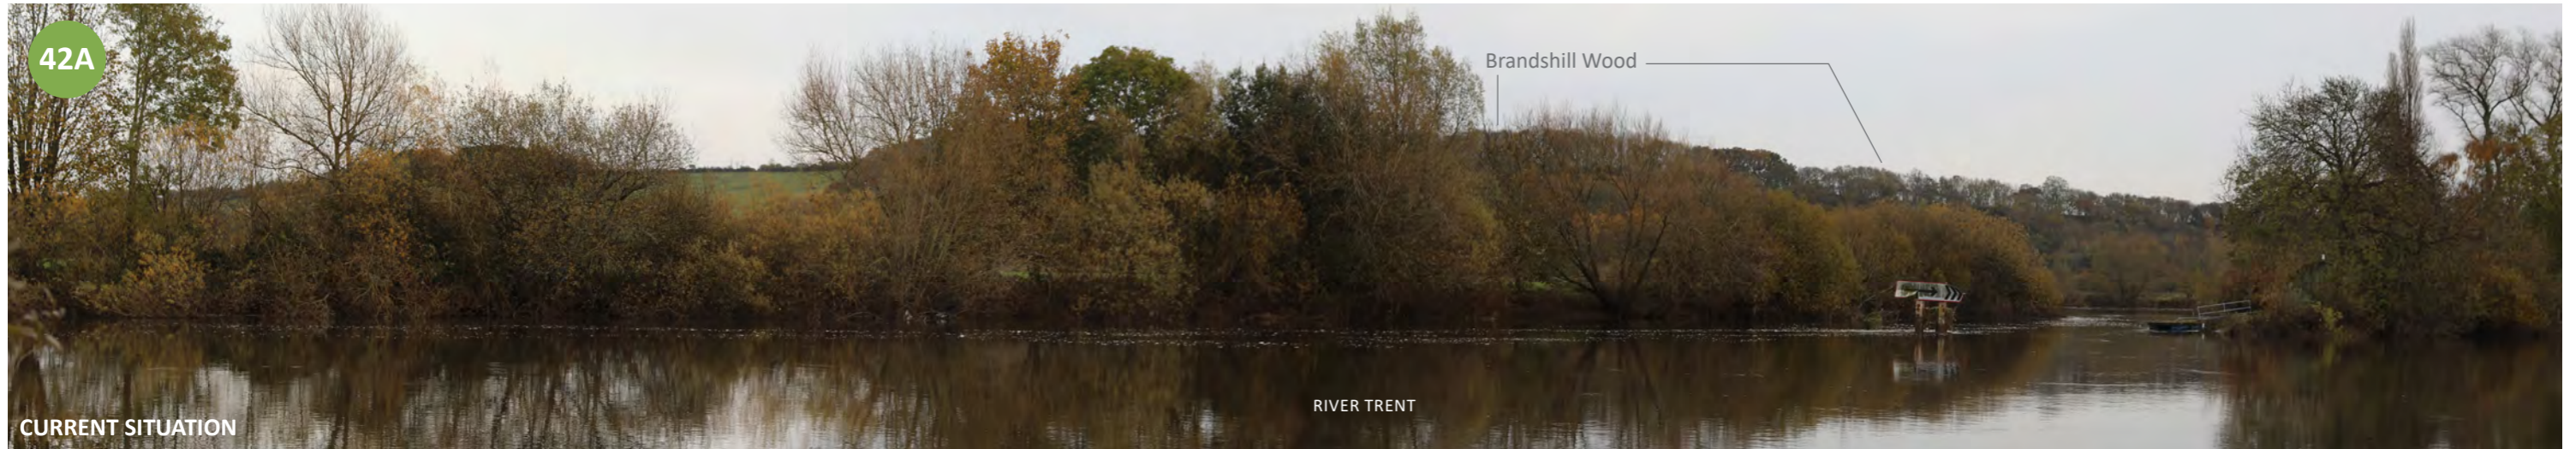
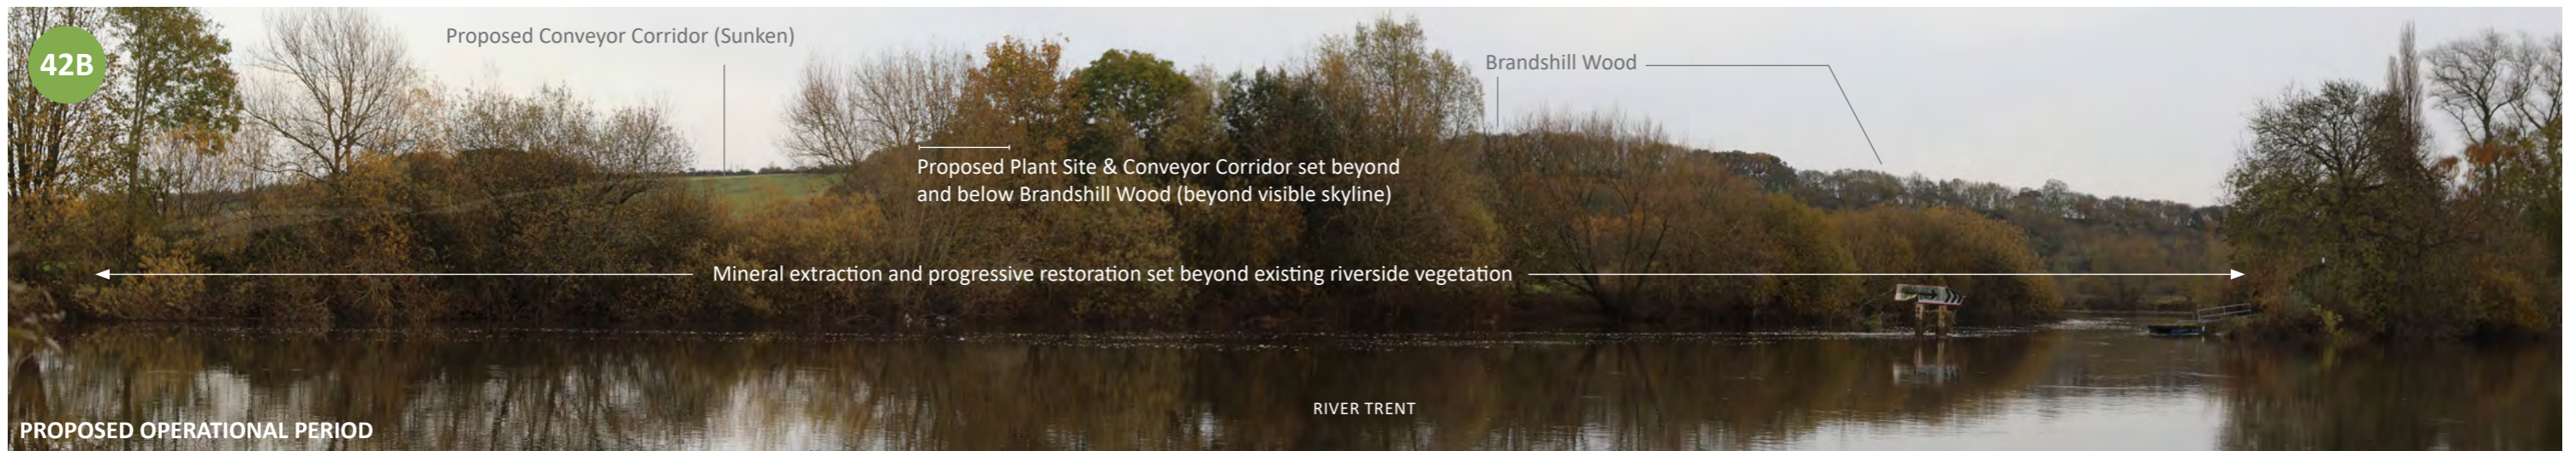
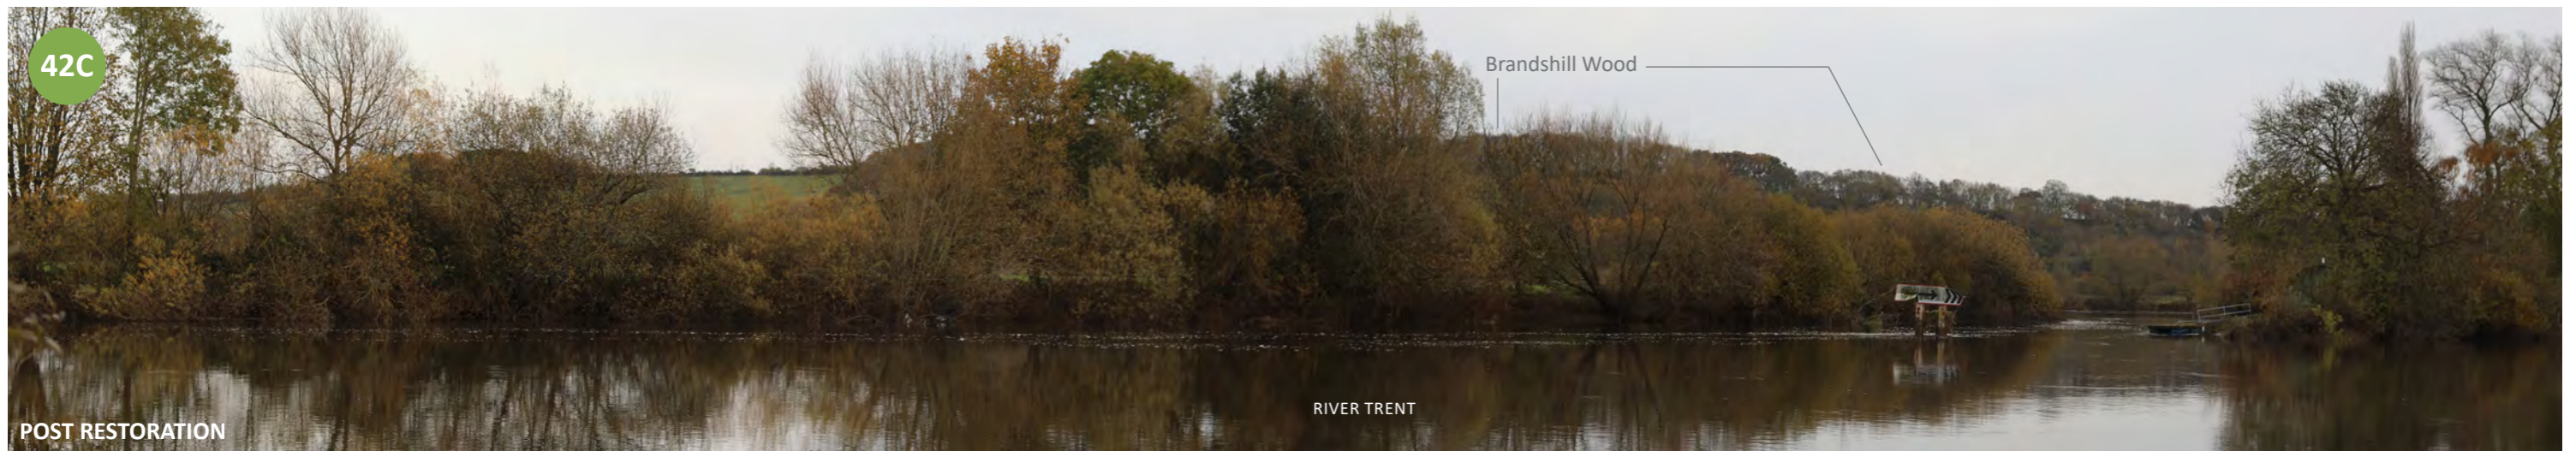
Photomontage Location 42: View looking East from PROW Ref. FP69, Attenborough Nature Reserve

Photomontage Location 42. View looking East towards the Site from PROW ref. FP69, located within the Attenborough Nature Reserve, adjacent to the River Trent. Visibility of the proposed development is generally restricted by existing short range, intervening vegetation structure. Partial visibility of the rising slope towards the plant site, where a short section of the conveyor corridor may be visible, albeit partially sunken. The plant site and associated permanent landform being set beyond and below Brandshill Wood, which forms the predominant skyline within the view.
