## **APPENDIX A**

### **SECTION 19 REPORT – ARNOLD – JUNE 19**

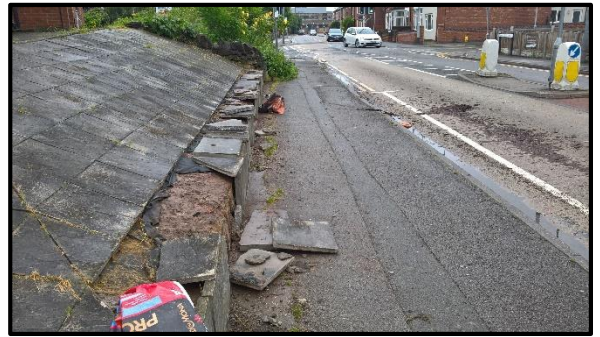
Fig 6. Gedling Road and surrounding area.

Using Brookfield Road as a channel the water continued to flow along Gedling Road and along the frontages of the terrace houses, shown in figure 6. The water was of sufficient depth at this point to enter some of these houses through the front doors. The photo between Figures 4 and 5 above shows damage to slabs along a raised sloping bank, indicating flow depth.
