Asbestos Inspection Report

P-338178 - Targeted Refurbishment Survey

01134 : Intake Farm Primary School

Survey date : 4-Jul-2019

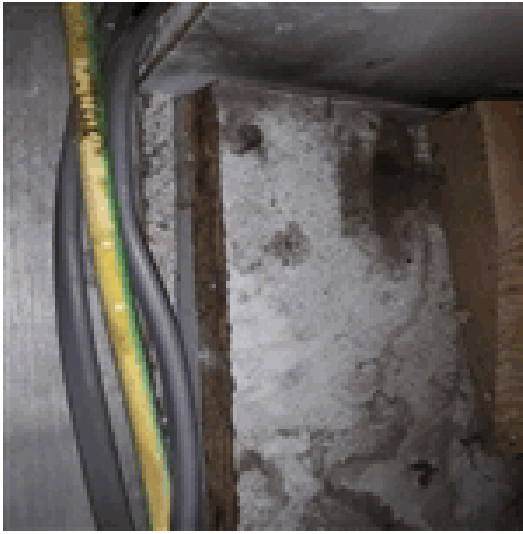
Reference	292	Sample number	01134-02-005-EE001
Survey date	4-Jul-19	Presumed	No
Building :	02 00 Nursery & Store		
Floor		Room	005 Dis WC
Location	Panels to wall edges		
Quantity sampled	6 m2	Use	Asbestos Insulating Board

Product type	AIB, Textiles, Rope, etc (see Use) (2)
Damage/deterioration	Low damage (1)
Surface treatment	Unsealed AIB, enc Lagging & Spray (2)
Asbestos type	Amphibole ex. Crocidolite (2)

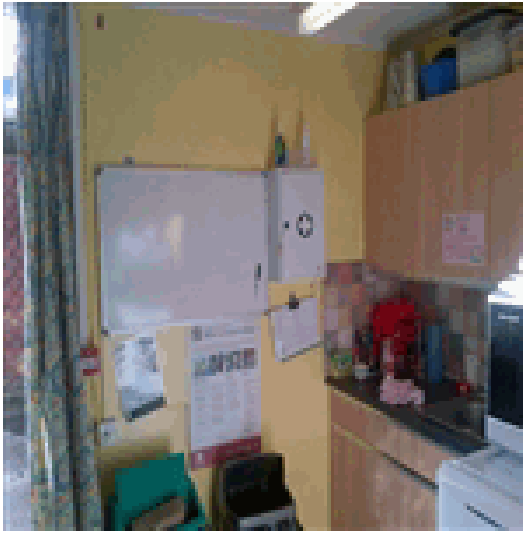
Insulation Board wall panels from floor to ceiling

Monitor & Manage

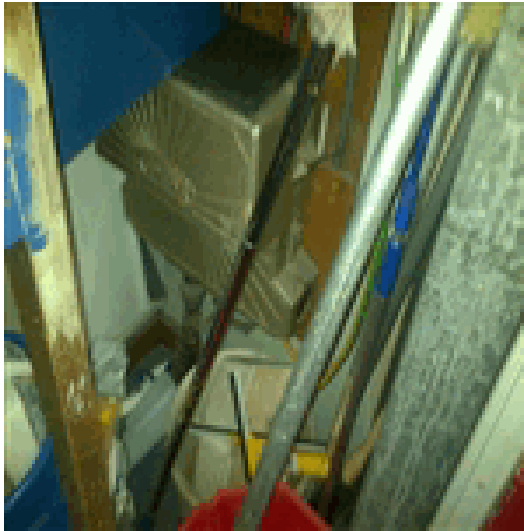
Strongly presumed asbestos containing material within old electric service head.

Monitor & Manage

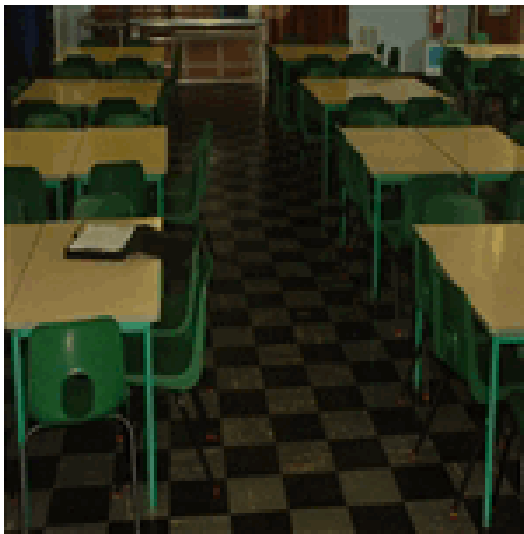
Possibly still located under blue vinyl floor covering

Monitor & Manage

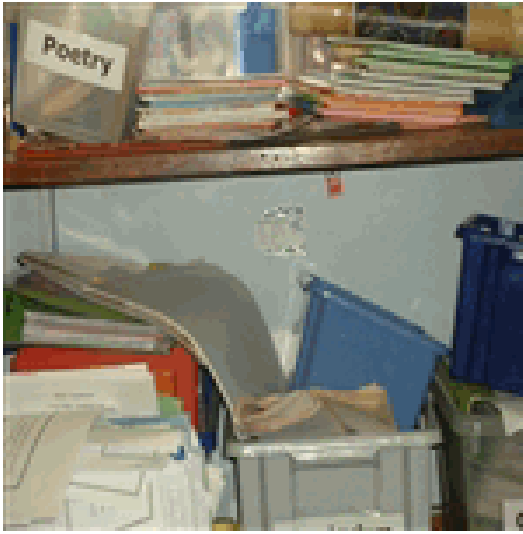
Reference	151	Sample number	01134-01-05-01
Survey date	20-May-19	Presumed	No
Building :	01 00 Main School Building		
Floor		Room	005 Classroom
Location	PANEL BELOW WINDOW		
Quantity sampled	1M2 X 9	Use	Asbestos Insulating Board

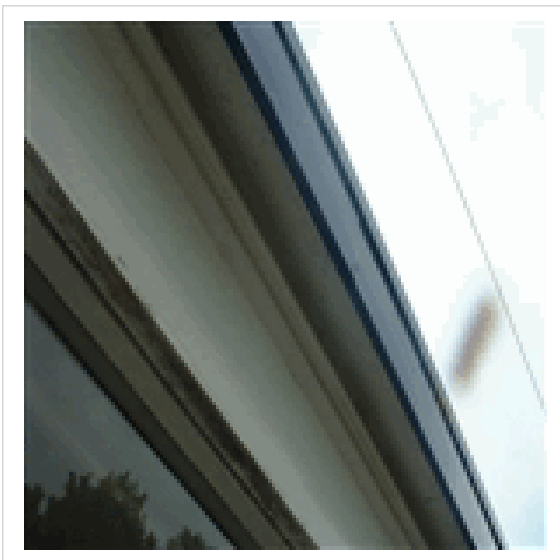
Reference	158	Sample number	01134-01-00-01
Survey date	20-May-19	Presumed	No
Building :	01 00 Main School Building		
Floor		Room	000 External/Fixtures
Location	SOFFIT	Use	Cement Fully compressed sheets
Quantity sampled	>30M2

Monitor & Manage

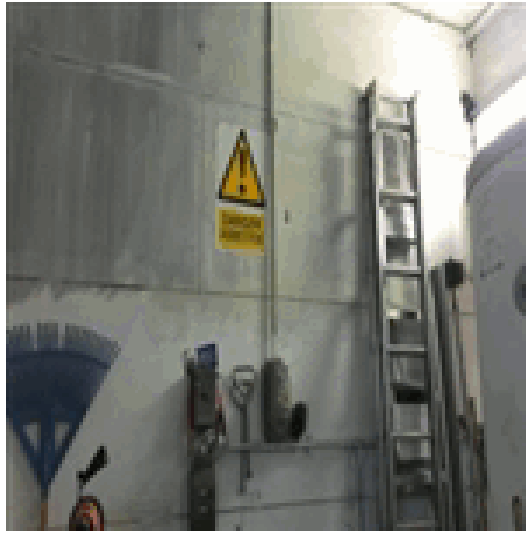
Insulation board wall panels to left hand side wall

Reference **189** Sample number **01134-01-26-HO000615**
 Survey date **20-May-19** Presumed **No**

REMOVED

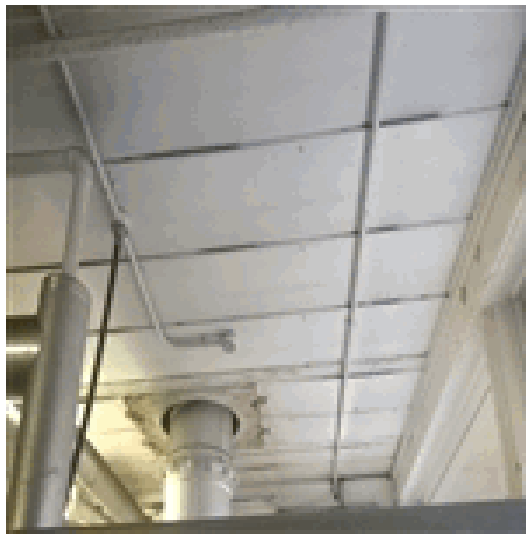
Cement ceiling panels

Monitor & Manage

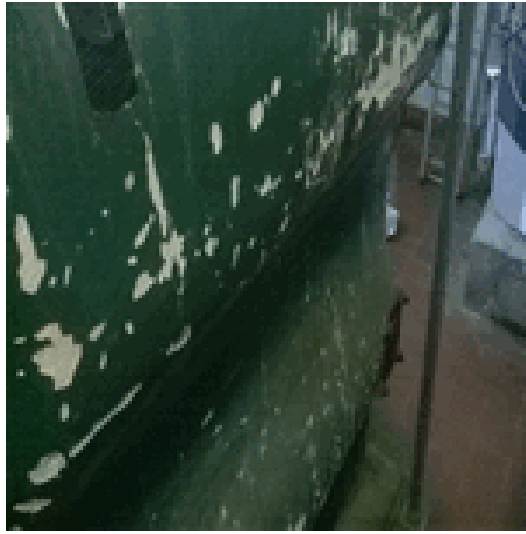
Insulation to boiler

Reference **193** Sample number **01134-01-26-HO000619**
 Survey date **20-May-19** Presumed **Yes**

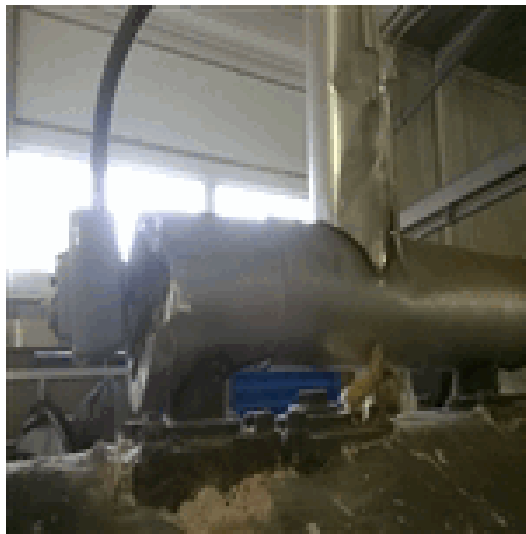
Residues to pipework beneath metal clad MMMF

Reference **194** Sample number **01134-01-26-HO000620**
 Survey date **20-May-19** Presumed **No**

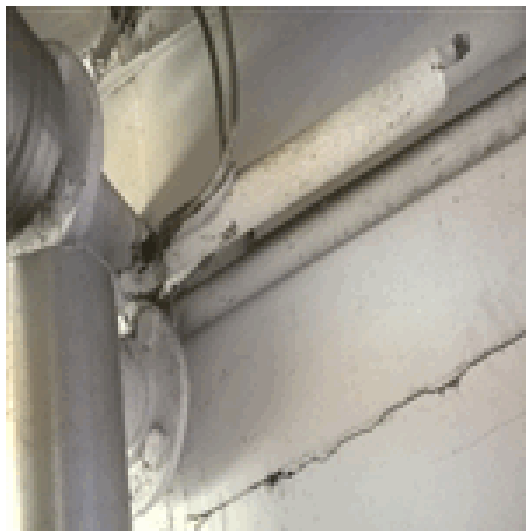
Residues to pipework painted white

Reference	195	Sample number	01134-01-26-HO000621
Survey date	20-May-19	Presumed	No
Building :	01 00 Main School Building		
Floor		Room	26 Boiler Room
Location			
Quantity sampled	6 m	Use	Debris

REMOVED

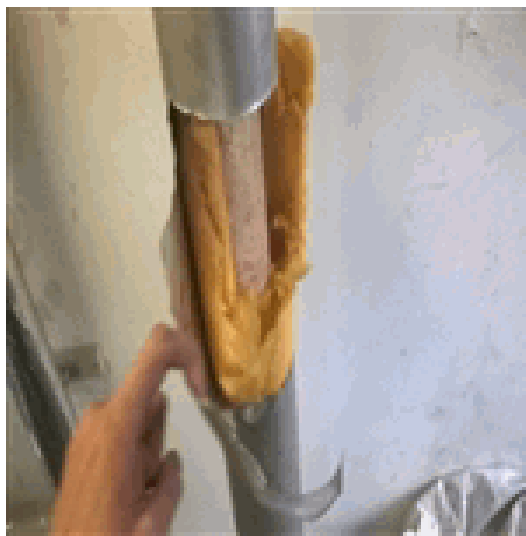
Residues to pipework beneath metal clad MMMF

Reference	196	Sample number	01134-01-26-HO000622
Survey date	20-May-19	Presumed	No
Building :	01 00 Main School Building		
Floor		Room	26 Boiler Room
Location			
Quantity sampled	13 m	Use	Debris

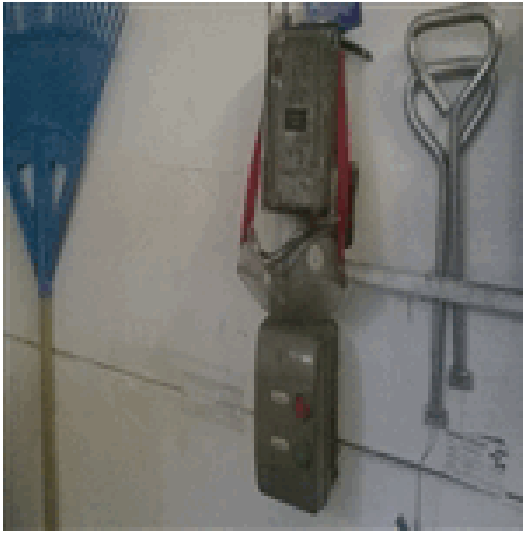
Reference **203** Sample number **01134-01-26-SP02**
Survey date **20-May-19** Presumed **Yes**

Building : 01 00 Main School Building
Floor Room 26 Boiler Room
Location
Quantity sampled 1 m2 Use Cloth

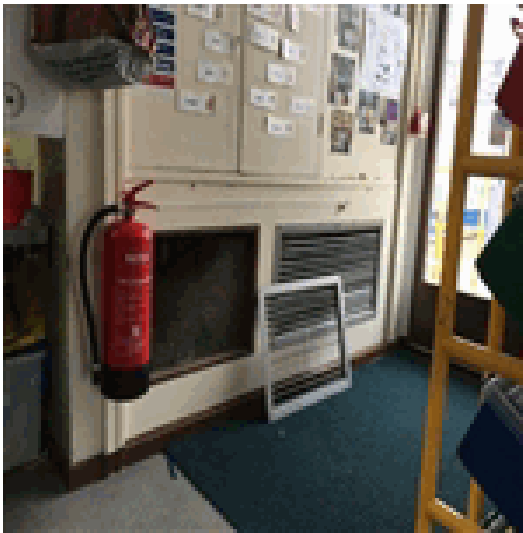
Panel above heating

REMOVED

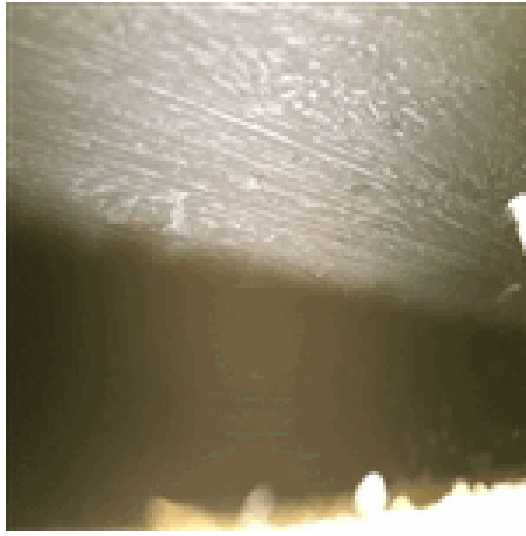
Panel above heater

Reference	217	Sample number	01334-01-11-02
Survey date	20-May-19	Presumed	No
Building :	01 00 Main School Building		
Floor	G	Room	011 Dining
Location			
Quantity sampled	1m2	Use	Asbestos Insulating Board

REMOVED

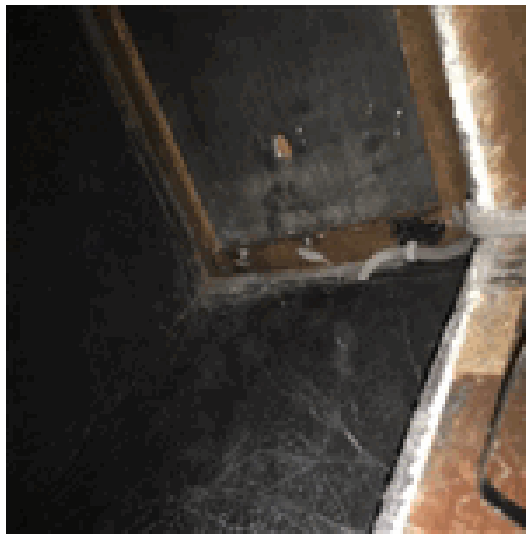
Panel above heater and to lining

Reference	218	Sample number	01334-01-21-02
Survey date	20-May-19	Presumed	No
Building :	01 00 Main School Building		
Floor	G	Room	021 Hall
Location			
Quantity sampled	4m2	Use	Asbestos Insulating Board

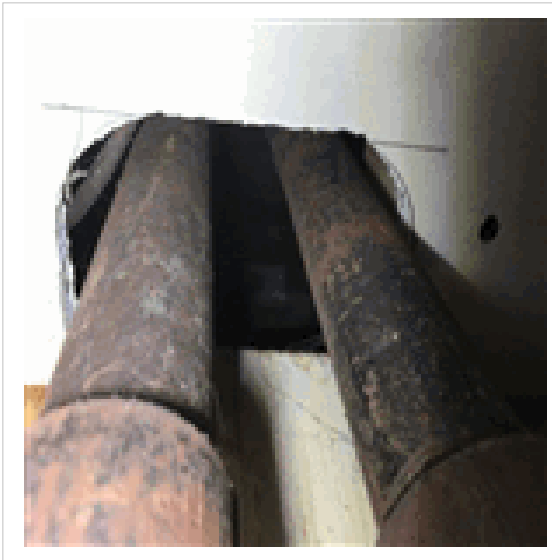
Panel above heater

Monitor & Manage

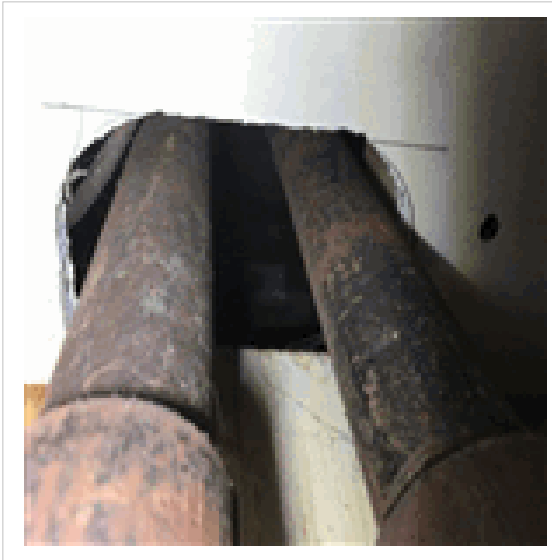
Panel above heater cupboard

Monitor & Manage

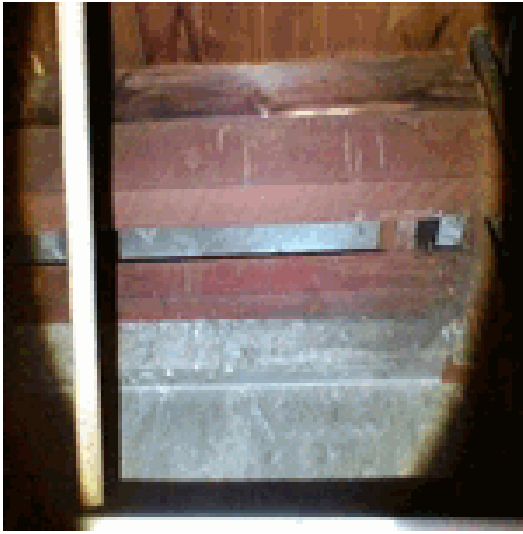
Reverse side of external soffit board is visible from within the ceiling void.

Remove

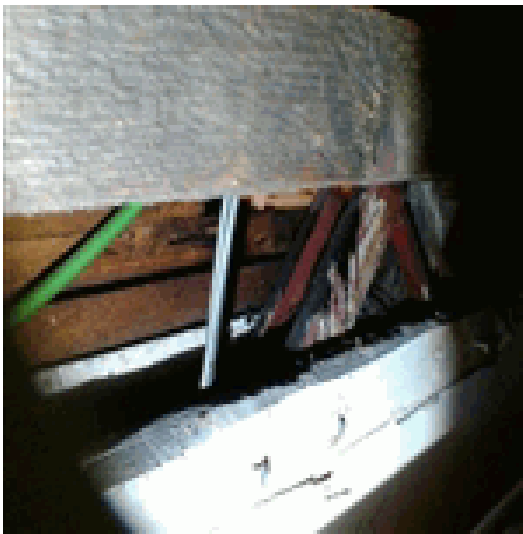
No Asbestos Detected

Reference	252	Sample number	01134-01-033-EEX003
Survey date	20-May-19	Presumed	No
Building :	01 00 Main School Building		
Floor	G	Room	033 Storage
Location	Ceiling void - Bitumen remains to s		
Quantity sampled	2 m2	Use	Bitumen products

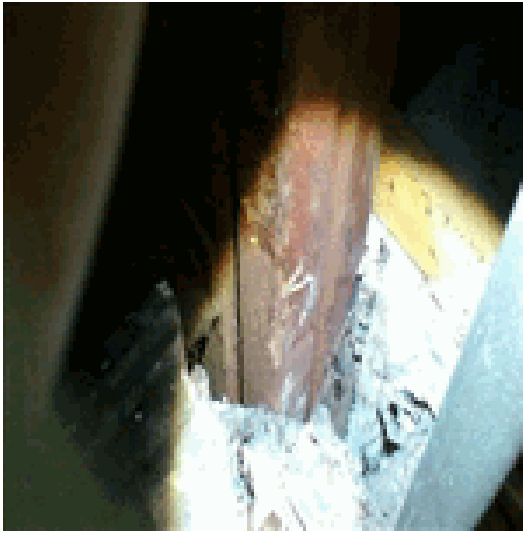
Reference	253	Sample number	01134-01-033-EEX004
Survey date	20-May-19	Presumed	No
Building :	01 00 Main School Building		
Floor	G	Room	033 Storage
Location	Columns - Impregnated bitumen pa		
Quantity sampled	2 Number	Use	Bitumen products

Paper lining to columns was observed from within the ceiling void.

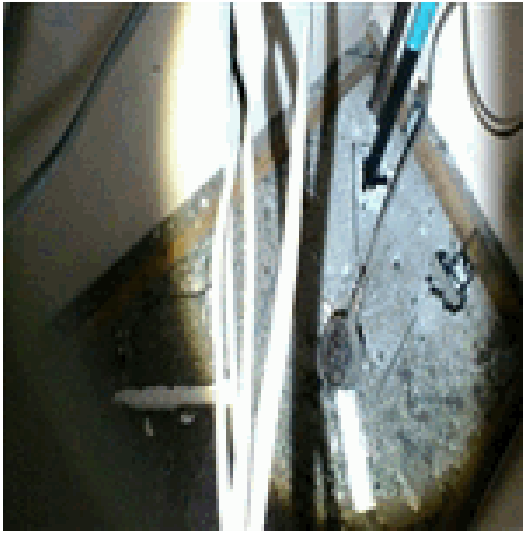
Asbestos insulating board debris and lining panel to heater unit below were observed via the ceiling void - No physical access to sample.

Remove

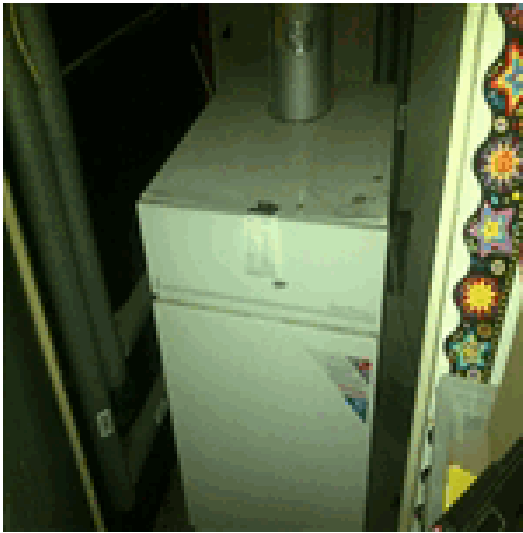
Strongly Presumed asbestos containing material within boiler

Monitor & Manage

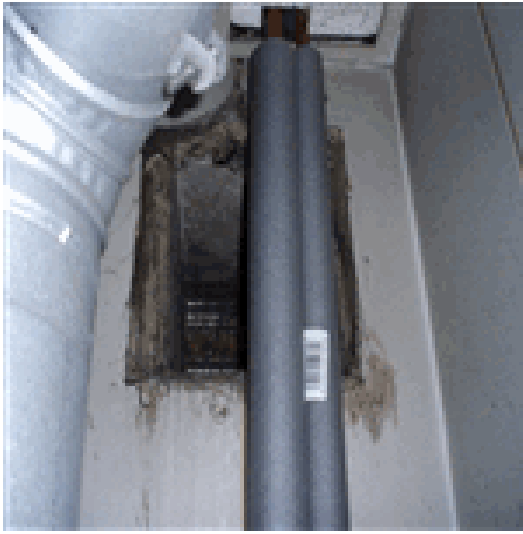
Lining to extractor fan casing at high level.

Reference	100	Sample number	01134-02-06-P03
Survey date	20-May-19	Presumed	Yes
Building :	02 00 Nursery & Store		
Floor		Room	006 Storage
Location			
Quantity sampled	0.25 SQ M	Use	Asbestos Insulating Board

REMOVED

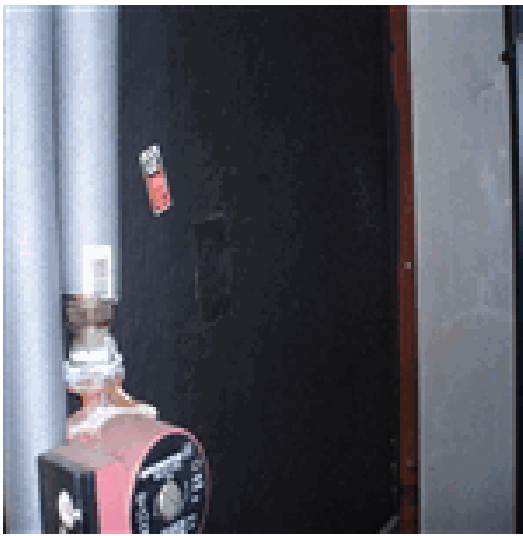
Wall to left hand side when facing boiler, and door lining.
See Environtec DEC 2011 report.

Monitor & Manage

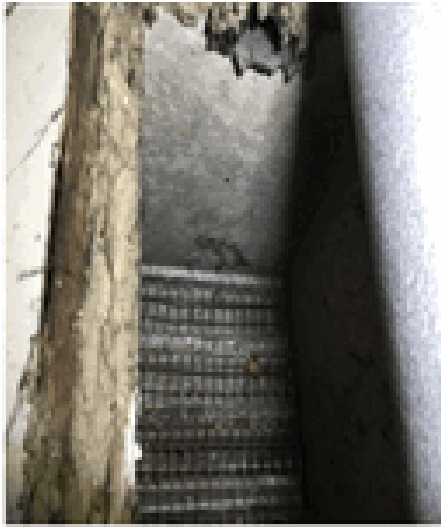
Reference	225	Sample number	01134-02-06-06
Survey date	20-May-19	Presumed	No
Building :	02 00 Nursery & Store		
Floor		Room	006 Storage
Location			
Quantity sampled	1m2	Use	Asbestos Insulating Board

Insulating board linings to vent to back wall.

REMOVED

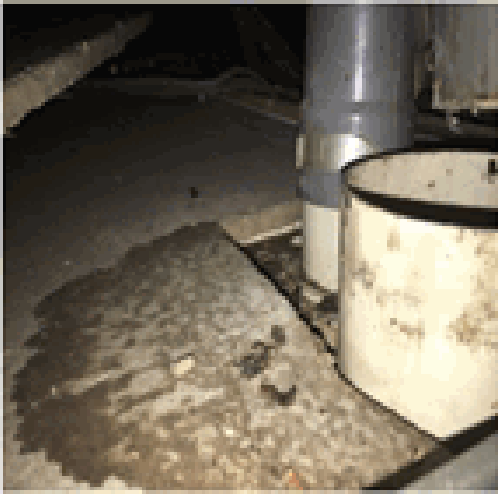
Bitumen debris on ceiling tiles

Reference	287	Sample number	01134-02-04-01
Survey date	20-May-19	Presumed	No
Building :	02 00 Nursery & Store		
Floor		Room	004 Staff WC
Location		Use	Bitumen products
Quantity sampled	4m2

Product type Asb-Reinfd comps,etc (see Use) (1)
Damage/deterioration Low damage (1)
Surface treatment Composite materials (0)
Asbestos type Chrysotile (1)

Material score	3
Priority score	5
Banding	Removed

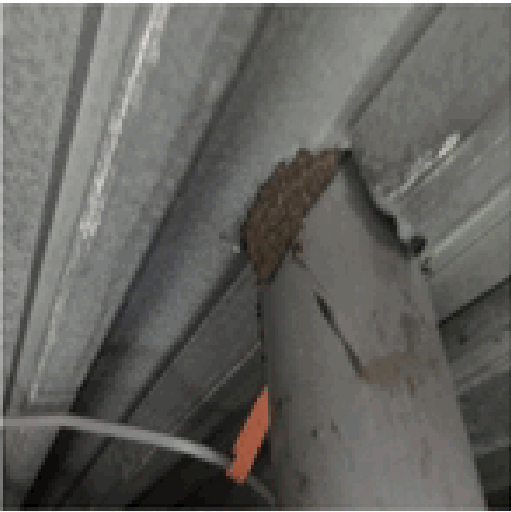
Bitumen felt to pipework penetration to roof

Product type Asb-Reinfd comps,etc (see Use) (1)
Damage/deterioration Low damage (1)
Surface treatment Composite materials (0)
Asbestos type Chrysotile (1)

Monitor & Manage

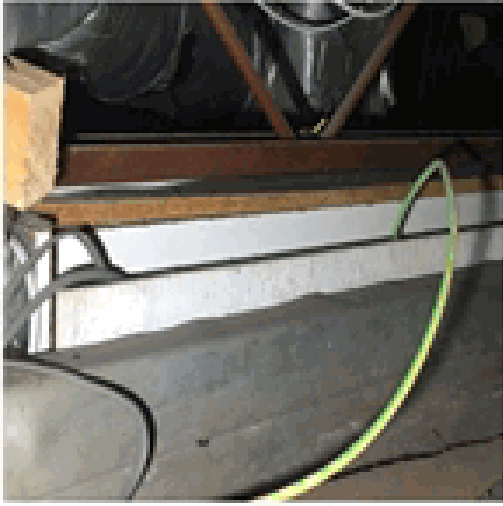
Insulating board panel within ceiling void above entrance door area.
Encapsulation of A B within ceiling void to Room 5.
Carried out by MJW Asbestos and Acorn Analytical Services
20.05.2019.
B-22671

Product type	AIB, Textiles, Rope, etc (see Use) (2)
Damage/deterioration	Good condition (0)
Surface treatment	Enc Lagging & Sprays, AIB, etc (1)
Asbestos type	Amphibole ex. Crocidolite (2)

Occupants using space	None (0)	Material score	5
Frequency of use	Infrequent (0)	Priority score	5
Average time of use	3 (0)	Banding	Low
Type of maintenance	High disturbance (3)		
Frequency of maintenance	>1 per year (2)

Monitor & Manage

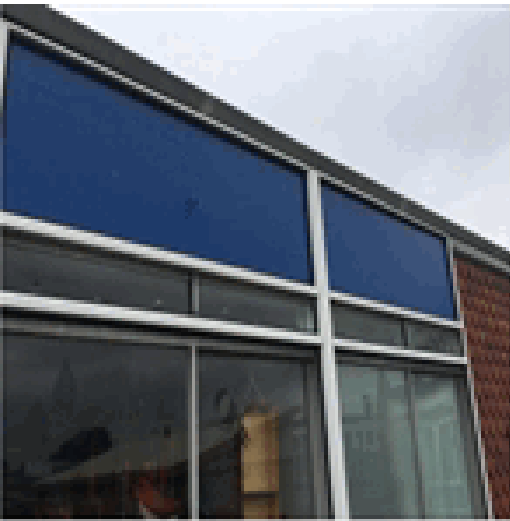
Cement infill panels above windows

Product type	Asb-Reinfd comps, etc (see Use) (1)
Damage/deterioration	Good condition (0)
Surface treatment	Composite materials (0)
Asbestos type	Chrysotile (1)

Monitor & Manage

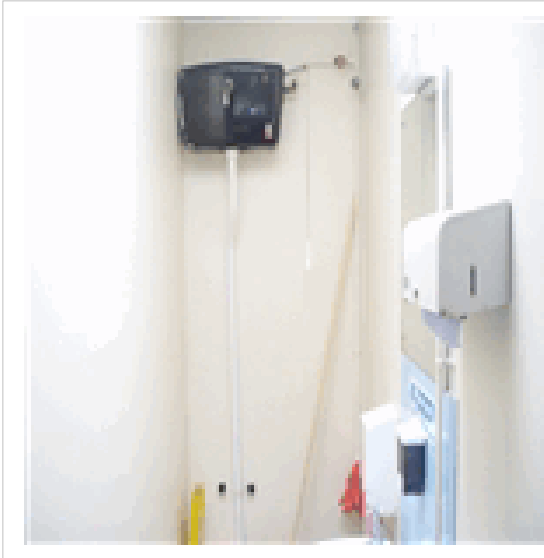
Toilet Cisterns

Reference	88	Sample number	01134-50-05-05
Survey date	20-May-19	Presumed	No
Building :	50 00 Catering Services		
Floor		Room	005 Staff WC
Location			
Quantity sampled	1NO	Use	Reinforced composites

Product type	Asb-Reinfd comps,etc (see Use) (1)
Damage/deterioration	Low damage (1)
Surface treatment	Composite materials (0)
Asbestos type	Amphibole ex. Crocidolite (2)

Occupants using space	>10 (3)	Material score	4
Frequency of use	Daily (3)	Priority score	5
Average time of use	<1 hour (0)	Banding	Removed
Type of maintenance	Low disturbance (1)		
Frequency of maintenance	<1 per year (1)

REMOVED

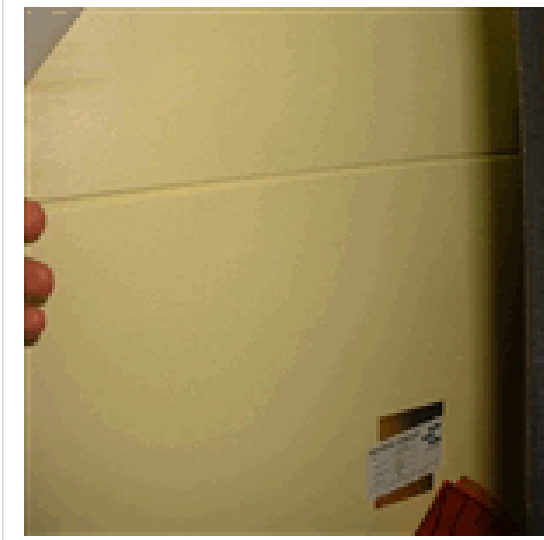
Kitchen Office panel below window

Reference	89	Sample number	01134-50-04-02
Survey date	20-May-19	Presumed	No
Building :	50 00 Catering Services		
Floor		Room	004 Office
Location			
Quantity sampled	2M2	Use	Asbestos Insulating Board

Product type	AIB,Textiles,Rope,etc(see Use) (2)
Damage/deterioration	Low damage (1)
Surface treatment	Enc Lagging&Sprays,AIB,etc (1)
Asbestos type	Amphibole ex. Crocidolite (2)

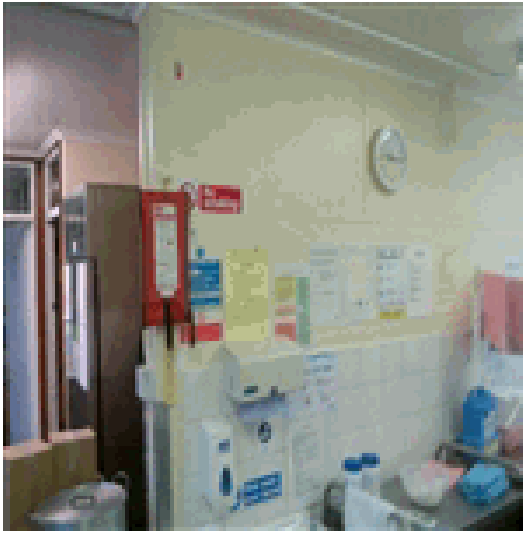
Insulation Board partition wall, both sides.
01134-50-01-02(Environtec)

Reference **98** **Sample number** **01134-50-01-02ENV**
Survey date **20-May-19** **Presumed** **No**

Product type AIB, Textiles, Rope, etc(see Use) (2)
Damage/deterioration Low damage (1)
Surface treatment Composite materials (0)
Asbestos type Amphibole ex. Crocidolite (2)

Occupants using space >10 (3)
Frequency of use Daily (3)
Average time of use >6 hours (3) **Material score** **5**
Type of maintenance Low disturbance (1) **Priority score** **7**
Frequency of maintenance <1 per year (1) **Banding** **Removed**

REMOVED

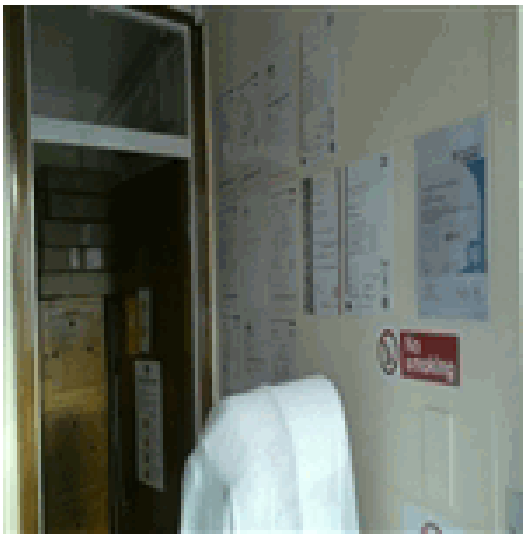
Reference **206** **Sample number** **01134-50-2-P24**
Survey date **20-May-19** **Presumed** **No**

Building : **50 00 Catering Services**
Floor **Room** **002 Storage**
Location Insulating board panels to dividing
Quantity sampled **9 m2** **Use**

Product type AIB, Textiles, Rope, etc(see Use) (2)
Damage/deterioration Low damage (1)
Surface treatment Enc Lagging&Sprays,AIB,etc (1)
Asbestos type Amphibole ex. Crocidolite (2)

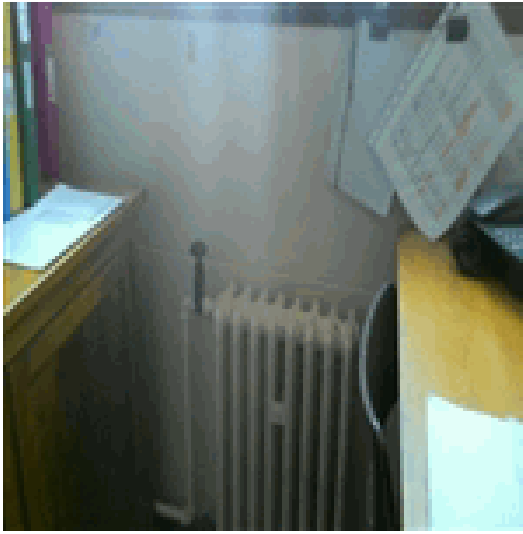
Reference **209** Sample number **01134-50-4-P41**
 Survey date **20-May-19** Presumed **No**

Building : **50 00 Catering Services**
 Floor _____ Room **004 Office**
 Location **Insulating board panels below win**
 Quantity sampled **3 m2** Use _____

Product type **AIB, Textiles, Rope, etc (see Use) (2)**
 Damage/deterioration **Low damage (1)**
 Surface treatment **Enc Lagging & Sprays, AIB, etc (1)**
 Asbestos type **Amphibole ex. Crocidolite (2)**

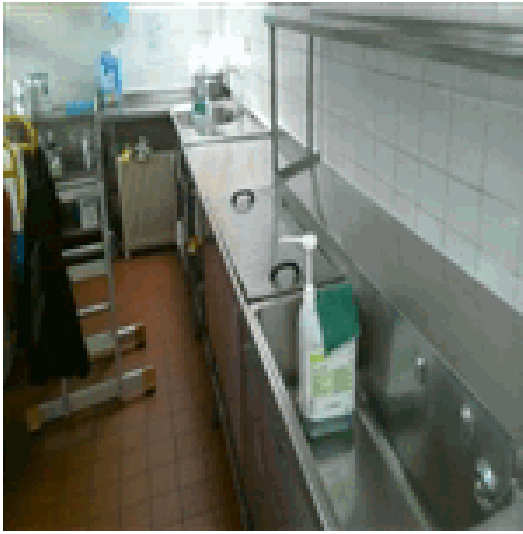
Reference	215	Sample number	01134-50-01-BR001090
Survey date	20-May-19	Presumed	No
Building :	50 00 Catering Services		
Floor	G	Room	001 Kitchen
Location	Bitumen to sinks		
Quantity sampled	3 m2	Use	No asbestos detected

Product type	Asb-Reinfd comps,etc (see Use) (1)
Damage/deterioration	Good condition (0)
Surface treatment	Composite materials (0)
Asbestos type	Not asbestos (0)

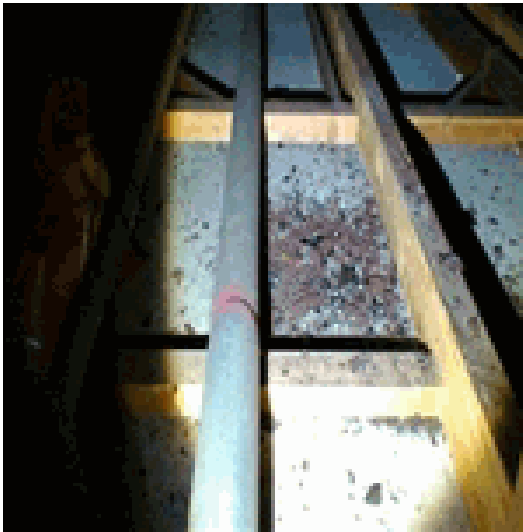
Reference	229	Sample number	01134-50-001-EE003
Survey date	20-May-19	Presumed	No
Building :	50 00 Catering Services		
Floor	G	Room	001 Kitchen
Location	Ceiling void - Bitumen debris		
Quantity sampled	50 m2	Use	Bitumen products

Product type	Asb-Reinfd comps,etc (see Use) (1)
Damage/deterioration	Good-no damage (0)
Surface treatment	Composite materials (0)
Asbestos type	Not asbestos (0)

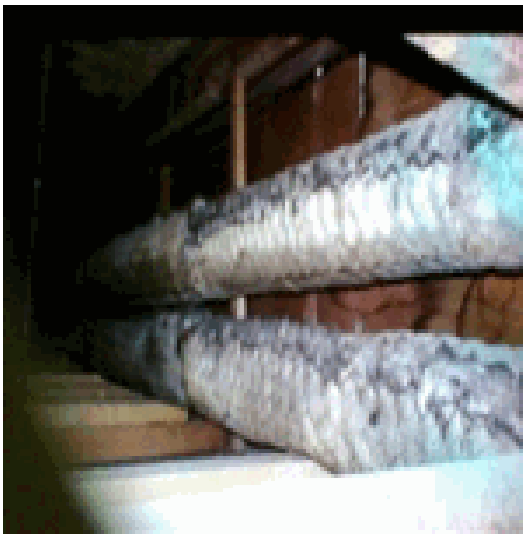
Reference	231	Sample number	01134-50-001-EE005
Survey date	20-May-19	Presumed	No
Building :	50 00 Catering Services		
Floor	G	Room	001 Kitchen
Location	Ceiling void - String ties to MMMF p		
Quantity sampled	30 m linear	Use	Cloth

Product type	Asb-Reinfd comps,etc (see Use) (1)
Damage/deterioration	Good-no damage (0)
Surface treatment	Composite materials (0)
Asbestos type	Not asbestos (0)

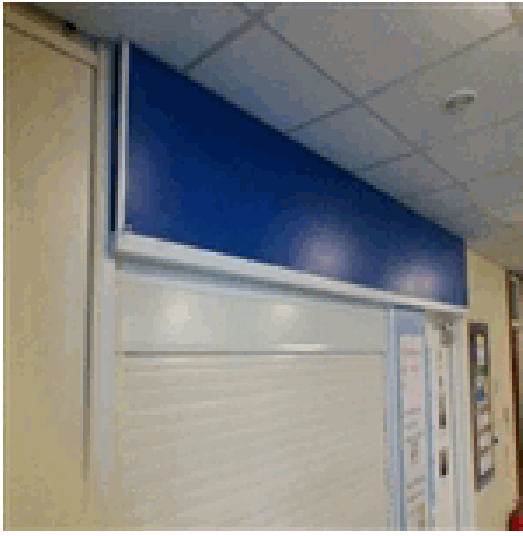
Reference	232	Sample number	01134-50-001-EE006
Survey date	20-May-19	Presumed	No
Building :	50 00 Catering Services		
Floor	G	Room	001 Kitchen
Location	Ceiling void - Remains to timber fra		
Quantity sampled	6 m linear	Use

Product type	Asb-Reinfd comps,etc (see Use) (1)
Damage/deterioration	Good-no damage (0)
Surface treatment	Composite materials (0)
Asbestos type	Not asbestos (0)

Remains/ residue was observed to the timber framework above and behind the Servery.

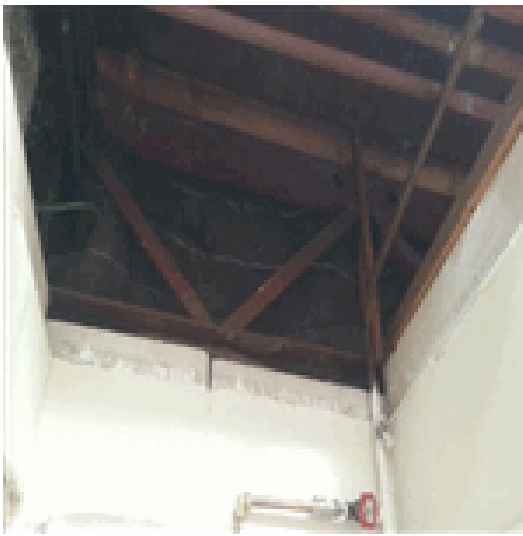
Reference	233	Sample number	01134-50-001-EE007
Survey date	20-May-19	Presumed	No
Building :	50 00 Catering Services		
Floor	G	Room	001 Kitchen
Location	Ceiling void - String ties to MMMF f		
Quantity sampled	6 m linear	Use	Cloth

Product type	AIB,Textiles,Rope,etc(see Use) (2)
Damage/deterioration	High damage (3)
Surface treatment	Unsealed AIB,enc Lagging&Spray (2)
Asbestos type	Chrysotile (1)

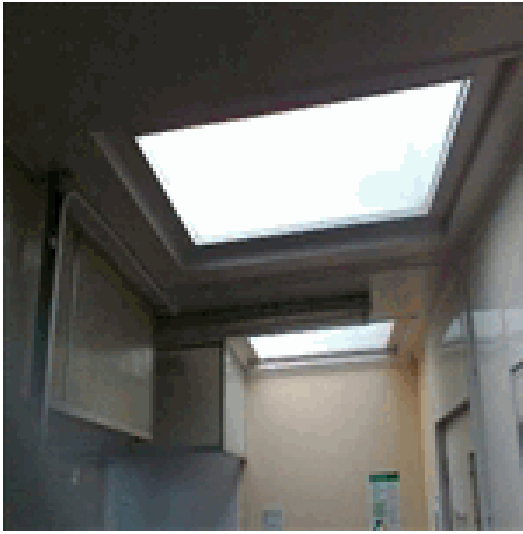
Reference	234	Sample number	01134-50-001-EE008
Survey date	20-May-19	Presumed	No
Building :	50 00 Catering Services		
Floor	G	Room	001 Kitchen
Location	Ceiling - Panels		
Quantity sampled	25 m2	Use

Product type	Asb-Reinfd comps,etc (see Use) (1)
Damage/deterioration	Good-no damage (0)
Surface treatment	Composite materials (0)
Asbestos type	Not asbestos (0)

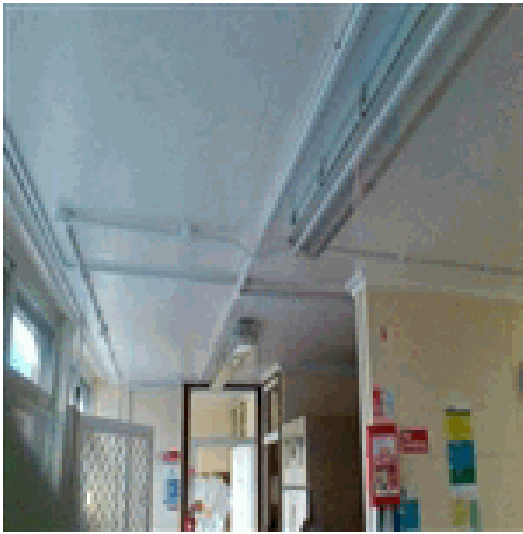
Reference	235	Sample number	01134-50-001-EE009
Survey date	20-May-19	Presumed	No
Building :	50 00 Catering Services		
Floor	G	Room	001 Kitchen
Location	Ceiling - Panels		
Quantity sampled	25 m2	Use

Product type	Asb-Reinfd comps,etc (see Use) (1)
Damage/deterioration	Good-no damage (0)
Surface treatment	Composite materials (0)
Asbestos type	Not asbestos (0)

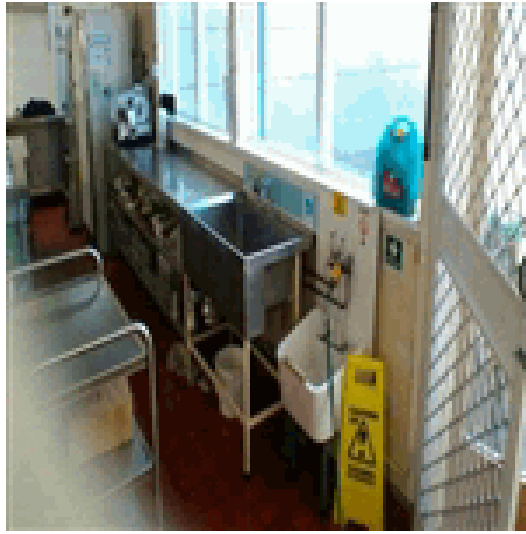
Reference 236 **Sample number** 01134-50-001-EE010
Survey date 20-May-19 **Presumed** No

Building : 50 00 Catering Services
Floor G **Room** 001 Kitchen
Location Wall panels - External wall beneat
Quantity sampled 5 m2 **Use**

Product type AIB, Textiles, Rope, etc (see Use) (2)
Damage/deterioration Good-no damage (0)
Surface treatment Enc Lagging & Sprays, AIB, etc (1)
Asbestos type Amphibole ex. Crocidolite (2)

Occupants using space 1 to 3 (1)
Frequency of use Daily (3)
Average time of use >3 to <6 hours (2) **Material score** 5
Type of maintenance Low disturbance (1) **Priority score** 5
Frequency of maintenance <1 per year (1) **Banding** **Removed**

REMOVED

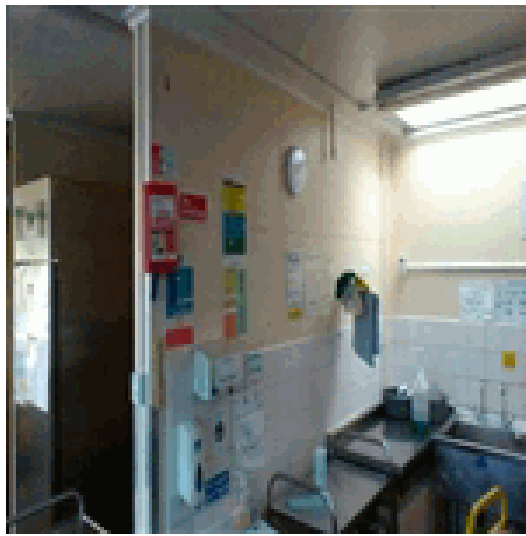
Reference 237 **Sample number** 01134-50-001-EE011
Survey date 20-May-19 **Presumed** No

Building : 50 00 Catering Services
Floor G **Room** 001 Kitchen
Location Wall panels - Adjoining Store 002
Quantity sampled 12 m2 **Use**

Product type AIB, Textiles, Rope, etc (see Use) (2)
Damage/deterioration Good-no damage (0)
Surface treatment Enc Lagging & Sprays, AIB, etc (1)
Asbestos type Amphibole ex. Crocidolite (2)

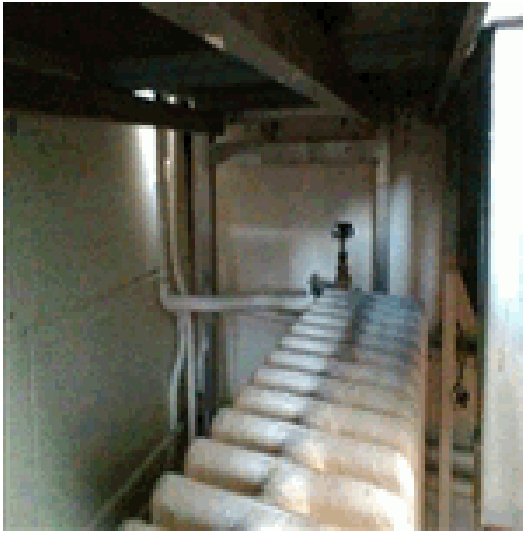
Reference	242	Sample number	01134-50-001-EE013
Survey date	20-May-19	Presumed	No
Building :	50 00 Catering Services		
Floor	G	Room	001 Kitchen
Location	Radiator - Control knob		
Quantity sampled	1 Number	Use	Reinforced composites

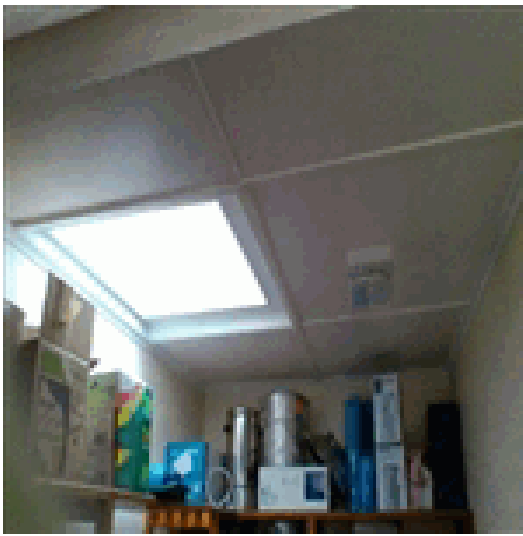
Reference	243	Sample number	01134-50-003-EEP002
Survey date	20-May-19	Presumed	No
Building :	50 00 Catering Services		
Floor		Room	003 Kitchen
Location	Ceiling void - Asbestos insulating		
Quantity sampled	6 m2	Use

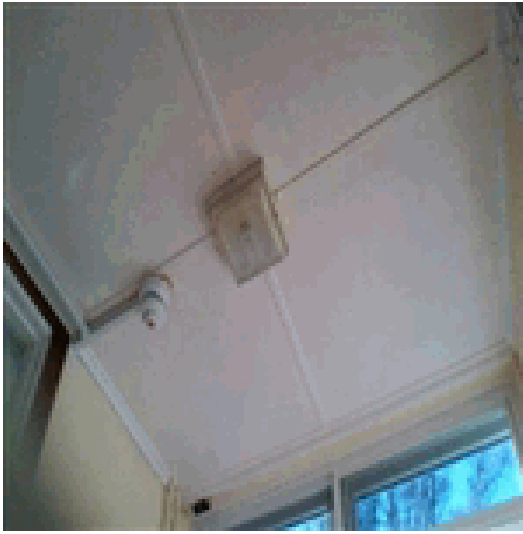
Reference	246	Sample number	01134-50-004-EEP004
Survey date	20-May-19	Presumed	No
Building :	50 00 Catering Services		
Floor		Room	004 Office
Location	Ceiling void - Asbestos insulating		
Quantity sampled	4 m2	Use

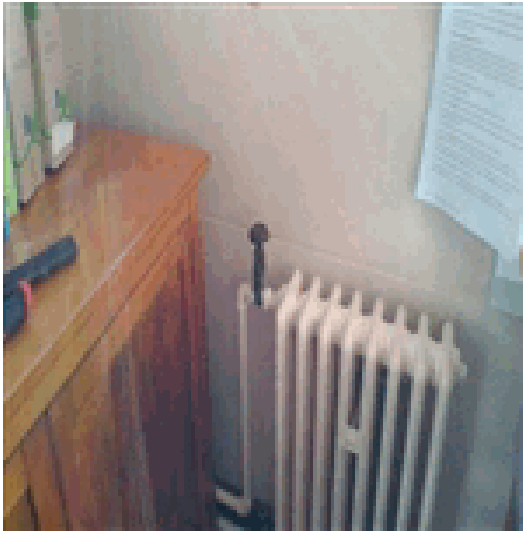
Reference	248	Sample number	01134-50-004-EEX013
Survey date	20-May-19	Presumed	No
Building :	50 00 Catering Services		
Floor		Room	004 Office
Location	Radiator - Control knob		
Quantity sampled	1 Number	Use	Reinforced composites

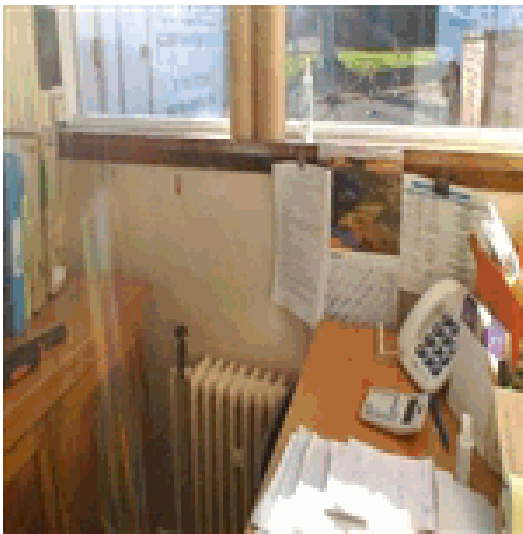
Reference	249	Sample number	01134-50-004-EEX010
Survey date	20-May-19	Presumed	No
Building :	50 00 Catering Services		
Floor		Room	004 Office
Location	Wall panels - External wall beneat		
Quantity sampled	2 m2	Use

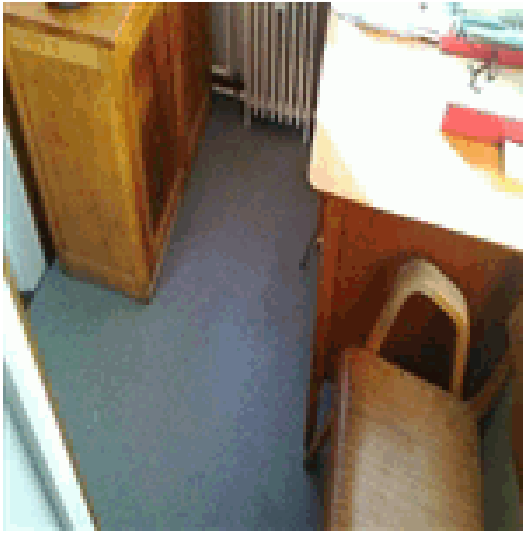
Reference	250	Sample number	01134-50-004-EEX015
Survey date	20-May-19	Presumed	No

Building :	50 00 Catering Services	Room	004 Office
Floor			
Location	Floor - Bitumen adhesive beneath		
Quantity sampled	4 m2	Use	Bitumen products
