A614 Warren Hill Gyratory

**Road Safety Audit
Stage 1 - Completion of Preliminary Design**

SA2288B
Dec 2019

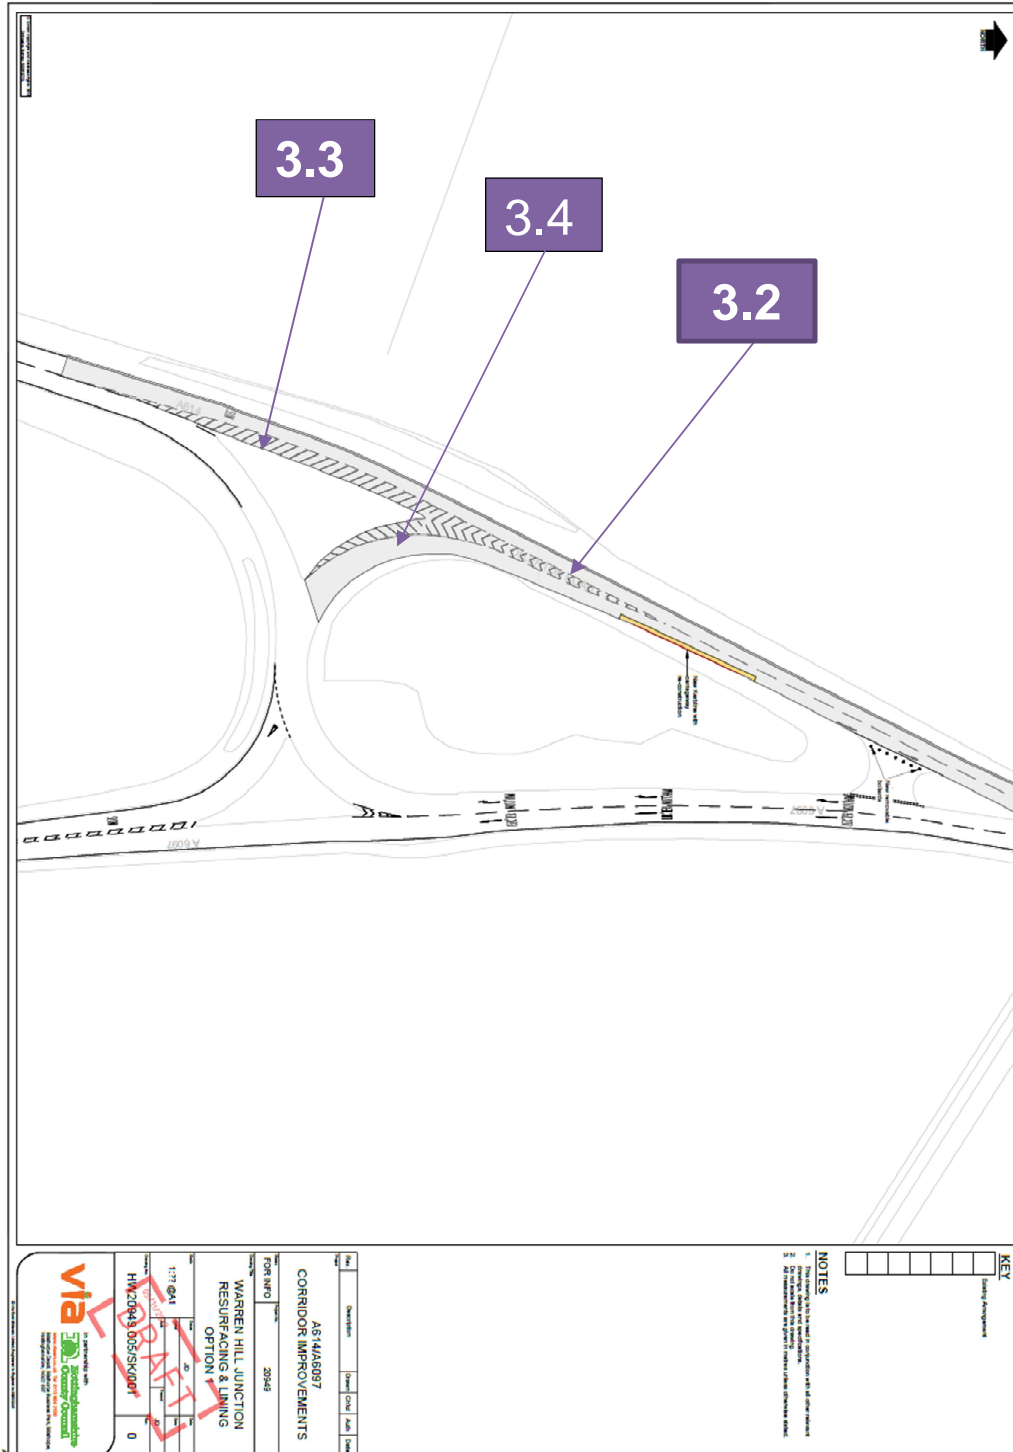
4. Reference Locations

Location: No reference – Caravan car park/ Baulker Lane.

Now northbound drivers from the A6097 have to give way and gap seek before joining the A614 northbound stream. In this proposal the A6097 northbound stream have to merge with a faster A614 northbound stream over a relatively short distance. This is an unusual manoeuvre, as offside lane traffic is usually travelling faster and seeks to merge over a specifically designed length for the speed of road. More hesitant drivers will find this a difficult manoeuvre. Failure to merge could result in side swipe accidents, head on collisions or shunt type accidents with subsequent driver/rider injury.

Summary: A614 northbound drivers failing to observe the hatch markings leading to overtaking accidents/side swipe accidents and resulting in driver/rider injury.

Summary: Increased risk of side swipe/ shunt accidents during the hours of darkness or in poor weather conditions at the merge.

Northbound drivers from the A6097 do not need to Give Way to northbound vehicles on the A614 in these proposals. They now merge with a faster moving stream of vehicles. During the hours of darkness or in poor weather conditions this increases the risk of side swipe/ shunt type accidents if lighting levels are not appropriate.

Provide the merge length required for this speed of road and ensure all road markings are laid in a MMA material to ensure road markings are highly visible and do not suffer from early wear and become a maintenance liability. Reduce the vegetation on the gyratory so that following vehicles from the A6097 can see across the gyratory to merging vehicles ahead.

Undertake a full lighting assessment to assess if lighting levels need improvement. Implement any recommendations made.
