APPENDIX F

SECTION 19 REPORT – RADCLIFFE ON TRENT FEBRUARY 2020

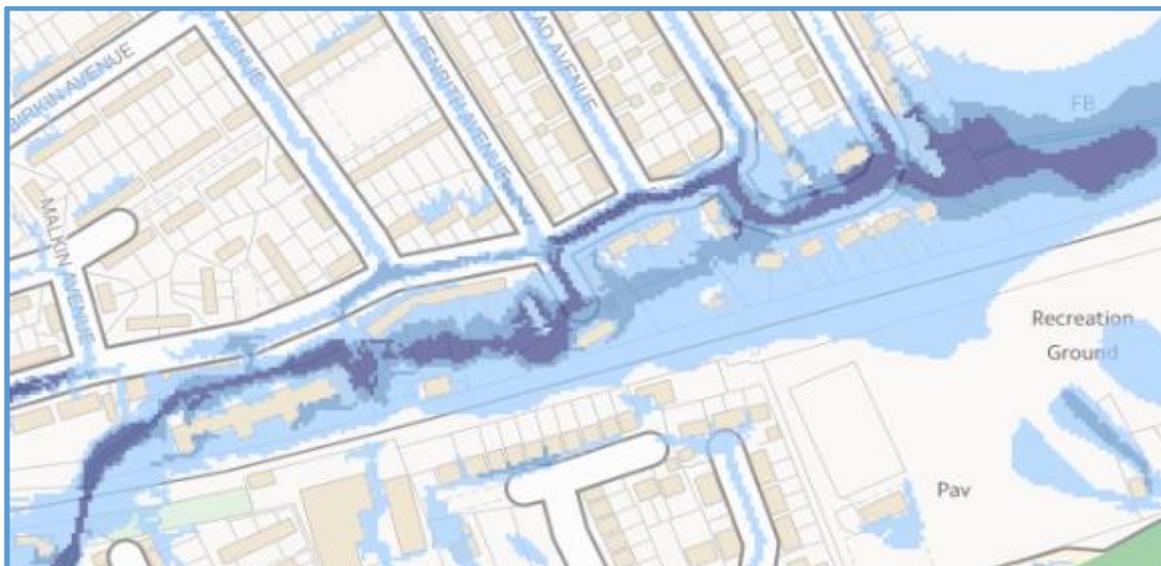
Figure 5. Extract from the Environment Agency's Surface Water Flood Risk mapping for Clumber Drive.

Figure 5 is an extract from the Environment Agency's surface water flood risk maps that shows the area to be at risk of surface water flooding however it is important to understand that the only other recorded incident of flooding in this area was in February 1977.

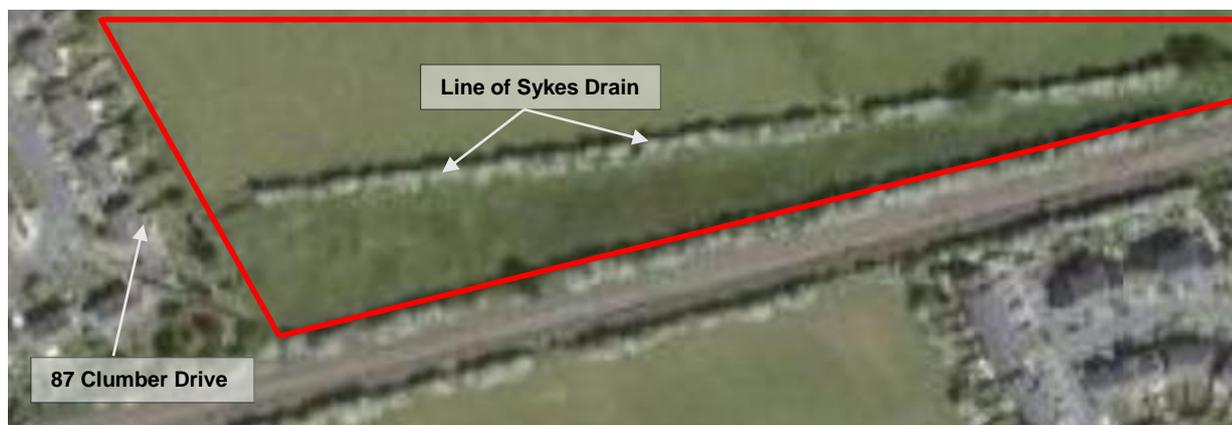
Figure 6. Land to east of Clumber Drive under William Davis Ltd. Ownership.

The land shown outlined red on Figure 6 is part of land currently owned and being developed by William Davis Ltd. with the development known as Prince's Place. Responsibility for the length of Sykes Drain that runs through this land falls to William Davis Ltd. As land owners and this responsibility was formally acknowledged by them in an email to a Nottinghamshire County Council Land Drainage Officer in September 2019.

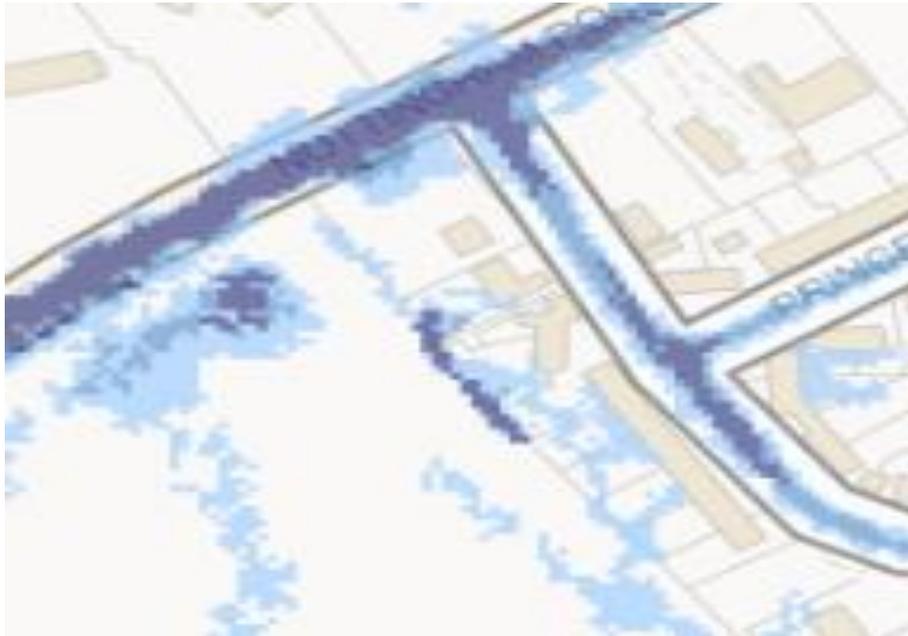
Figure 6. Extract from the Environment Agency's Surface Water flood risk mapping.

Figure 6 below shows an extract from the Environment Agency's surface water flood risk mapping. This information suggests that flooding should be retained primarily within the highway network and watercourse to rear of properties on St. Lawrence Boulevard.

20. Investigations into the condition and connectivity of the surface water system in the St. Lawrence Boulevard area and Main Road / The Green are scheduled for mid 2020. These findings will be shared and actioned as appropriate.

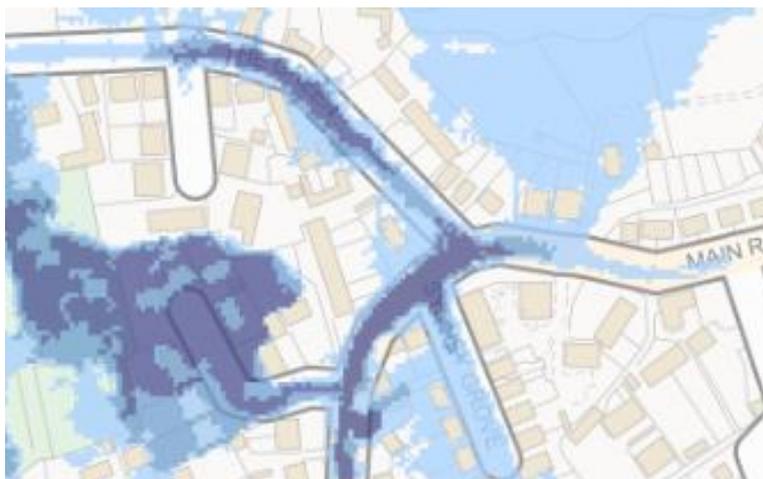
Figure 7. Extract from the Environment Agency's Surface Water flood risk mapping.

Figure 7 below shows an extract from the Environment Agency's surface water flood risk map for the area clearly showing the reported surface water flooding and flow paths.
