Asbestos Inspection Report

01038 : Bracken Lane Primary and Nursery

Survey date : 17-Jul-2017

Type of survey **Management Survey**

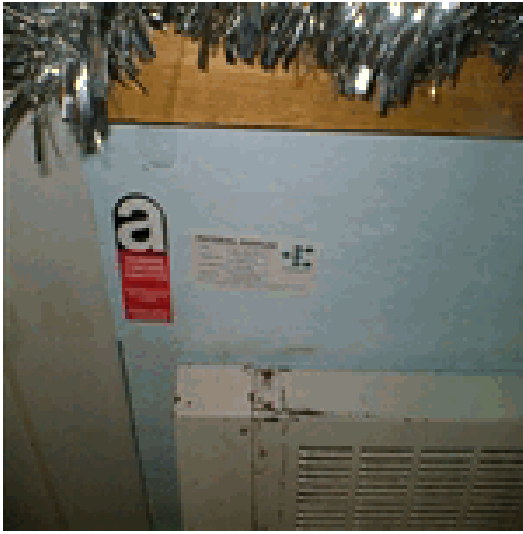
Monitor & Manage

Amosite asbestos. School informed removed at time of 2012/2013 refurbishment but cannot confirm. Treat with caution.

Product type AIB, Textiles, Rope, etc (see Use) (2)
Damage/deterioration Medium damage (2)
Surface treatment Enc Lagging & Sprays, AIB, etc (1)
Asbestos type Amphibole ex. Crocidolite (2)

Material score 7
Priority score 5
Banding Low

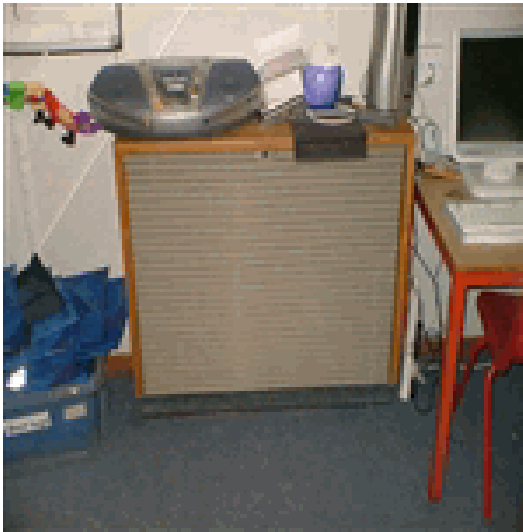
Reference 105 Sample number 01038-01-44-P01
Survey date 17-Jul-17 Presumed No

Product type AIB, Textiles, Rope, etc (see Use) (2)
Damage/deterioration High damage (3)
Surface treatment Unsealed AIB, enc Lagging & Spray (2)
Asbestos type Crocidolite (3)

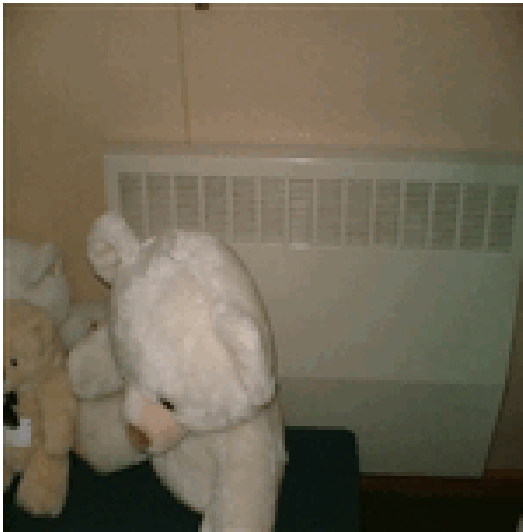
Reference **111** Sample number **01038-01-38-P02**
 Survey date **17-Jul-17** Presumed **Yes**
 Building : **01 00 Main School**
 Floor Room **038 Classroom**
 Location **WALL MOUNTED**
 Quantity sampled **1 NO** Use **Asbestos Insulating Board**

Product type AIB, Textiles, Rope, etc (see Use) (2)
 Damage/deterioration Low damage (1)
 Surface treatment Unsealed AIB, enc Lagging & Spray (2)
 Asbestos type Crocidolite (3)

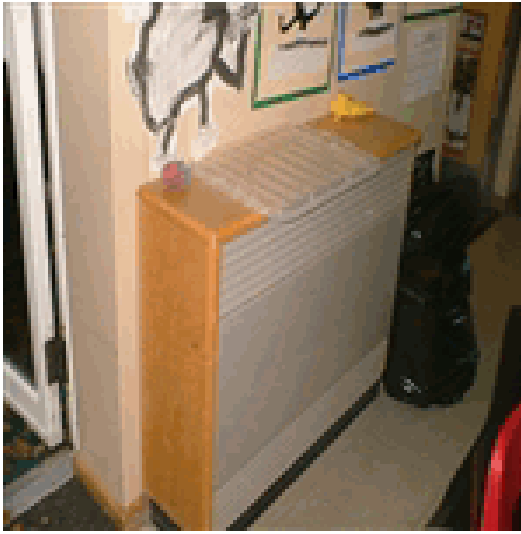
Reference	112	Sample number	01038-01-37-P01
Survey date	17-Jul-17	Presumed	No
Building :	01 00 Main School		
Floor	G	Room	037 Classroom
Location	WALL MOUNTED		
Quantity sampled	1 NO	Use	Asbestos Insulating Board

Product type	AIB, Textiles, Rope, etc (see Use) (2)
Damage/deterioration	High damage (3)
Surface treatment	Unsealed AIB, enc Lagging & Spray (2)
Asbestos type	Crocidolite (3)

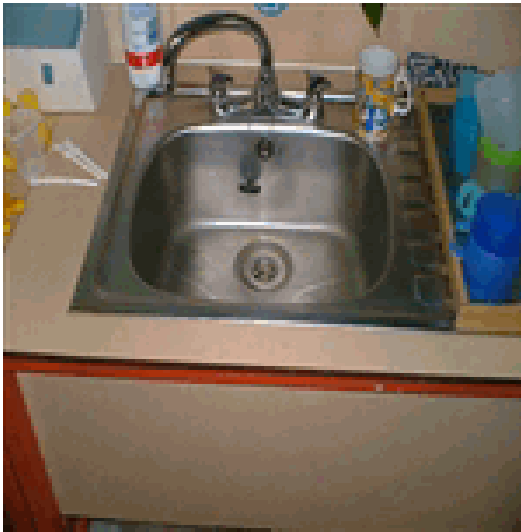
Reference	113	Sample number	01038-01-37-P02
Survey date	17-Jul-17	Presumed	Yes
Building :	01 00 Main School		
Floor	G	Room	037 Classroom
Location	UNDER SINK		
Quantity sampled	1 NO	Use	Bitumen products

Product type	Asb-Reinfd comps, etc (see Use) (1)
Damage/deterioration	High damage (3)
Surface treatment	Composite materials (0)
Asbestos type	Crocidolite (3)

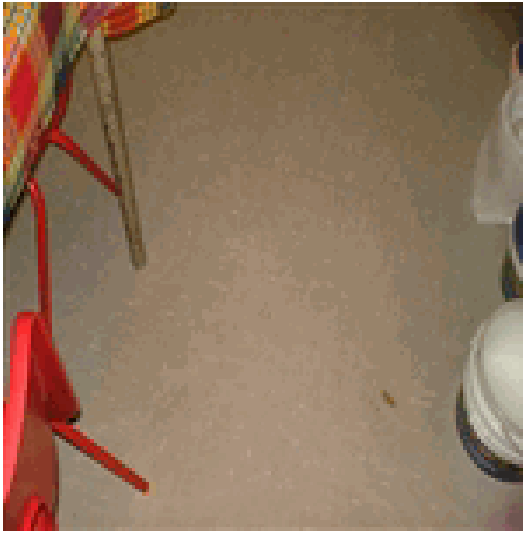
Reference 114 Sample number 01038-01-37-26
Survey date 17-Jul-17 Presumed No

Building : 01 00 Main School
Floor G Room 037 Classroom
Location FLOOR
Quantity sampled 25M2 Use Flooring

Product type Asb-Reinfd comps,etc (see Use) (1)
Damage/deterioration Good condition (0)
Surface treatment Composite materials (0)
Asbestos type Not asbestos (0)

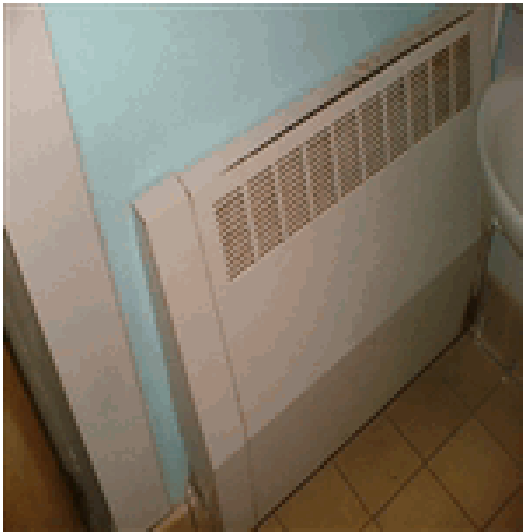
Reference 115 Sample number 01038-01-33-P01
Survey date 17-Jul-17 Presumed Yes
Building : 01 00 Main School
Floor Room 033 Pupil WC
Location WALL MOUNTED
Quantity sampled 1 NO Use Asbestos Insulating Board

Product type AIB,Textiles,Rope,etc(see Use) (2)
Damage/deterioration Low damage (1)
Surface treatment Unsealed AIB,enc Lagging&Spray (2)
Asbestos type Crocidolite (3)

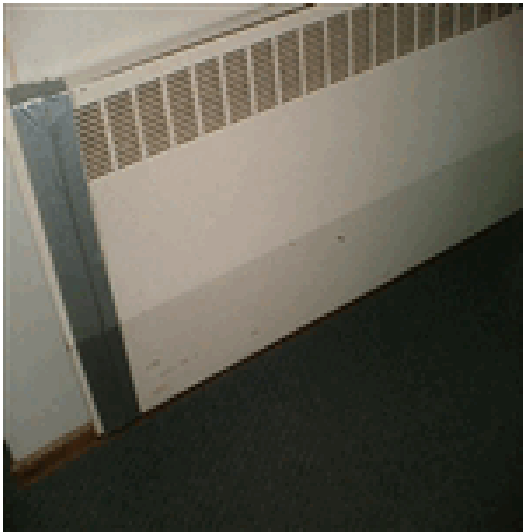
Reference	117	Sample number	01038-01-31-P01
Survey date	17-Jul-17	Presumed	Yes
Building :	01 00 Main School		
Floor		Room	031 Circulation
Location	WALL MOUNTED		
Quantity sampled	1 NO	Use	Asbestos Insulating Board

Product type	AIB, Textiles, Rope, etc (see Use) (2)
Damage/deterioration	Low damage (1)
Surface treatment	Unsealed AIB, enc Lagging & Spray (2)
Asbestos type	Crocidolite (3)

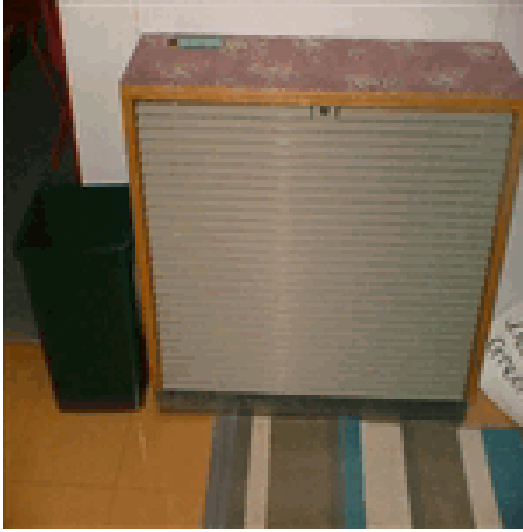
Reference	118	Sample number	01038-01-30-P01
Survey date	17-Jul-17	Presumed	No
Building :	01 00 Main School		
Floor	G	Room	030 Classroom
Location	WALL MOUNTED		
Quantity sampled	1 NO	Use	Asbestos Insulating Board

Product type	AIB, Textiles, Rope, etc (see Use) (2)
Damage/deterioration	High damage (3)
Surface treatment	Unsealed AIB, enc Lagging & Spray (2)
Asbestos type	Crocidolite (3)

Material score	10
Priority score	6
Banding	Removed

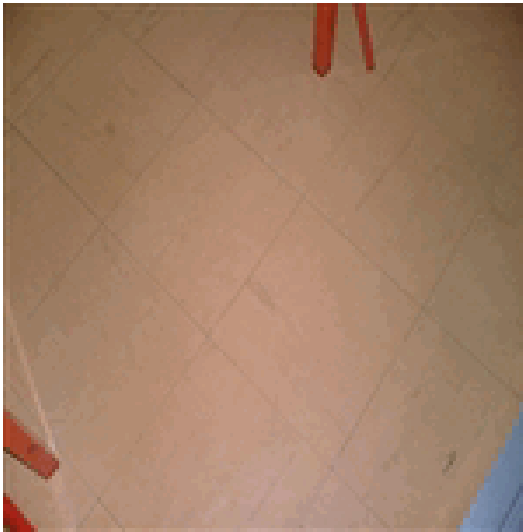
Reference	119	Sample number	01038-01-30-13
Survey date	17-Jul-17	Presumed	No
Building :	01 00 Main School		
Floor	G	Room	030 Classroom
Location	WHOLE FLOOR		
Quantity sampled	30M2	Use	Flooring

Product type	Asb-Reinfd comps, etc (see Use) (1)
Damage/deterioration	Good condition (0)
Surface treatment	Composite materials (0)
Asbestos type	Not asbestos (0)

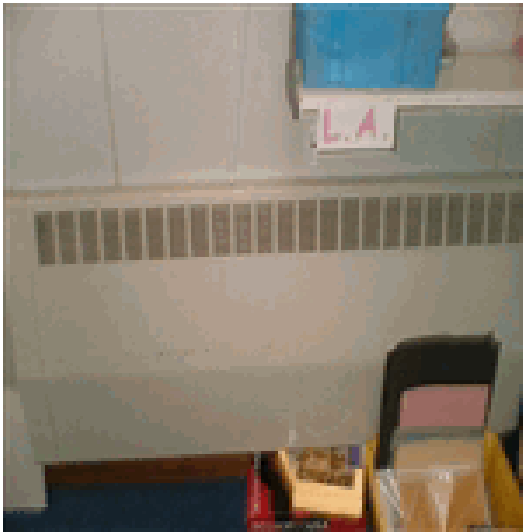
Reference	121	Sample number	01038-01-28-P01
Survey date	17-Jul-17	Presumed	Yes
Building :	01 00 Main School		
Floor	G	Room	028 Quiet room
Location	WALL MOUNTED		
Quantity sampled	1 NO	Use	Asbestos Insulating Board

Product type	AIB, Textiles, Rope, etc (see Use) (2)
Damage/deterioration	Low damage (1)
Surface treatment	Unsealed AIB, enc Lagging & Spray (2)
Asbestos type	Crocidolite (3)

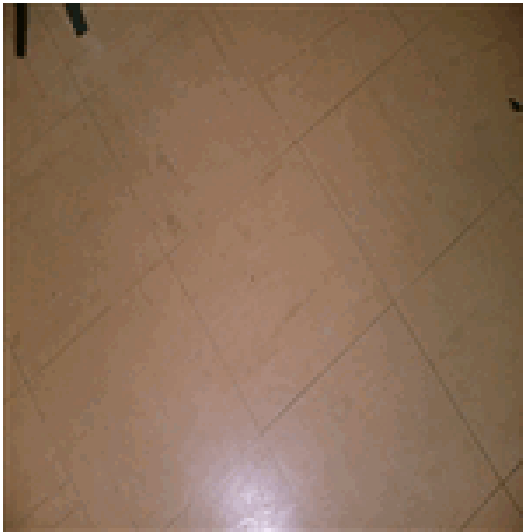
Reference	123	Sample number	01038-01-27-19
Survey date	17-Jul-17	Presumed	No

Building :	01 00 Main School		
Floor		Room	027 Classroom
Location	WHOLE FLOOR		
Quantity sampled	30M2	Use	Flooring

Product type	Asb-Reinfd comps, etc (see Use) (1)
Damage/deterioration	Good condition (0)
Surface treatment	Composite materials (0)
Asbestos type	Not asbestos (0)

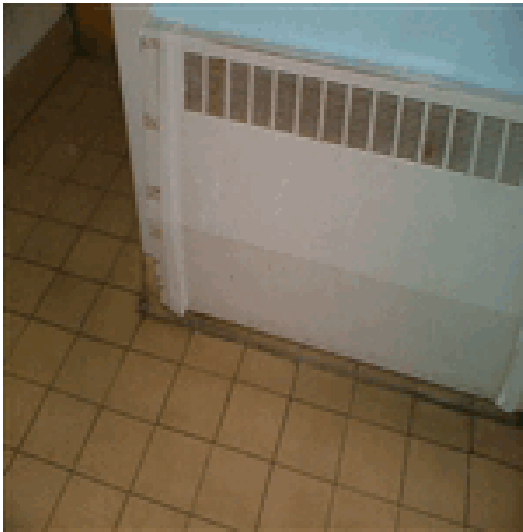
Reference	125	Sample number	01038-01-25-P01
Survey date	17-Jul-17	Presumed	Yes
Building :	01 00 Main School		
Floor		Room	025 Pupil WC
Location	WALL MOUNTED		
Quantity sampled	1 NO	Use	Asbestos Insulating Board

Product type	AIB, Textiles, Rope, etc (see Use) (2)
Damage/deterioration	Low damage (1)
Surface treatment	Unsealed AIB, enc Lagging & Spray (2)
Asbestos type	Crocidolite (3)

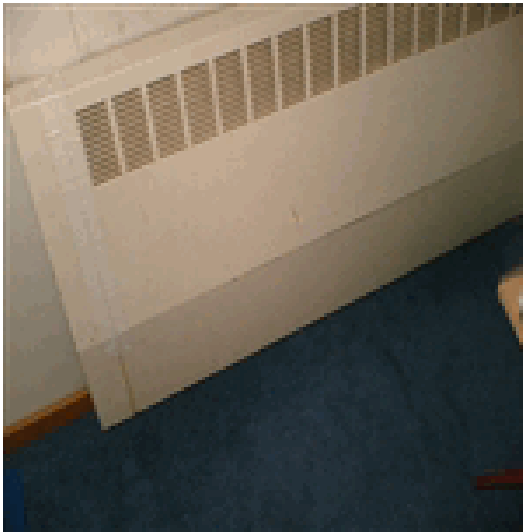
Reference	127	Sample number	01038-01-23-P01
Survey date	17-Jul-17	Presumed	Yes
Building :	01 00 Main School		
Floor	G	Room	023 Quiet room
Location	OFFICE		
Quantity sampled	1 NO	Use	Asbestos Insulating Board

Product type	AIB, Textiles, Rope, etc (see Use) (2)
Damage/deterioration	Low damage (1)
Surface treatment	Unsealed AIB, enc Lagging & Spray (2)
Asbestos type	Crocidolite (3)

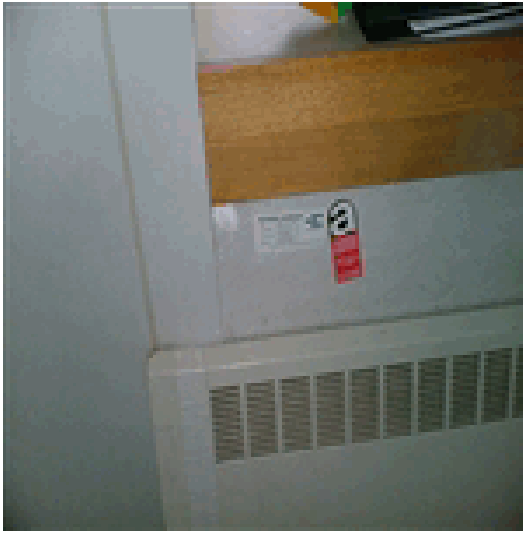
Monitor & Manage

Amosite asbestos. School informed removed at time of 2012/2013 refurbishment but cannot confirm. Treat with caution.

Product type	AIB, Textiles, Rope, etc (see Use) (2)
Damage/deterioration	Low damage (1)
Surface treatment	Enc Lagging & Sprays, AIB, etc (1)
Asbestos type	Amphibole ex. Crocidolite (2)

Material score	6
Priority score	6
Banding	Low

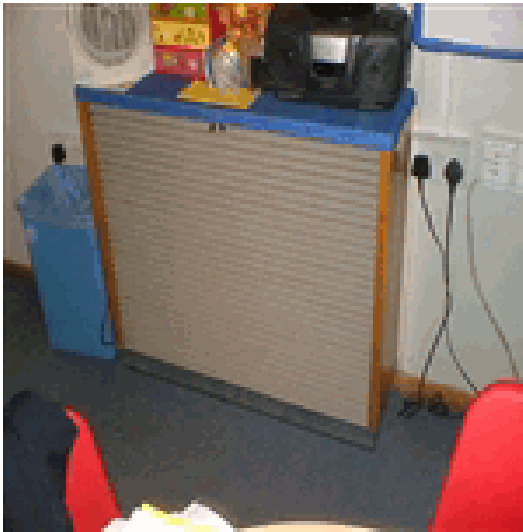
Reference	129	Sample number	01038-01-22-P01
Survey date	17-Jul-17	Presumed	No
Building :	01 00 Main School		
Floor		Room	022 Classroom
Location	WALL MOUNTED		
Quantity sampled	1 NO	Use	Asbestos Insulating Board

Product type	AIB, Textiles, Rope, etc (see Use) (2)
Damage/deterioration	High damage (3)
Surface treatment	Unsealed AIB, enc Lagging & Spray (2)
Asbestos type	Crocidolite (3)

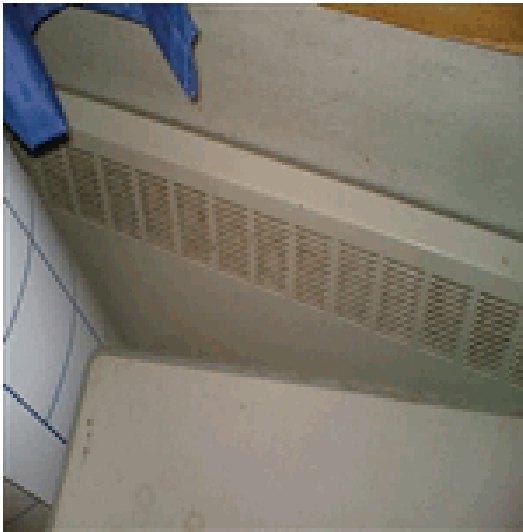
Reference	131	Sample number	01038-01-21-P01
Survey date	17-Jul-17	Presumed	Yes
Building :	01 00 Main School		
Floor		Room	021 Reprographics
Location	WALL MOUNTED		
Quantity sampled	1 NO	Use	Asbestos Insulating Board

Product type	AIB, Textiles, Rope, etc(see Use) (2)
Damage/deterioration	Low damage (1)
Surface treatment	Unsealed AIB, enc Lagging&Spray (2)
Asbestos type	Crocidolite (3)

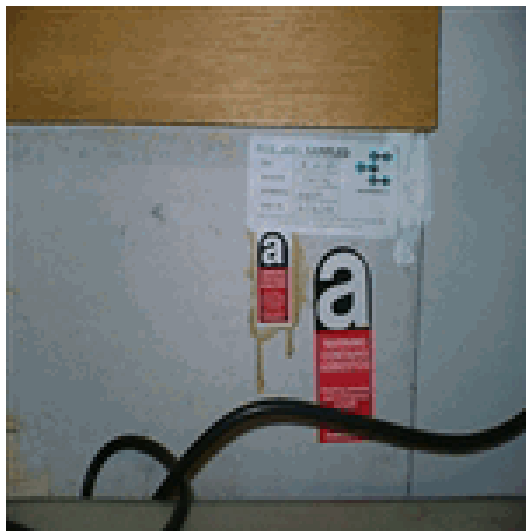
Monitor & Manage

Amosite asbestos. School informed removed at time of 2012/13 refurbishment but cannot confirm. Treat with caution.

Product type	AIB, Textiles, Rope, etc (see Use) (2)
Damage/deterioration	Low damage (1)
Surface treatment	Enc Lagging & Sprays, AIB, etc (1)
Asbestos type	Amphibole ex. Crocidolite (2)

Material score	6
Priority score	6
Banding	Low

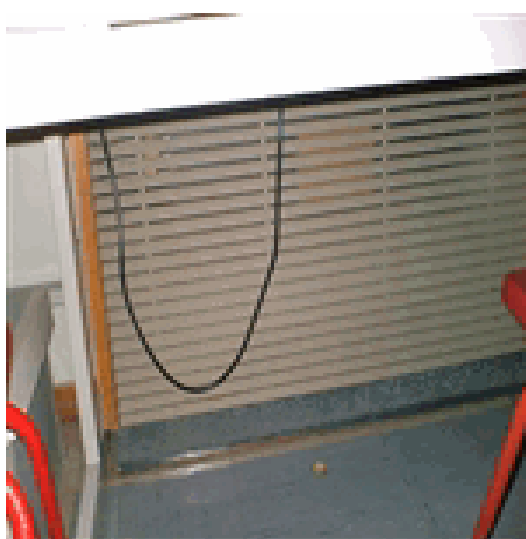
Reference	133	Sample number	01038-01-20-P01
Survey date	17-Jul-17	Presumed	Yes
Building :	01 00 Main School	Room	020 ICT Suite
Floor			
Location	WALL MOUNTED		
Quantity sampled	1 NO	Use	Asbestos Insulating Board

Product type	AIB, Textiles, Rope, etc (see Use) (2)
Damage/deterioration	High damage (3)
Surface treatment	Unsealed AIB, enc Lagging & Spray (2)
Asbestos type	Crocidolite (3)

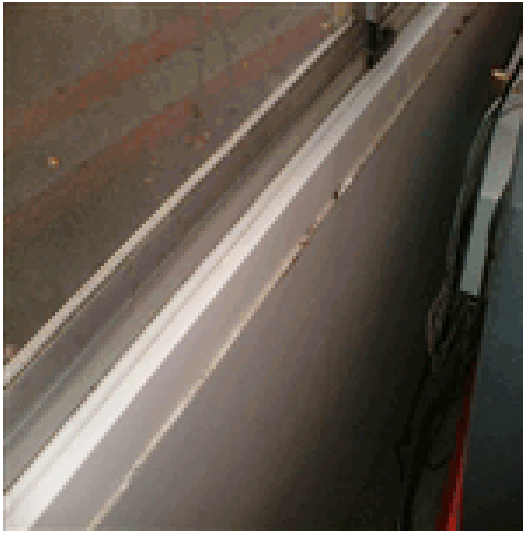
Reference	134	Sample number	01038-01-20-16
Survey date	17-Jul-17	Presumed	No
Building :	01 00 Main School		
Floor		Room	020 ICT Suite
Location	BEHIND WALL PANELS		
Quantity sampled	2M2	Use	Asbestos Insulating Board
Material assessment			
Product type	AIB, Textiles, Rope, etc (see Use) (2)		
Damage/deterioration	Medium damage (2)		
Surface treatment	Enc Lagging&Sprays, AIB, etc (1)		
Asbestos type	Not asbestos (0)

No Asbestos Detected

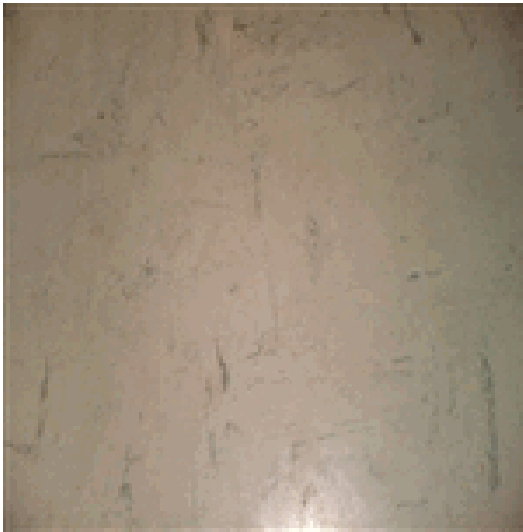
Reference	135	Sample number	01038-01-20-14
Survey date	17-Jul-17	Presumed	No
Building :	01 00 Main School		
Floor		Room	020 ICT Suite
Location	DARK GREY TILES. WHOLE FLOOR		
Quantity sampled	20M2	Use	Flooring
Material assessment			
Product type	Asb-Reinfd comps, etc (see Use) (1)		
Damage/deterioration	Good condition (0)		
Surface treatment	Composite materials (0)		
Asbestos type	Not asbestos (0)

No Asbestos Detected

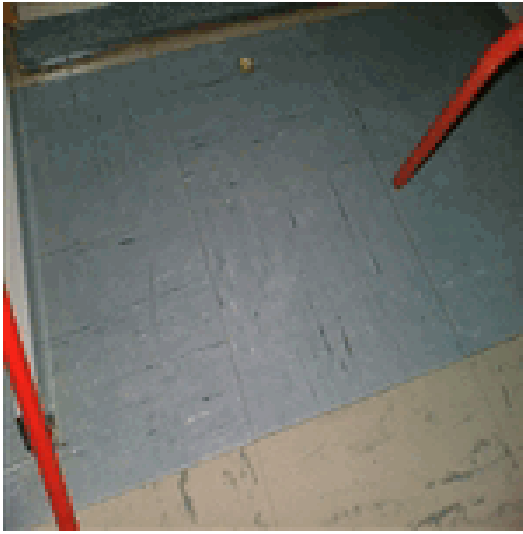
Reference 136 Sample number 01038-01-20-15
Survey date 17-Jul-17 Presumed No

Building : 01 00 Main School
Floor Room 020 ICT Suite
Location GREY TILE PATCHES TO FLOOR
Quantity sampled 2M2 Use Flooring

Product type Asb-Reinfd comps,etc (see Use) (1)
Damage/deterioration Good condition (0)
Surface treatment Composite materials (0)
Asbestos type Not asbestos (0)

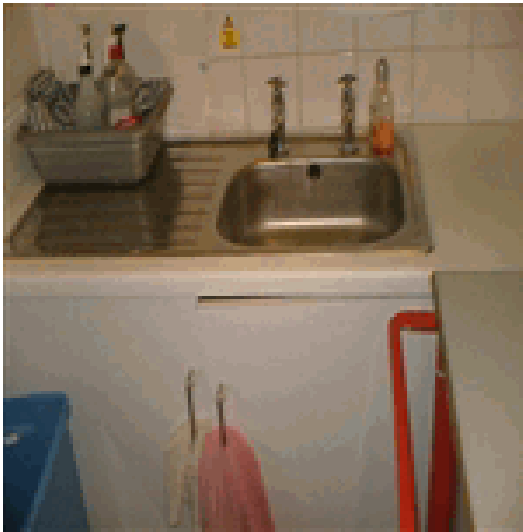
Reference 138 Sample number 01038-01-19-23
Survey date 17-Jul-17 Presumed No

Building : 01 00 Main School
Floor Room 019 Classroom
Location UNDER SINK
Quantity sampled 1 NO Use Bitumen products

Product type Asb-Reinfd comps,etc (see Use) (1)
Damage/deterioration Good condition (0)
Surface treatment Composite materials (0)
Asbestos type Not asbestos (0)

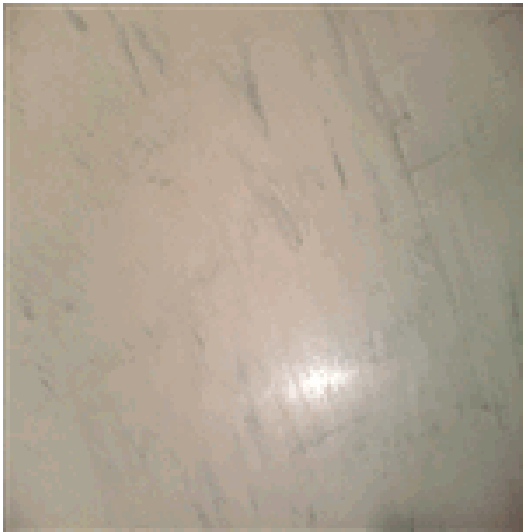
Reference	140	Sample number	01038-01-15-20
Survey date	17-Jul-17	Presumed	No
Building :	01 00 Main School		
Floor	G	Room	015 Resources
Location	GREY BLACK TILES. WHOLE FLO		
Quantity sampled	25M2	Use	Flooring

Product type	Asb-Reinfd comps, etc (see Use) (1)
Damage/deterioration	Good condition (0)
Surface treatment	Composite materials (0)
Asbestos type	Not asbestos (0)

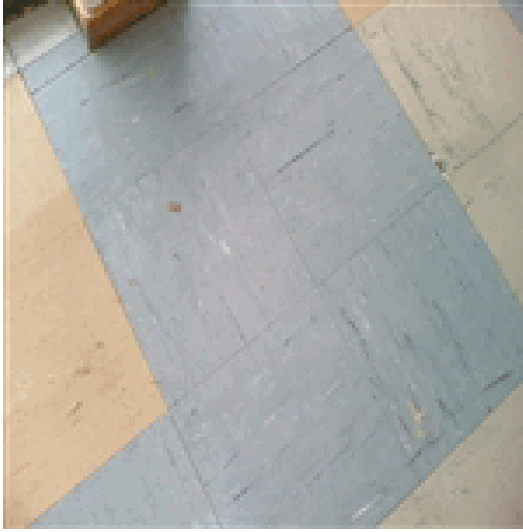
Reference	141	Sample number	01038-01-15-21
Survey date	17-Jul-17	Presumed	No
Building :	01 00 Main School		
Floor	G	Room	015 Resources
Location	GREY TILES. PATCHES TO FLOOR		
Quantity sampled	2M2	Use	Flooring
Material assessment			
Product type	Asb-Reinfd comps,etc (see Use) (1)		
Damage/deterioration	Good condition (0)		
Surface treatment	Composite materials (0)		
Asbestos type	Not asbestos (0)

No Asbestos Detected

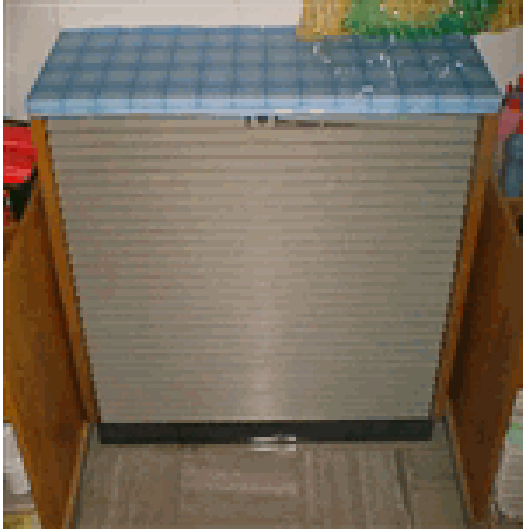
Reference	143	Sample number	01038-01-14-P01
Survey date	17-Jul-17	Presumed	No
Building :	01 00 Main School		
Floor		Room	014 Craft Room
Location	WALL MOUNTED		
Quantity sampled	1 NO	Use	Asbestos Insulating Board

Product type	AIB, Textiles, Rope, etc (see Use) (2)
Damage/deterioration	High damage (3)
Surface treatment	Unsealed AIB, enc Lagging & Spray (2)
Asbestos type	Crocidolite (3)

Material score	10
Priority score	6
Banding	Removed

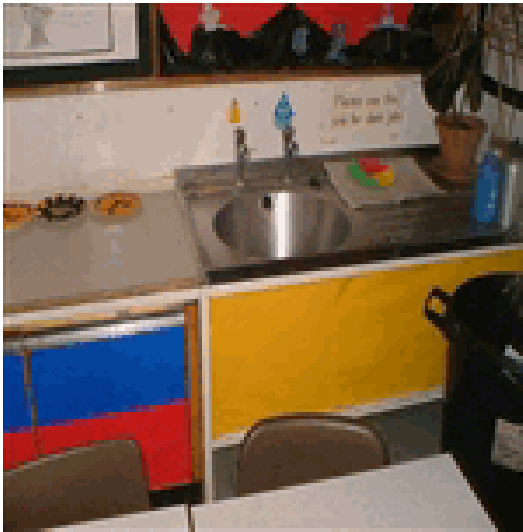
Reference	144	Sample number	01038-01-14-10
Survey date	17-Jul-17	Presumed	No
Building :	01 00 Main School		
Floor		Room	014 Craft Room
Location	UNDER SINK		
Quantity sampled	1 NO	Use	Bitumen products

Product type	Asb-Reinfd comps, etc (see Use) (1)
Damage/deterioration	Good condition (0)
Surface treatment	Composite materials (0)
Asbestos type	Chrysotile (1)

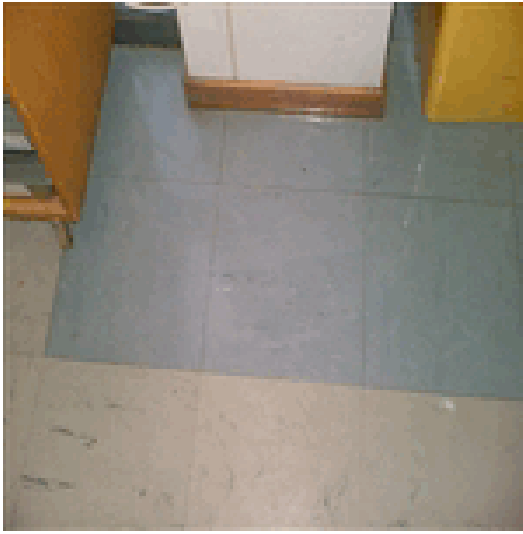
Reference	147	Sample number	01038-01-14-11
Survey date	17-Jul-17	Presumed	No
Building :	01 00 Main School		
Floor		Room	014 Craft Room
Location	DARK GREY FLOOR TILES		
Quantity sampled	2M2	Use	Flooring
Material assessment			
Product type	Asb-Reinfd comps,etc (see Use) (1)		
Damage/deterioration	Good condition (0)		
Surface treatment	Composite materials (0)		
Asbestos type	Not asbestos (0)

No Asbestos Detected

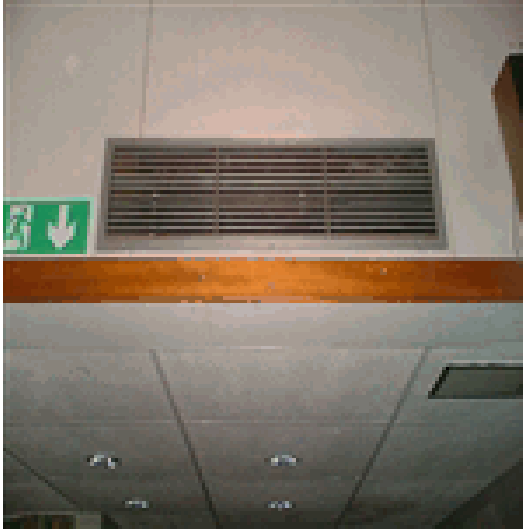
Monitor & Manage

Presumed crocidolite asbestos. No access. Presumed to contain Insulation board and gaskets

Material score	8
Priority score	5
Banding	Low

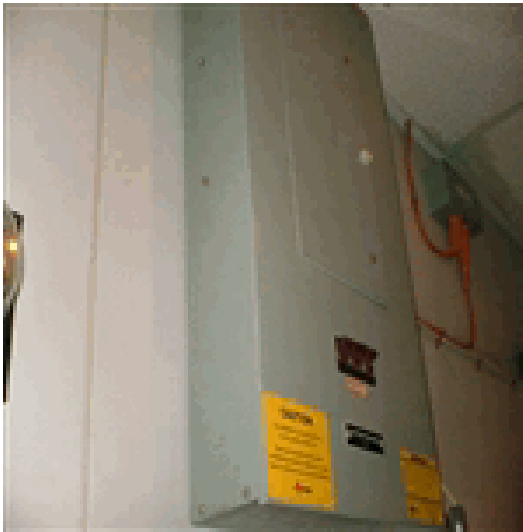
Reference	150	Sample number	01038-01-12-P01
Survey date	17-Jul-17	Presumed	Yes
Building :	01 00 Main School		
Floor		Room	012 Storage
Location	WALL MOUNTED		
Quantity sampled	1 NO	Use	Asbestos Insulating Board

Presumed crocidolite asbestos. Presume to contain Insulation board, rope seals and flash pads

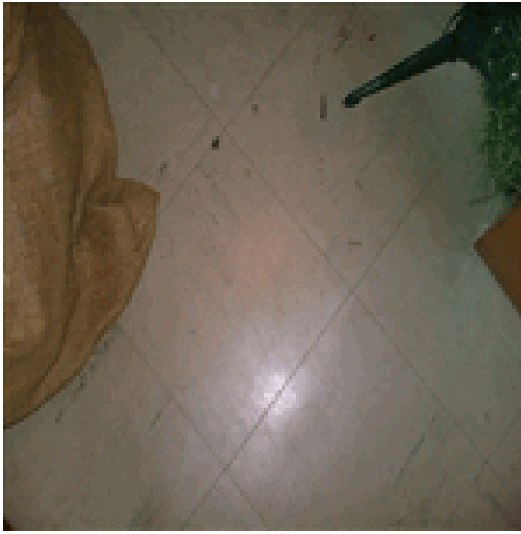
Reference **151** Sample number **01038-01-12-07**
Survey date **17-Jul-17** Presumed **No**

Building : 01 00 Main School
Floor Room 012 Storage
Location FLOOR
Quantity sampled 6M2 Use Flooring

Occupants using space 1 to 3 (1)
Frequency of use Monthly (1)
Average time of use >6 hours (3) Material score 3
Type of maintenance Minor disturbance (0) Priority score 6
Frequency of maintenance <1 per year (1) Banding **Low**

Monitor & Manage

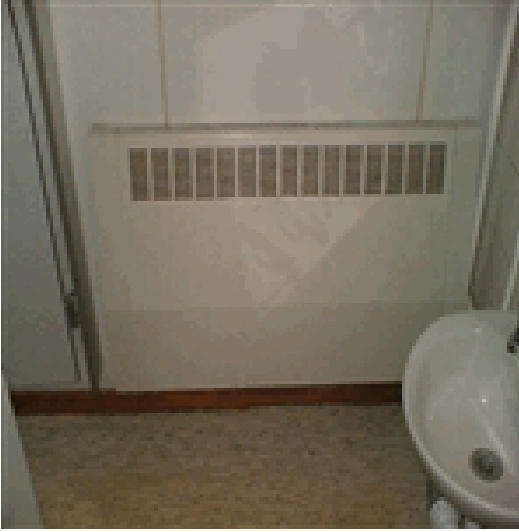
Reference	153	Sample number	01038-01-11-P01
Survey date	17-Jul-17	Presumed	Yes
Building :	01 00 Main School		
Floor	G	Room	011 Pupil WC
Location	WALL MOUNTED		
Quantity sampled	1 NO	Use	Asbestos Insulating Board

Monitor & Manage

Presumed crocidolite asbestos. No access. Presumed to contain Insulation board and gaskets

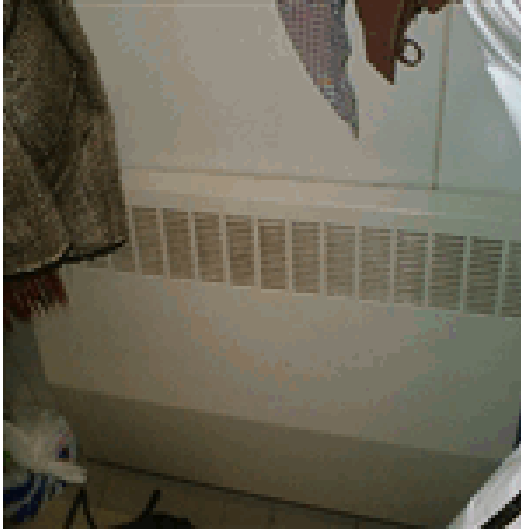
Reference	155	Sample number	01038-01-09-P01
Survey date	17-Jul-17	Presumed	Yes
Building :	01 00 Main School		
Floor	G	Room	009 Nursery
Location	WALL MOUNTED		
Quantity sampled	1 NO	Use	Asbestos Insulating Board

Banding **Removed**

No access. Presumed to contain Insulation board and gaskets.
Presumed crocidolite asbestos.

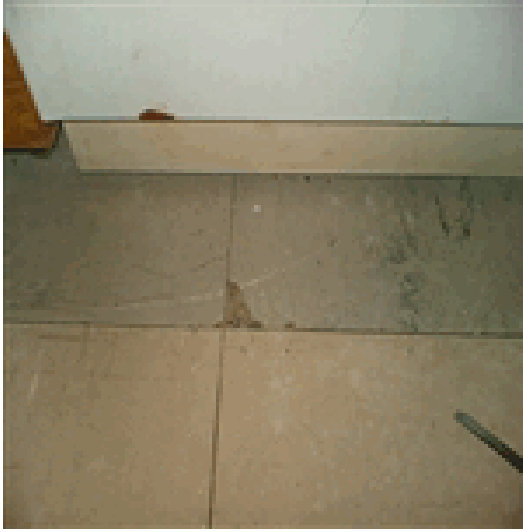
Reference **157** Sample number **01038-01-09-05**
Survey date **17-Jul-17** Presumed **No**

Building : 01 00 Main School
Floor G Room 009 Nursery
Location GREY FLOOR TILES
Quantity sampled 1.5M2 Use Flooring

Product type Asb-Reinfd comps,etc (see Use) (1)
Damage/deterioration Low damage (1)
Surface treatment Composite materials (0)
Asbestos type Chrysotile (1)

Occupants using space 1 to 3 (1)
Frequency of use Monthly (1)
Average time of use >6 hours (3) Material score 3
Type of maintenance Minor disturbance (0) Priority score 4
Frequency of maintenance ACM unlikely to be disturbed (0) Banding **Removed**

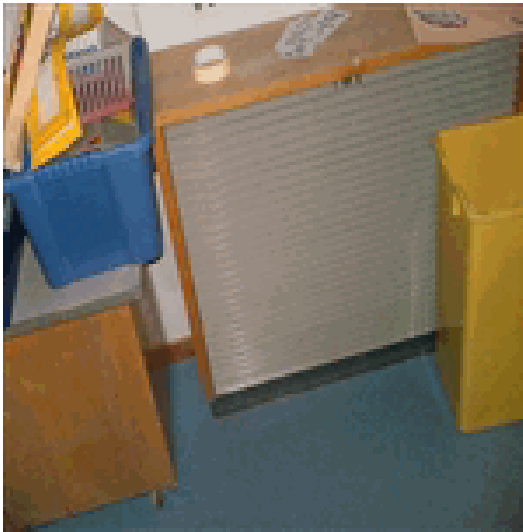
Reference **158** Sample number **01038-01-08-P02**
Survey date **17-Jul-17** Presumed **No**

Building : 01 00 Main School
Floor G Room 008 Nursery
Location WALL MOUNTED
Quantity sampled 2 NO Use Asbestos Insulating Board

Product type AIB,Textiles,Rope,etc(see Use) (2)
Damage/deterioration High damage (3)
Surface treatment Unsealed AIB,enc Lagging&Spray (2)
Asbestos type Crocidolite (3)

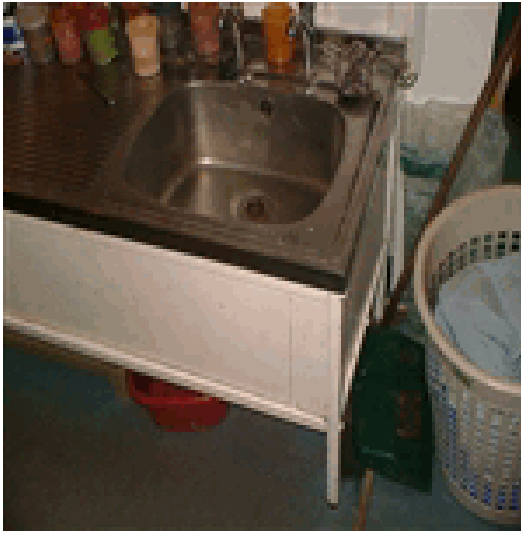
Reference	159	Sample number	01038-01-08-P03
Survey date	17-Jul-17	Presumed	No
Building :	01 00 Main School		
Floor	G	Room	008 Nursery
Location	UNDER SINK		
Quantity sampled	1 NO	Use	Bitumen products

Product type	Asb-Reinfd comps,etc (see Use) (1)
Damage/deterioration	Good condition (0)
Surface treatment	Composite materials (0)
Asbestos type	Crocidolite (3)

Banding **Removed**

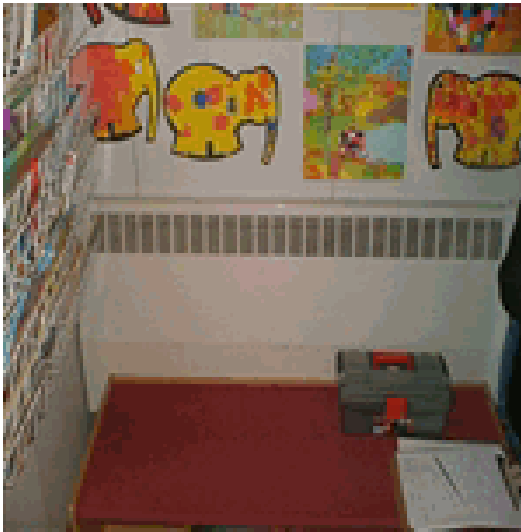
Reference	160	Sample number	01038-01-08-P01
Survey date	17-Jul-17	Presumed	Yes
Building :	01 00 Main School		
Floor	G	Room	008 Nursery
Location	WALL MOUNTED		
Quantity sampled	1 NO	Use	Asbestos Insulating Board

Product type	AIB,Textiles,Rope,etc(see Use) (2)
Damage/deterioration	Low damage (1)
Surface treatment	Unsealed AIB,enc Lagging&Spray (2)
Asbestos type	Crocidolite (3)

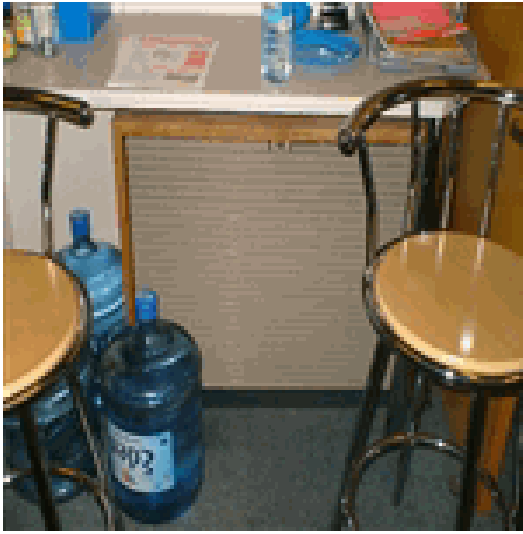
Reference	161	Sample number	01038-01-07-P01
Survey date	17-Jul-17	Presumed	No
Building :	01 00 Main School		
Floor		Room	007 Staff Room
Location	WALL MOUNTED		
Quantity sampled	1 NO	Use	Asbestos Insulating Board

Product type	AIB, Textiles, Rope, etc (see Use) (2)
Damage/deterioration	High damage (3)
Surface treatment	Unsealed AIB, enc Lagging & Spray (2)
Asbestos type	Crocidolite (3)

Banding	Removed
---------	---------

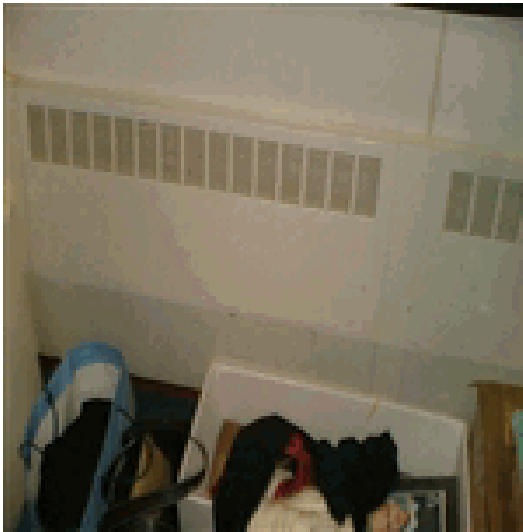
Reference	162	Sample number	01038-01-06-P01
Survey date	17-Jul-17	Presumed	No
Building :	01 00 Main School		
Floor		Room	006 Office
Location	WALL MOUNTED		
Quantity sampled	1 NO	Use	Asbestos Insulating Board

Product type	AIB, Textiles, Rope, etc (see Use) (2)
Damage/deterioration	High damage (3)
Surface treatment	Unsealed AIB, enc Lagging & Spray (2)
Asbestos type	Crocidolite (3)

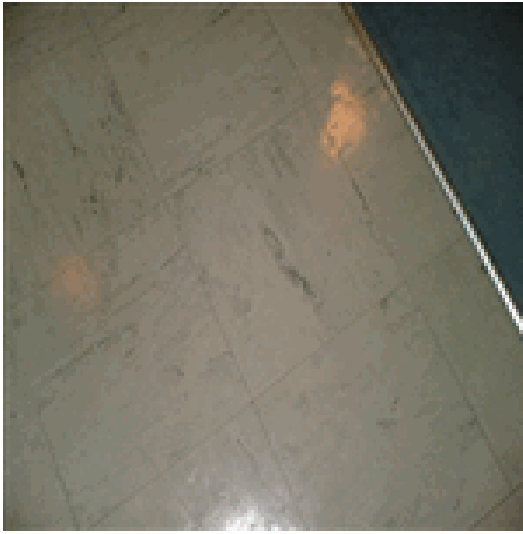
Reference	163	Sample number	01038-01-05-01
Survey date	17-Jul-17	Presumed	No
Building :	01 00 Main School		
Floor		Room	005 Circulation
Location	GREY FLOOR TILES		
Quantity sampled	10M2	Use	Flooring
Material assessment			
Product type	Asb-Reinfd comps,etc (see Use) (1)		
Damage/deterioration	Good condition (0)		
Surface treatment	Composite materials (0)		
Asbestos type	Not asbestos (0)

No Asbestos Detected

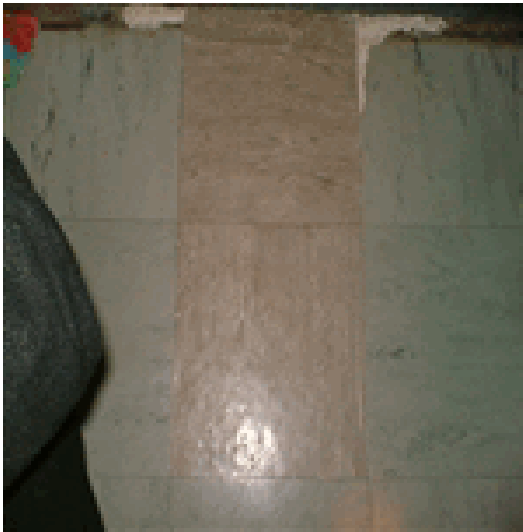
Reference	164	Sample number	01038-01-05-02
Survey date	17-Jul-17	Presumed	No
Building :	01 00 Main School		
Floor		Room	005 Circulation
Location	BROWN PATTERN FLOOR TILE		
Quantity sampled	1.5M2	Use	Flooring
Material assessment			
Product type	Asb-Reinfd comps,etc (see Use) (1)		
Damage/deterioration	Good condition (0)		
Surface treatment	Composite materials (0)		
Asbestos type	Not asbestos (0)

No Asbestos Detected

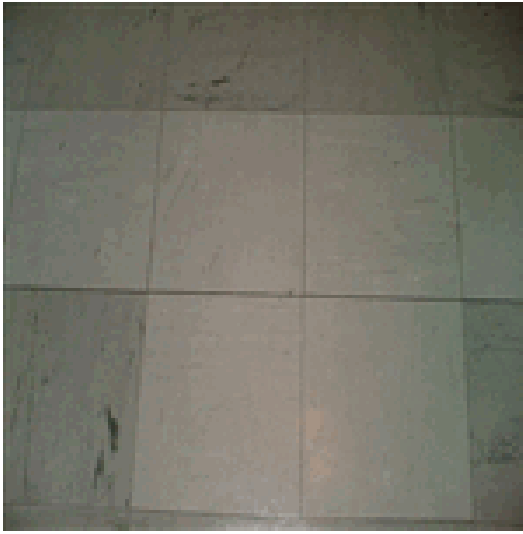
Reference	165	Sample number	01038-01-05-03
Survey date	17-Jul-17	Presumed	No
Building :	01 00 Main School		
Floor		Room	005 Circulation
Location	WHITE FLOOR TILE		
Quantity sampled	1.5M2	Use	Flooring
Material assessment			
Product type	Asb-Reinfd comps,etc (see Use) (1)		
Damage/deterioration	Good condition (0)		
Surface treatment	Composite materials (0)		
Asbestos type	Not asbestos (0)

No Asbestos Detected

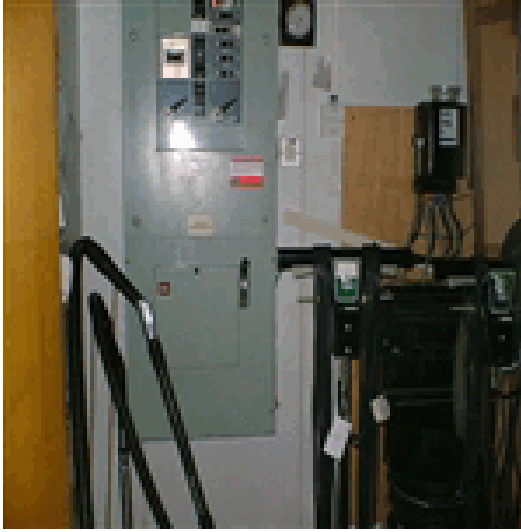
Presumed crocidolite asbestos. Presume to contain Insulation board, rope seals and flash pads

Product type	AIB, Textiles, Rope, etc (see Use) (2)
Damage/deterioration	Low damage (1)
Surface treatment	Unsealed AIB, enc Lagging & Spray (2)
Asbestos type	Crocidolite (3)

Material score	8
Priority score	5
Banding	Low

Monitor & Manage

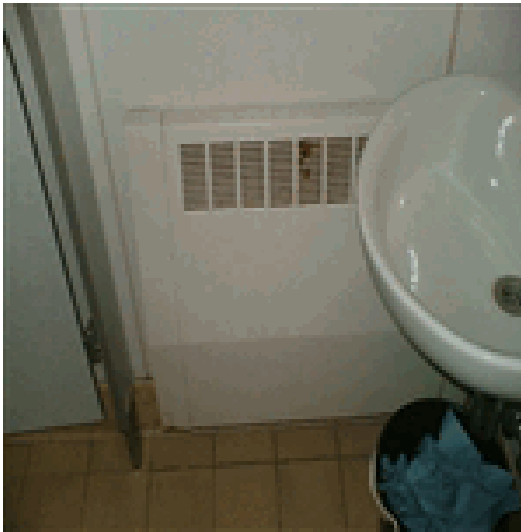
Reference	168	Sample number	01038-01-02-P01
Survey date	17-Jul-17	Presumed	Yes
Building :	01 00 Main School		
Floor		Room	002 Staff WC
Location	WALL MOUNTED		
Quantity sampled	1 NO	Use	Asbestos Insulating Board

Product type	AIB, Textiles, Rope, etc (see Use) (2)
Damage/deterioration	Low damage (1)
Surface treatment	Unsealed AIB, enc Lagging & Spray (2)
Asbestos type	Crocidolite (3)

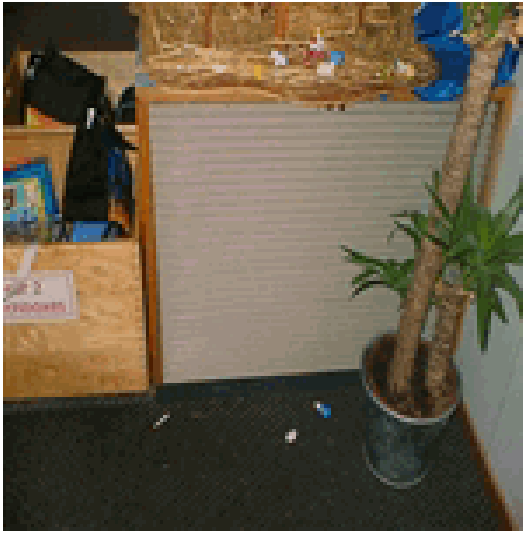
Reference **169** Sample number **01038-01-01-P01**
 Survey date **17-Jul-17** Presumed **No**
 Building : **01 00 Main School**
 Floor Room 001 Circulation
 Location WALL MOUNTED
 Quantity sampled 1 NO Use Asbestos Insulating Board

Product type AIB, Textiles, Rope, etc (see Use) (2)
 Damage/deterioration High damage (3)
 Surface treatment Unsealed AIB, enc Lagging & Spray (2)
 Asbestos type Crocidolite (3)

Material score **10**
 Priority score **6**
 Banding **Removed**

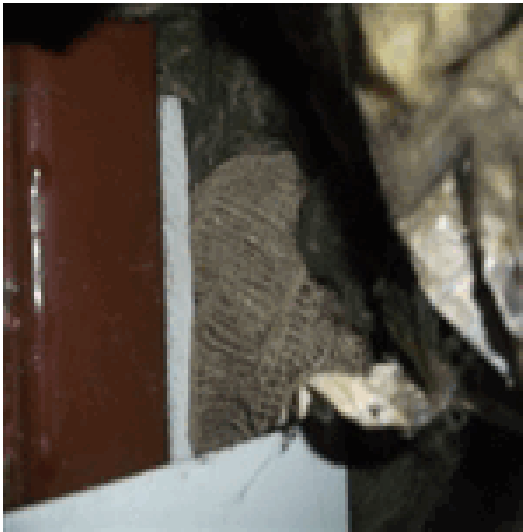
Reference **178** Sample number **01038-01-15-55**
 Survey date **17-Jul-17** Presumed **No**
 Building : **01 00 Main School**
 Floor G Room 015 Resources
 Location
 Quantity sampled <10m linear Use Asbestos Insulating Board

Product type AIB, Textiles, Rope, etc (0)
 Damage/deterioration Low damage (1)
 Surface treatment Unsealed AIB, enc Lagging & Spray (0)
 Asbestos type Amphibole ex. Crocidolite (2)

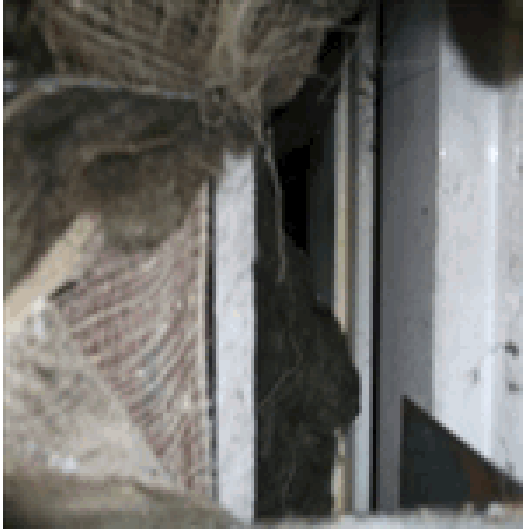
Reference	181	Sample number	01038-01-20-58	
Survey date	17-Jul-17	Presumed	No	
Building :	01 00 Main School			
Floor		Room	020 ICT Suite	
Location				
Quantity sampled	<10m2	Use	Asbestos Insulating Board	
Material assessment				
Product type	AIB, Textiles, Rope, etc (0)			
Damage/deterioration	Low damage (1)			
Surface treatment	Unsealed AIB, enc Lagging&Spray (0)			
Asbestos type	Amphibole ex. Crocidolite (2)			
Priority assessment				
Type of activity	Low disturbance activity (0)			
Location	Rooms up to 100m2 (2)			
Accessibility	Usually inaccessible/unlikely (0)			
Extent	<10m2 or 10m pipe run (1)			
Occupants using space	>10 (3)			
Frequency of use	Daily (3)			
Average time of use	>3 to <6 hours (2)		Material score	3
Type of maintenance	Minor disturbance (0)		Priority score	4
Frequency of maintenance	ACM unlikely to be disturbed (0)		Banding	Very Low

Restrict Access

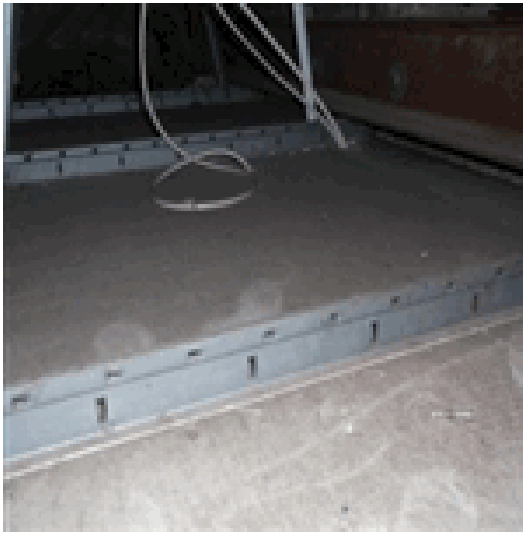
Reference	186	Sample number	01038-01-24-63	
Survey date	17-Jul-17	Presumed	No	
Building :	01 00 Main School			
Floor		Room	024 Circulation	
Location				
Quantity sampled	>10m2 <50m2		Use	Asbestos Insulating Board
Material assessment				
Product type	AIB,Textiles,Rope,etc (0)			
Damage/deterioration	Low damage (1)			
Surface treatment	Unsealed AIB,enc Lagging&Spray (0)			
Asbestos type	Amphibole ex. Crocidolite (2)			
Priority assessment				
Type of activity	Low disturbance activity (0)			
Location	Rooms up to 100m2 (2)			
Accessibility	Usually inaccessible/unlikely (0)			
Extent	>10m2 to <50m2 or >10m to <50m (2)			
Occupants using space	4 to 10 (2)			
Frequency of use	Daily (3)			
Average time of use	>1 to <3 hours (1)		Material score	3
Type of maintenance	Minor disturbance (0)		Priority score	4
Frequency of maintenance	ACM unlikely to be disturbed (0)		Banding	Very Low

Restrict Access

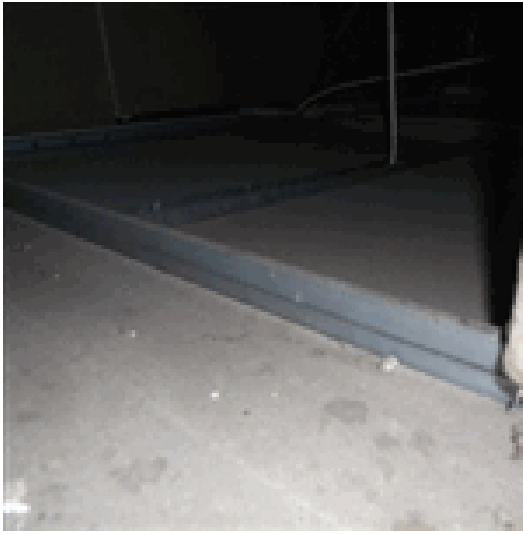
Reference	187	Sample number	01038-01-24-64	
Survey date	17-Jul-17	Presumed	No	
Building :	01 00 Main School			
Floor		Room	024 Circulation	
Location				
Quantity sampled	<10m2	Use	Asbestos Insulating Board	
Material assessment				
Product type	AIB, Textiles, Rope, etc (0)			
Damage/deterioration	Low damage (1)			
Surface treatment	Unsealed AIB, enc Lagging&Spray (0)			
Asbestos type	Amphibole ex. Crocidolite (2)			
Priority assessment				
Type of activity	Low disturbance activity (0)			
Location	Rooms up to 100m2 (2)			
Accessibility	Usually inaccessible/unlikely (0)			
Extent	<10m2 or 10m pipe run (1)			
Occupants using space	4 to 10 (2)			
Frequency of use	Weekly (2)			
Average time of use	>1 to <3 hours (1)		Material score	3
Type of maintenance	Minor disturbance (0)		Priority score	3
Frequency of maintenance	ACM unlikely to be disturbed (0)		Banding	Very Low

Restrict Access

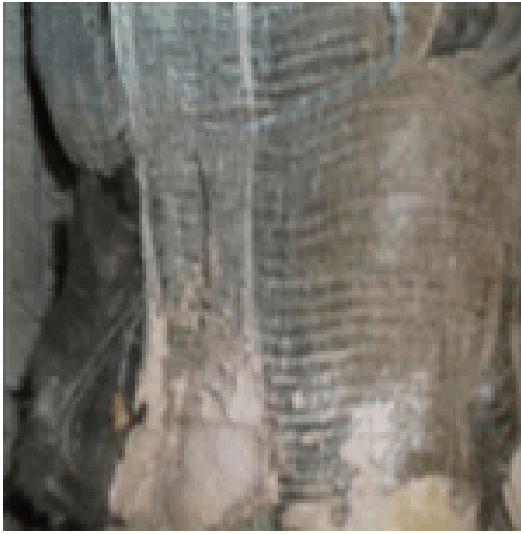
Reference	189	Sample number	01038-01-22-66
Survey date	17-Jul-17	Presumed	No
Building :	01 00 Main School		
Floor		Room	022 Classroom
Location		Use	Asbestos Insulating Board
Quantity sampled	<10m2

Product type	AIB, Textiles, Rope, etc (0)
Damage/deterioration	Low damage (1)
Surface treatment	Unsealed AIB, enc Lagging & Spray (0)
Asbestos type	Amphibole ex. Crocidolite (2)

Material score	3
Priority score	4
Banding	Very Low

Restrict Access

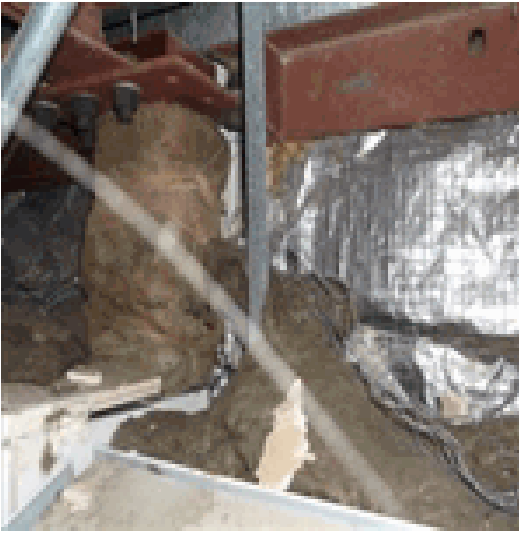
Reference	193	Sample number	01038-01-29-70SP
Survey date	17-Jul-17	Presumed	Yes
Building :	01 00 Main School		
Floor	G	Room	029 Office
Location			
Quantity sampled	>10m2 ,50m2	Use	Asbestos Insulating Board

Product type	AIB, Textiles, Rope, etc (0)
Damage/deterioration	Low damage (1)
Surface treatment	Unsealed AIB, enc Lagging & Spray (0)
Asbestos type	Amphibole ex. Crocidolite (2)

Type of activity	Low disturbance activity (0)
Location	Rooms up to 100m2 (2)
Accessibility	Usually inaccessible/unlikely (0)
Extent	>10m2 to <50m2 or >10m to <50m (2)
Occupants using space	1 to 3 (1)
Frequency of use	Daily (3)
Average time of use	>6 hours (3)
Type of maintenance	Minor disturbance (0)
Frequency of maintenance	ACM unlikely to be disturbed (0)
Material score	3
Priority score	4
Banding	Very Low

Restrict Access

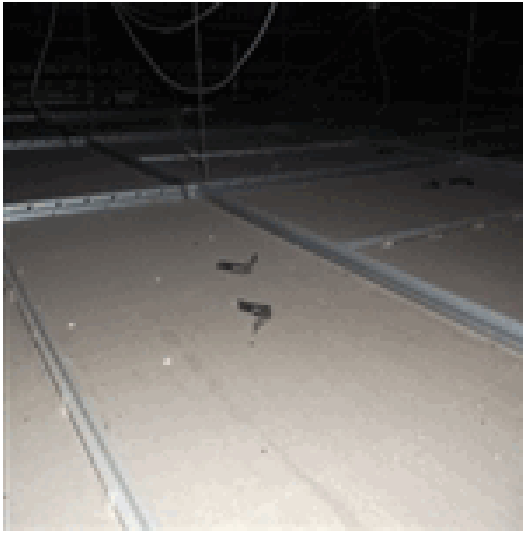
Reference	197	Sample number	01038-01-42-74	
Survey date	17-Jul-17	Presumed	No	
Building :	01 00 Main School			
Floor		Room	042 Classroom	
Location				
Quantity sampled	>10m2 <50m2	Use	Asbestos Insulating Board	
Material assessment				
Product type	AIB, Textiles, Rope, etc (0)			
Damage/deterioration	Low damage (1)			
Surface treatment	Unsealed AIB, enc Lagging&Spray (0)			
Asbestos type	Amphibole ex. Crocidolite (2)			
Priority assessment				
Type of activity	Low disturbance activity (0)			
Location	Rooms up to 100m2 (2)			
Accessibility	Usually inaccessible/unlikely (0)			
Extent	>10m2 to <50m2 or >10m to <50m (2)			
Occupants using space	>10 (3)			
Frequency of use	Daily (3)			
Average time of use	>6 hours (3)		Material score	3
Type of maintenance	Minor disturbance (0)		Priority score	5
Frequency of maintenance	ACM unlikely to be disturbed (0)		Banding	Very Low

Restrict Access

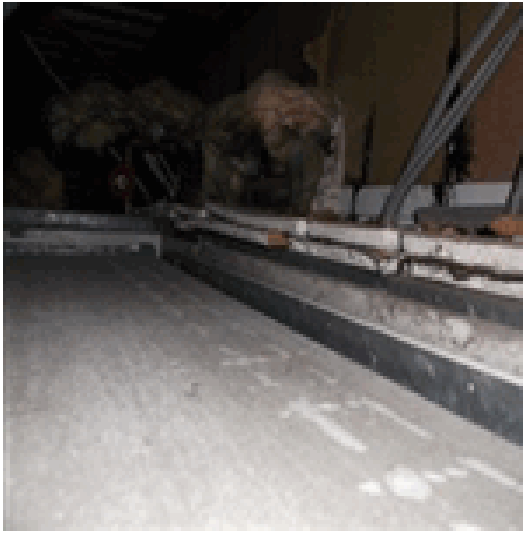
No Asbestos Detected

Reference	203	Sample number	01038-01-48-80
Survey date	17-Jul-17	Presumed	No
Building :	01 00 Main School		
Floor		Room	048 Staff WC
Location			
Quantity sampled		Use	
Material assessment			
Product type	()		
Damage/deterioration	()		
Surface treatment	()		
Asbestos type	Not asbestos (0)

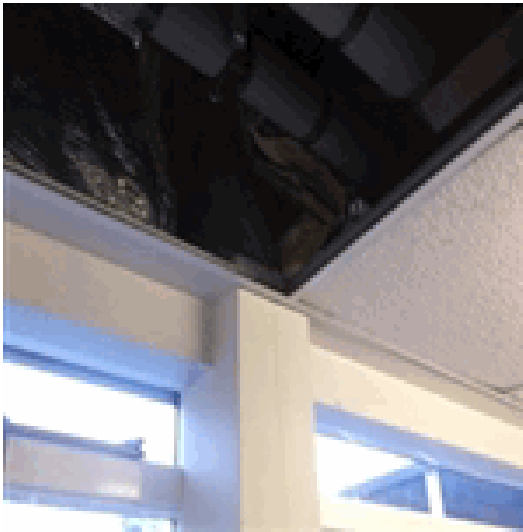
Reference	204	Sample number	01038-01-01-81
Survey date	17-Jul-17	Presumed	No
Building :	01 00 Main School		
Floor		Room	002 Staff WC
Location			
Quantity sampled	>10m2 <50m2	Use	Asbestos Insulating Board
Material assessment			
Product type	AIB, Textiles, Rope, etc (0)		
Damage/deterioration	Low damage (1)		
Surface treatment	Unsealed AIB, enc Lagging & Spray (0)		
Asbestos type	Amphibole ex. Crocidolite (2)

Restrict Access

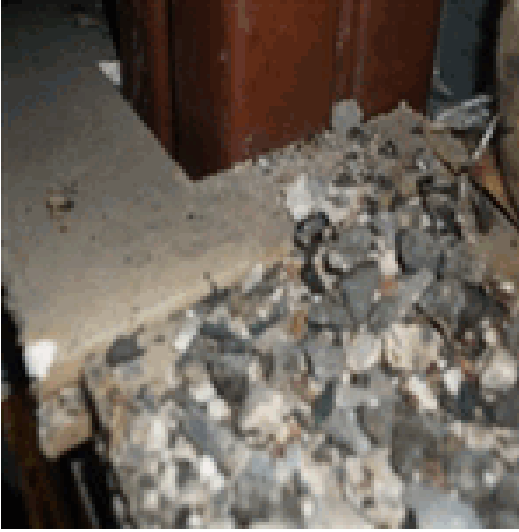
Reference 205 Sample number 01038-01-08-82
Survey date 17-Jul-17 Presumed No

Building : 01 00 Main School
Floor G Room 008 Nursery
Location
Quantity sampled Use

Material assessment
Product type ()
Damage/deterioration ()
Surface treatment ()
Asbestos type Not asbestos (0)

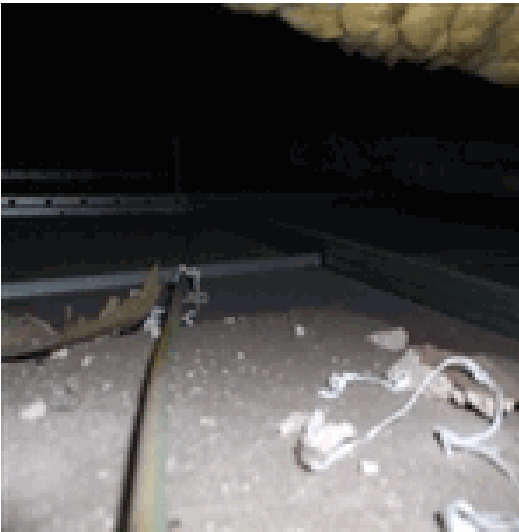
Reference 206 Sample number 01038-01-08-83
Survey date 17-Jul-17 Presumed No

Building : 01 00 Main School
Floor G Room 008 Nursery
Location
Quantity sampled Use

Material assessment
Product type ()
Damage/deterioration ()
Surface treatment ()
Asbestos type Not asbestos (0)
