Asbestos Inspection Report

01038 : Bracken Lane Primary and Nursery

Survey date : 17-Jul-2017

Type of survey **Management Survey**

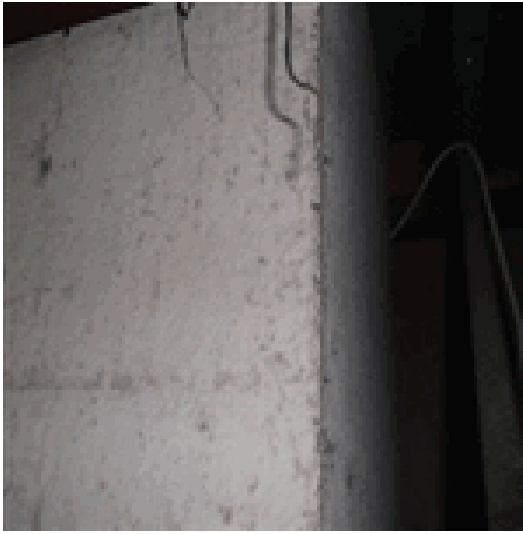
Reference	207	Sample number	01038-01-11-84	
Survey date	17-Jul-17	Presumed	No	
Building :	01 00 Main School			
Floor	G	Room	011 Pupil WC	
Location				
Quantity sampled	<10m2	Use	Asbestos Insulating Board	
Material assessment				
Product type	AIB,Textiles,Rope,etc (0)			
Damage/deterioration	Low damage (1)			
Surface treatment	Unsealed AIB,enc Lagging&Spray (0)			
Asbestos type	Amphibole ex. Crocidolite (2)			
Priority assessment				
Type of activity	Low disturbance activity (0)			
Location	Rooms up to 100m2 (2)			
Accessibility	Usually inaccessible/unlikely (0)			
Extent	<10m2 or 10m pipe run (1)			
Occupants using space	1 to 3 (1)			
Frequency of use	Daily (3)			
Average time of use	>1 to <3 hours (1)		Material score	3
Type of maintenance	Minor disturbance (0)		Priority score	3
Frequency of maintenance	ACM unlikely to be disturbed (0)		Banding	Very Low

Restrict Access

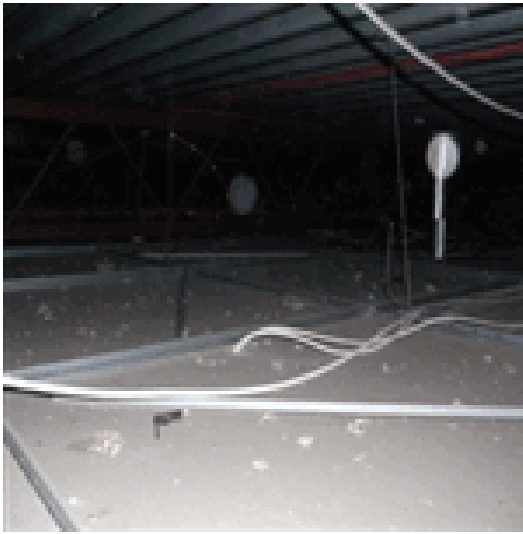
No Asbestos Detected

Reference	208	Sample number	01038-01-13-85
Survey date	17-Jul-17	Presumed	No
Building :	01 00 Main School		
Floor		Room	013 Hall
Location			
Quantity sampled		Use	
Material assessment			
Product type	()		
Damage/deterioration	()		
Surface treatment	()		
Asbestos type	Not asbestos (0)

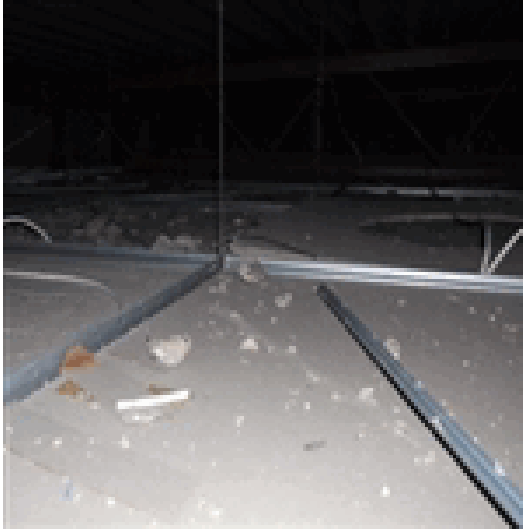
Reference 209 Sample number 01038-01-13-86
Survey date 17-Jul-17 Presumed No

Building : 01 00 Main School
Floor Room 013 Hall
Location
Quantity sampled Use

Material assessment
Product type ()
Damage/deterioration ()
Surface treatment ()
Asbestos type Not asbestos (0)

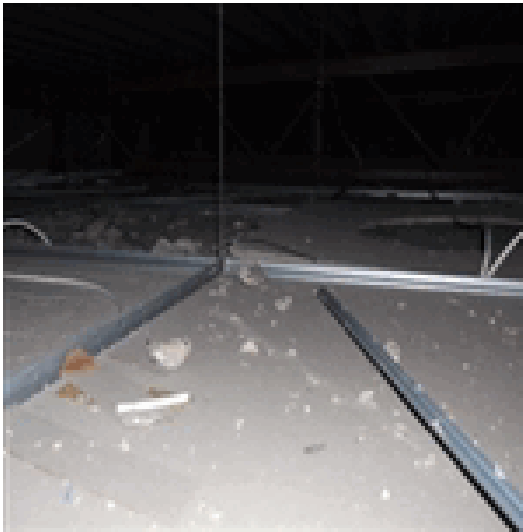
Reference 210 Sample number 01038-01-500-87
Survey date 17-Jul-17 Presumed No

Building : 01 00 Main School
Floor Room 000 External/Fixtures
Location
Quantity sampled Use

Material assessment
Product type ()
Damage/deterioration ()
Surface treatment ()
Asbestos type Not asbestos (0)

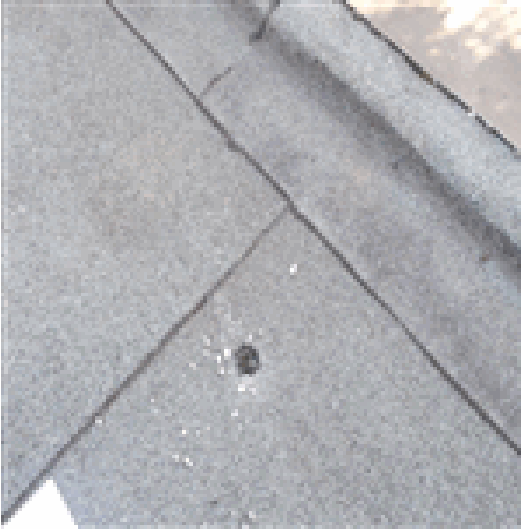
Reference	211	Sample number	01038-01-500-89
Survey date	17-Jul-17	Presumed	No
Building :	01 00 Main School		
Floor		Room	000 External/Fixtures
Location		Use	
Quantity sampled			
Material assessment			
Product type	()		
Damage/deterioration	()		
Surface treatment	()		
Asbestos type	Not asbestos (0)

No Asbestos Detected

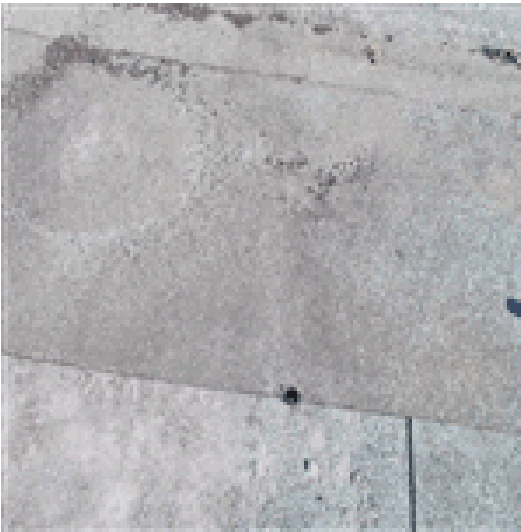
Reference	212	Sample number	01038-01-500-90
Survey date	17-Jul-17	Presumed	No
Building :	01 00 Main School		
Floor		Room	000 External/Fixtures
Location		Use	
Quantity sampled			
Material assessment			
Product type	()		
Damage/deterioration	()		
Surface treatment	()		
Asbestos type	Not asbestos (0)

No Asbestos Detected

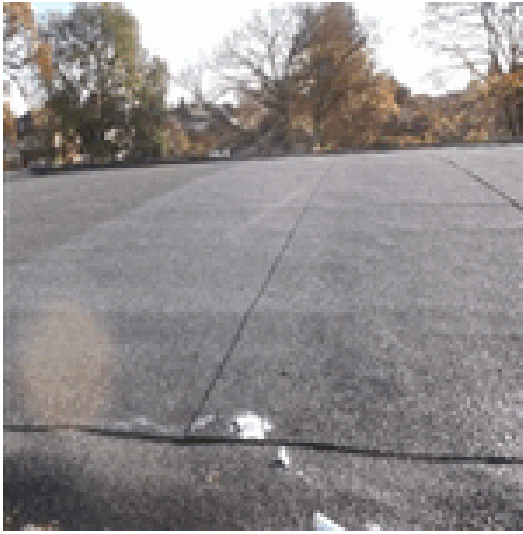
Reference	213	Sample number	01038-01-500-91
Survey date	17-Jul-17	Presumed	No
Building :	01 00 Main School		
Floor		Room	000 External/Fixtures
Location			
Quantity sampled		Use	
Material assessment			
Product type	()		
Damage/deterioration	()		
Surface treatment	()		
Asbestos type	Not asbestos (0)

No Asbestos Detected

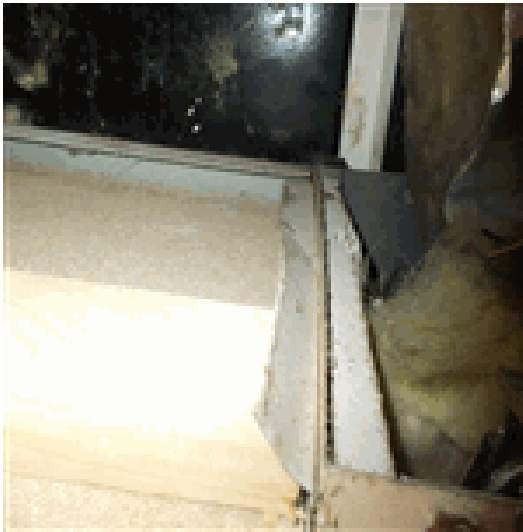
Reference	214	Sample number	01038-01-37-101
Survey date	17-Jul-17	Presumed	No
Building :	01 00 Main School		
Floor	G	Room	037 Classroom
Location			
Quantity sampled		Use	
Material assessment			
Product type	()		
Damage/deterioration	()		
Surface treatment	()		
Asbestos type	Not asbestos (0)

No Asbestos Detected

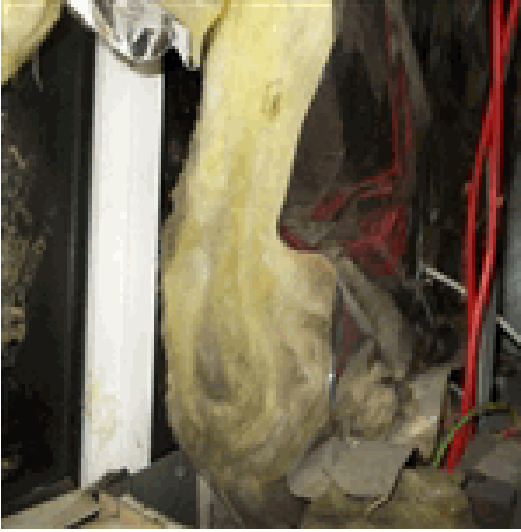
Reference 215 Sample number 01038-01-37-102
Survey date 17-Jul-17 Presumed No

Building : 01 00 Main School
Floor G Room 037 Classroom
Location
Quantity sampled Use

Material assessment
Product type ()
Damage/deterioration ()
Surface treatment ()
Asbestos type Not asbestos (0)

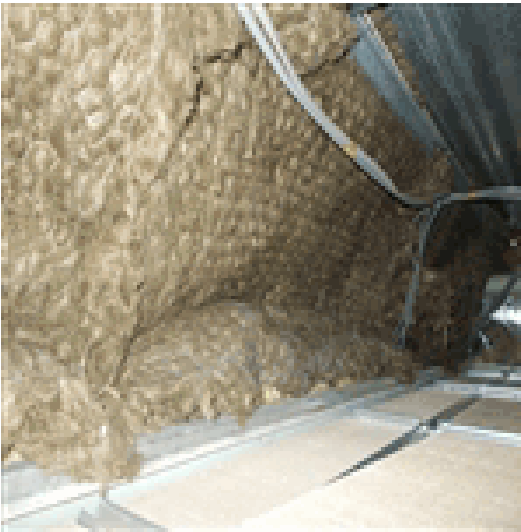
Reference 216 Sample number 01038-01-37-103
Survey date 17-Jul-17 Presumed No

Building : 01 00 Main School
Floor G Room 037 Classroom
Location
Quantity sampled Use

Material assessment
Product type ()
Damage/deterioration ()
Surface treatment ()
Asbestos type Not asbestos (0)

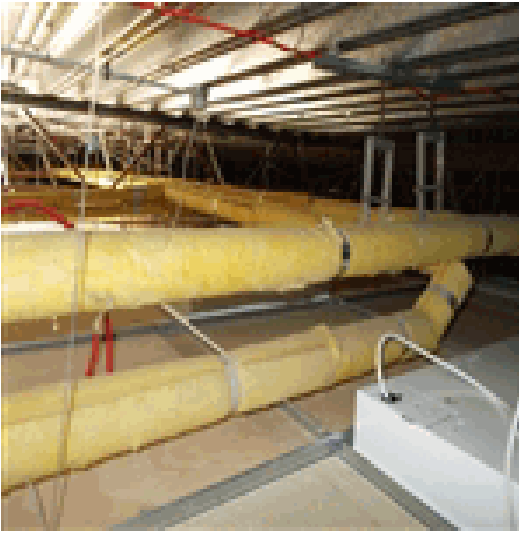
Reference 217 Sample number 01038-01-41-104
Survey date 17-Jul-17 Presumed No

Building : 01 00 Main School
Floor G Room 041 Quiet room
Location
Quantity sampled Use

Material assessment
Product type ()
Damage/deterioration ()
Surface treatment ()
Asbestos type Not asbestos (0)

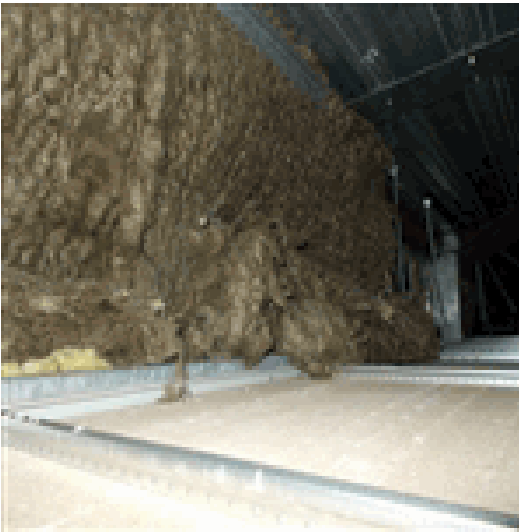
Reference 218 Sample number 01038-01-39-105
Survey date 17-Jul-17 Presumed No

Building : 01 00 Main School
Floor G Room 039 Quiet room
Location
Quantity sampled Use

Material assessment
Product type ()
Damage/deterioration ()
Surface treatment ()
Asbestos type Not asbestos (0)

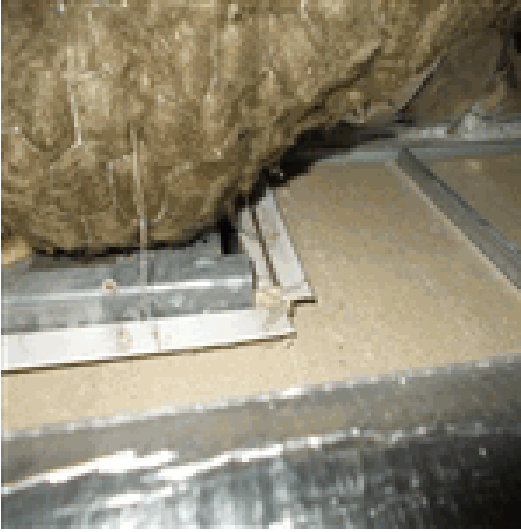
Reference 219 Sample number 01038-01-39-106
Survey date 17-Jul-17 Presumed No

Building : 01 00 Main School
Floor G Room 039 Quiet room
Location
Quantity sampled Use

Product type ()
Damage/deterioration ()
Surface treatment ()
Asbestos type Not asbestos (0)

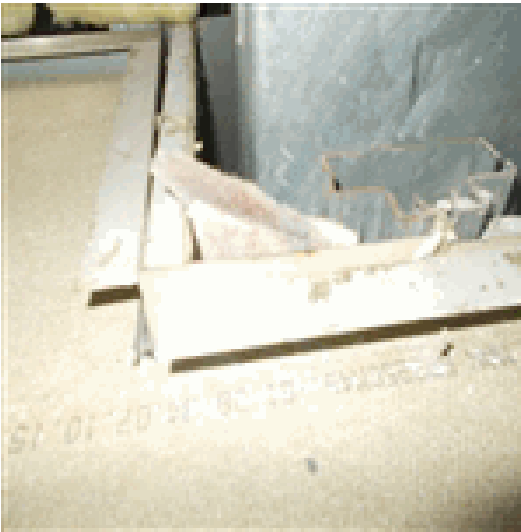
Reference 220 Sample number 01038-01-34-107
Survey date 17-Jul-17 Presumed No

Building : 01 00 Main School
Floor Room 034 Circulation
Location
Quantity sampled Use

Product type ()
Damage/deterioration ()
Surface treatment ()
Asbestos type Not asbestos (0)

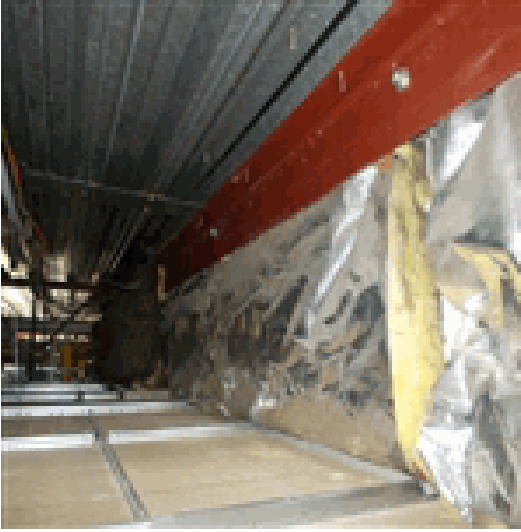
Reference 221 Sample number 01038-01-34-108
Survey date 17-Jul-17 Presumed No

Building : 01 00 Main School
Floor Room 034 Circulation
Location
Quantity sampled Use

Material assessment
Product type ()
Damage/deterioration ()
Surface treatment ()
Asbestos type Not asbestos (0)

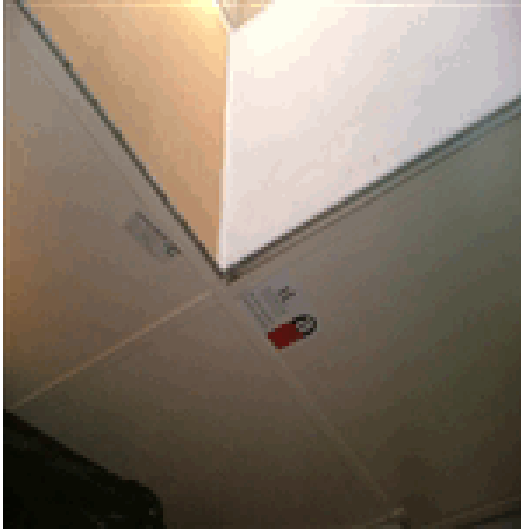
Reference	86	Sample number	01038-50-04-04
Survey date	17-Jul-17	Presumed	No
Building :	50 00 Catering Services		
Floor		Room	004 Kitchen
Location	CEILING TILES, UPRISER		
Quantity sampled	8M2	Use	Asbestos Insulating Board

Product type	AIB, Textiles, Rope, etc (see Use) (2)
Damage/deterioration	Good condition (0)
Surface treatment	Enc Lagging&Sprays, AIB, etc (1)
Asbestos type	Amphibole ex. Crocidolite (2)

Amosite asbestos

Monitor & Manage

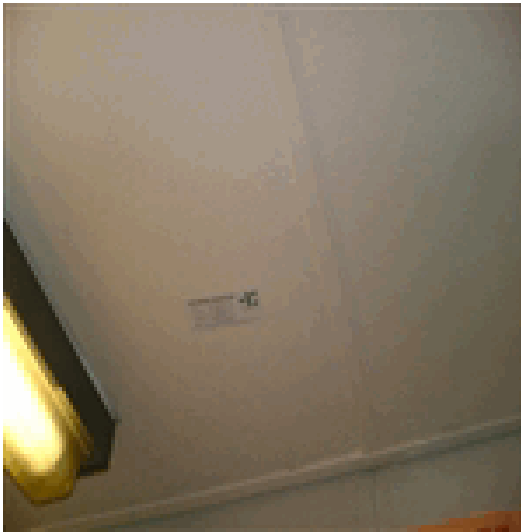
Reference	87	Sample number	01038-50-03-03
Survey date	17-Jul-17	Presumed	No
Building :	50 00 Catering Services		
Floor		Room	003 Office
Location	CEILING TILES		
Quantity sampled	6M2	Use	Asbestos Insulating Board

Product type	AIB, Textiles, Rope, etc (see Use) (2)
Damage/deterioration	Good condition (0)
Surface treatment	Enc Lagging&Sprays, AIB, etc (1)
Asbestos type	Amphibole ex. Crocidolite (2)

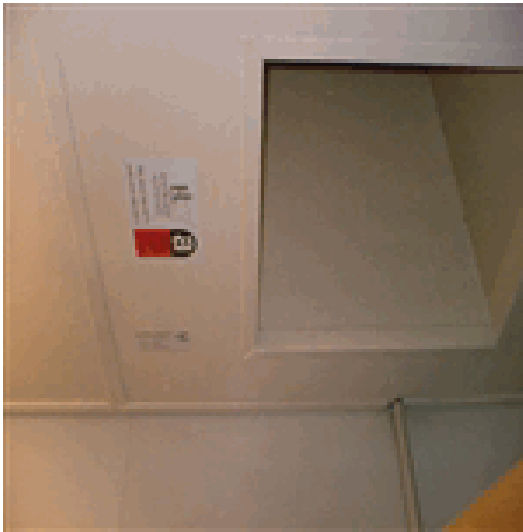
Reference **89** Sample number **01038-50-02-02**
 Survey date **17-Jul-17** Presumed **No**
 Building : **50 00 Catering Services**
 Floor Room 002 Staff WC
 Location CEILING TILES, UPRISER
 Quantity sampled 6M2 Use Asbestos Insulating Board

Product type AIB, Textiles, Rope, etc (see Use) (2)
 Damage/deterioration Good condition (0)
 Surface treatment Enc Lagging & Sprays, AIB, etc (1)
 Asbestos type Amphibole ex. Crocidolite (2)

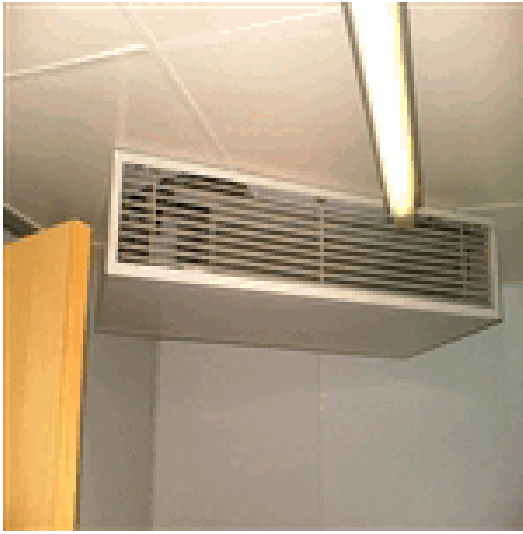
Reference	90	Sample number	01038-50-01-P01
Survey date	17-Jul-17	Presumed	No
Building :	50 00 Catering Services		
Floor	G	Room	001 Kitchen
Location	CEILING MOUNTED		
Quantity sampled	1 NO	Use	Asbestos Insulating Board

Product type	AIB, Textiles, Rope, etc (see Use) (2)
Damage/deterioration	High damage (3)
Surface treatment	Unsealed AIB, enc Lagging & Spray (2)
Asbestos type	Crocidolite (3)

Material score	10
Priority score	7
Banding	Removed

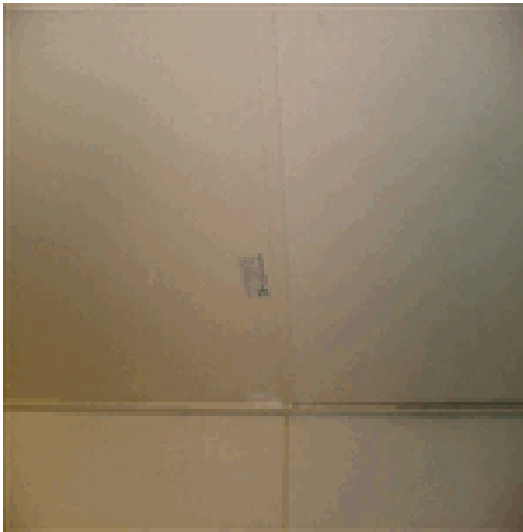
Reference	91	Sample number	01038-50-01-01
Survey date	17-Jul-17	Presumed	No
Building :	50 00 Catering Services		
Floor	G	Room	001 Kitchen
Location	CEILING TILES		
Quantity sampled	50M2	Use	Asbestos Insulating Board

Product type	AIB, Textiles, Rope, etc (see Use) (2)
Damage/deterioration	Good condition (0)
Surface treatment	Enc Lagging & Sprays, AIB, etc (1)
Asbestos type	Amphibole ex. Crocidolite (2)

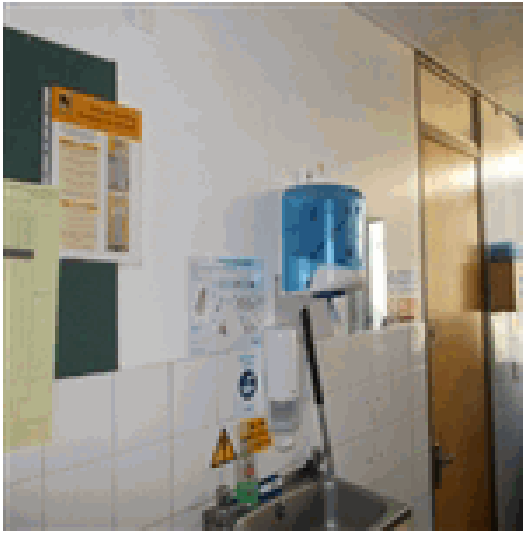
Reference 170 Sample number 01038-50-01-51v
Survey date 17-Jul-17 Presumed No

Building : 50 00 Catering Services
Floor G Room 001 Kitchen
Location
Quantity sampled Use

Material assessment
Product type ()
Damage/deterioration ()
Surface treatment ()
Asbestos type Not asbestos (0)

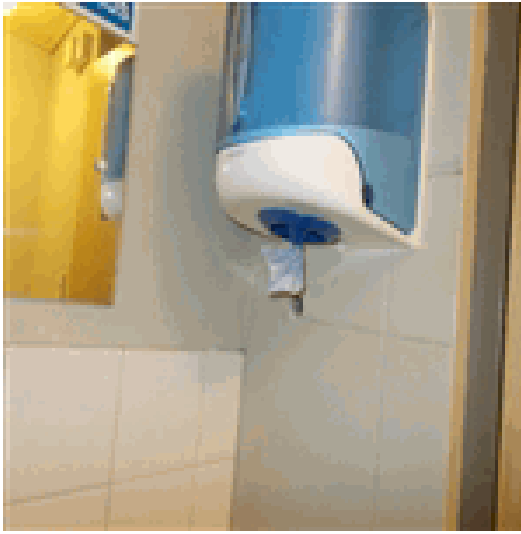
Reference 172 Sample number 01038-50-02-53v
Survey date 17-Jul-17 Presumed No

Building : 50 00 Catering Services
Floor Room 002 Staff WC
Location
Quantity sampled Use

Material assessment
Product type ()
Damage/deterioration ()
Surface treatment ()
Asbestos type Not asbestos (0)

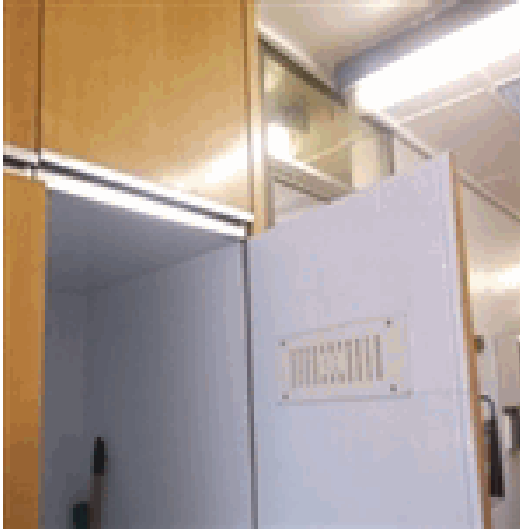
Reference	174	Sample number	01038-50-01-51
Survey date	17-Jul-17	Presumed	No
Building :	50 00 Catering Services		
Floor	G	Room	001 Kitchen
Location			
Quantity sampled	<10m2	Use	Asbestos Insulating Board

Product type	AIB, Textiles, Rope, etc (0)
Damage/deterioration	Low damage (1)
Surface treatment	Unsealed AIB, enc Lagging & Spray (0)
Asbestos type	Amphibole ex. Crocidolite (2)

Priority score 4

Banding **Removed**

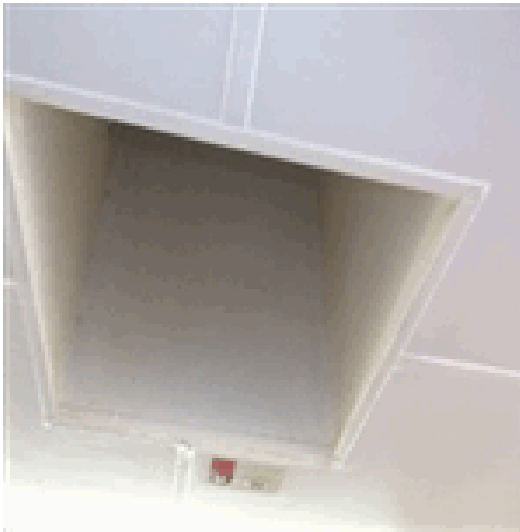
Reference	175	Sample number	01038-50-01-52
Survey date	17-Jul-17	Presumed	No
Building :	50 00 Catering Services		
Floor	G	Room	001 Kitchen
Location			
Quantity sampled	<10m2	Use	Asbestos Insulating Board

Product type	AIB, Textiles, Rope, etc (0)
Damage/deterioration	Low damage (1)
Surface treatment	Unsealed AIB, enc Lagging & Spray (0)
Asbestos type	Amphibole ex. Crocidolite (2)

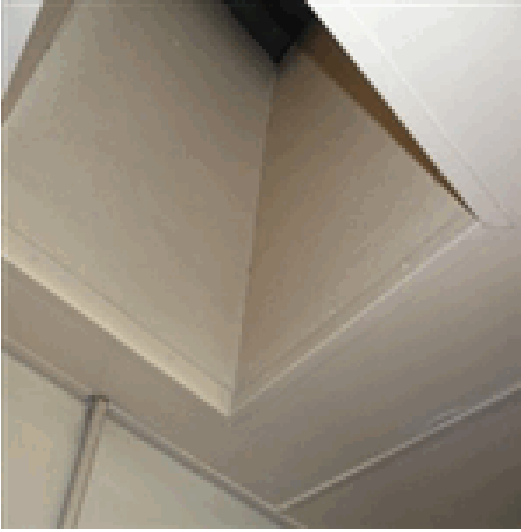
Reference	176	Sample number	01038-50-02-53	
Survey date	17-Jul-17	Presumed	No	
Building :	50 00 Catering Services			
Floor		Room	002 Staff WC	
Location				
Quantity sampled	<10m2	Use	Asbestos Insulating Board	
Material assessment				
Product type	AIB,Textiles,Rope,etc (0)			
Damage/deterioration	Low damage (1)			
Surface treatment	Unsealed AIB,enc Lagging&Spray (0)			
Asbestos type	Amphibole ex. Crocidolite,Chrysotile (2)			
Priority assessment				
Type of activity	()			
Location	Rooms up to 100m2 (2)			
Accessibility	Usually inaccessible/unlikely (0)			
Extent	<10m2 or 10m pipe run (1)			
Occupants using space	1 to 3 (1)			
Frequency of use	Daily (3)			
Average time of use	<1 hour (0)		Material score	3
Type of maintenance	Minor disturbance (0)		Priority score	
Frequency of maintenance	ACM unlikely to be disturbed (0)		Banding

Monitor & Manage

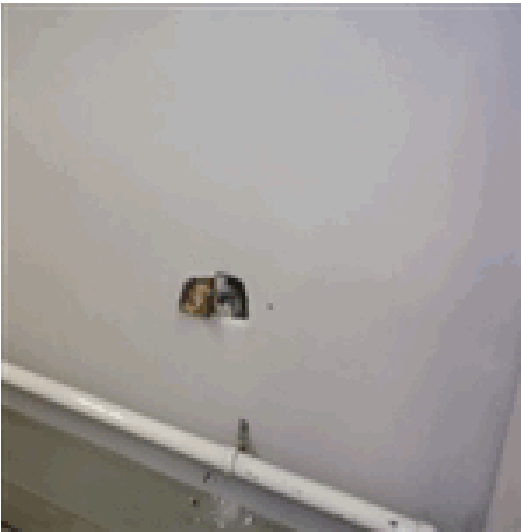
Reference	177	Sample number	01038-50-01-54
Survey date	17-Jul-17	Presumed	No
Building :	50 00 Catering Services		
Floor	G	Room	001 Kitchen
Location			
Quantity sampled		Use	
Material assessment			
Product type	()		
Damage/deterioration	()		
Surface treatment	()		
Asbestos type	Not asbestos (0)

No Asbestos Detected
