## **APPENDIX A**

### **SECTION 19 REPORT – BURTON JOYCE – STORM HENK, JANUARY 2024**

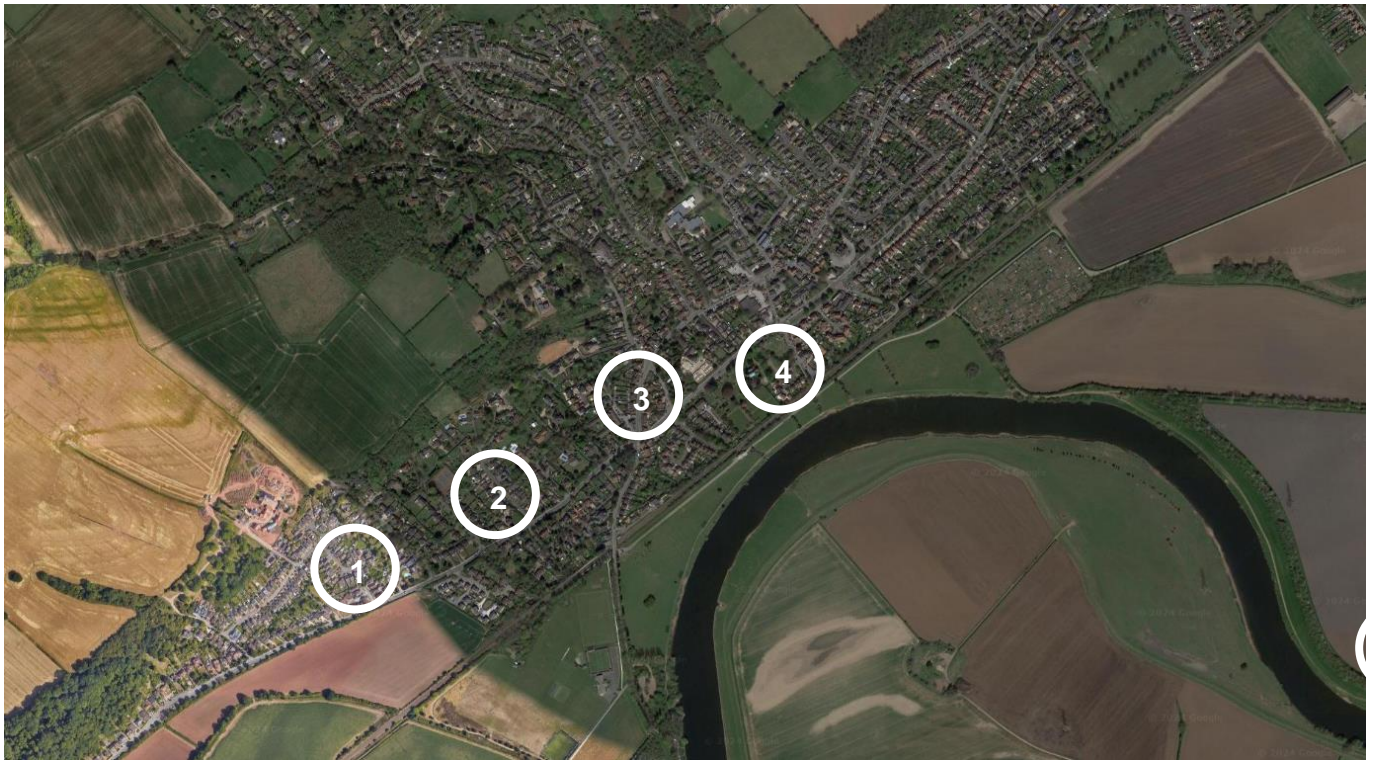
10. A location map of Burton Joyce is shown in Figure 2. The areas affected were:
  - Nottingham Road (4 properties)
  - Cragmoor Road (1 property)
  - Main Street (1 property)
  - Chestnut Grove (4 properties)

**Figure 2.** Reference Map for flood affected areas across Burton Joyce. Nottingham Road (1), Cragmoor Road (2), Main Street (3), Chestnut Grove (4).

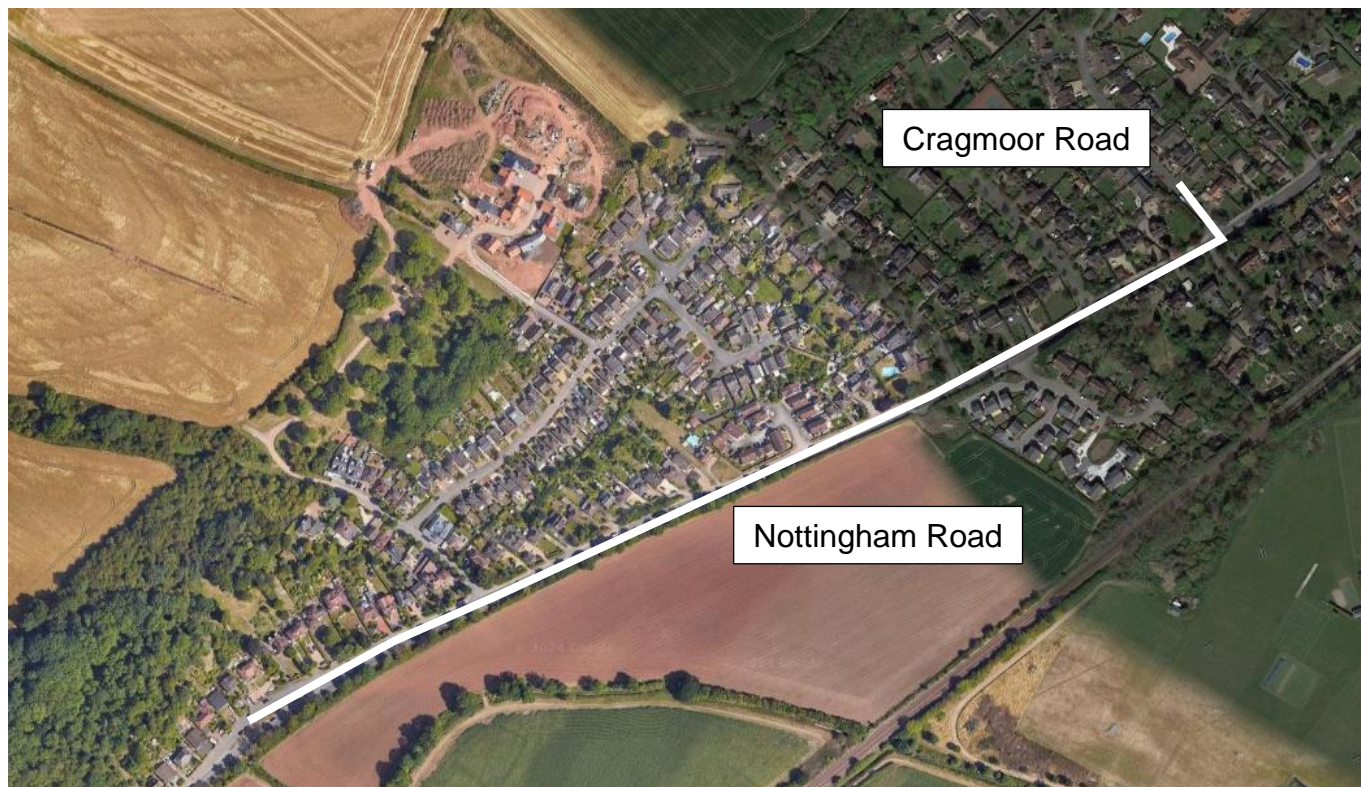
11. Areas impacted by flooding on Nottingham Road and Cragmoor Road are shown in Figure 4. In total, 4 residential properties were impacted by internal flooding on Nottingham Road with 1 impacted on Cragmoor Road. Many other properties suffered external flooding in this area during Storm Henk.

12. Three watercourses exist in this area; one flowing from the north along Whitworth Drive, another originating north of Woodside Road and a third originating from north of Crow Park Drive. These three watercourses become culverted as they enter the village, with the Woodside Road and Crow Park Drive watercourses ultimately flowing through the STW surface water sewers within the village. During Storm Henk, upper catchment runoff influenced by rainfall onto an already saturated catchment caused all three watercourses to exceed the capacity of the downstream culverts, with water then flowing along the adjacent roads/gardens. At Whitworth Drive, water flowed eastwards along Nottingham Road which caused highway flooding and consequent issues for vehicles, but was not found to directly cause internal property flooding. The watercourse originating from the north of Crow Park drive caused some external flooding locally.

13. Following the flooding, investigations by NCC and STW have found that the watercourse originating from the north of Woodside Road had been misconnected into the STW combined sewer system which caused the system to surcharge onto Woodside Road and Nottingham Road. This may have contributed to the flooding on Nottingham Road and further along the combined sewer system at Cragmoor Road. It should be noted that the misconnection has now been resolved, with NCC and STW monitoring for any flooding occurrences in the area.

**Figure 4.** View of Nottingham Road and Cragmoor Road.

26. Investigations by NCC and STW on the flooding issues originating from the watercourse north of Woodside Road have been undertaken with the misconnection now resolved. NCC and STW are monitoring the flooding situation.

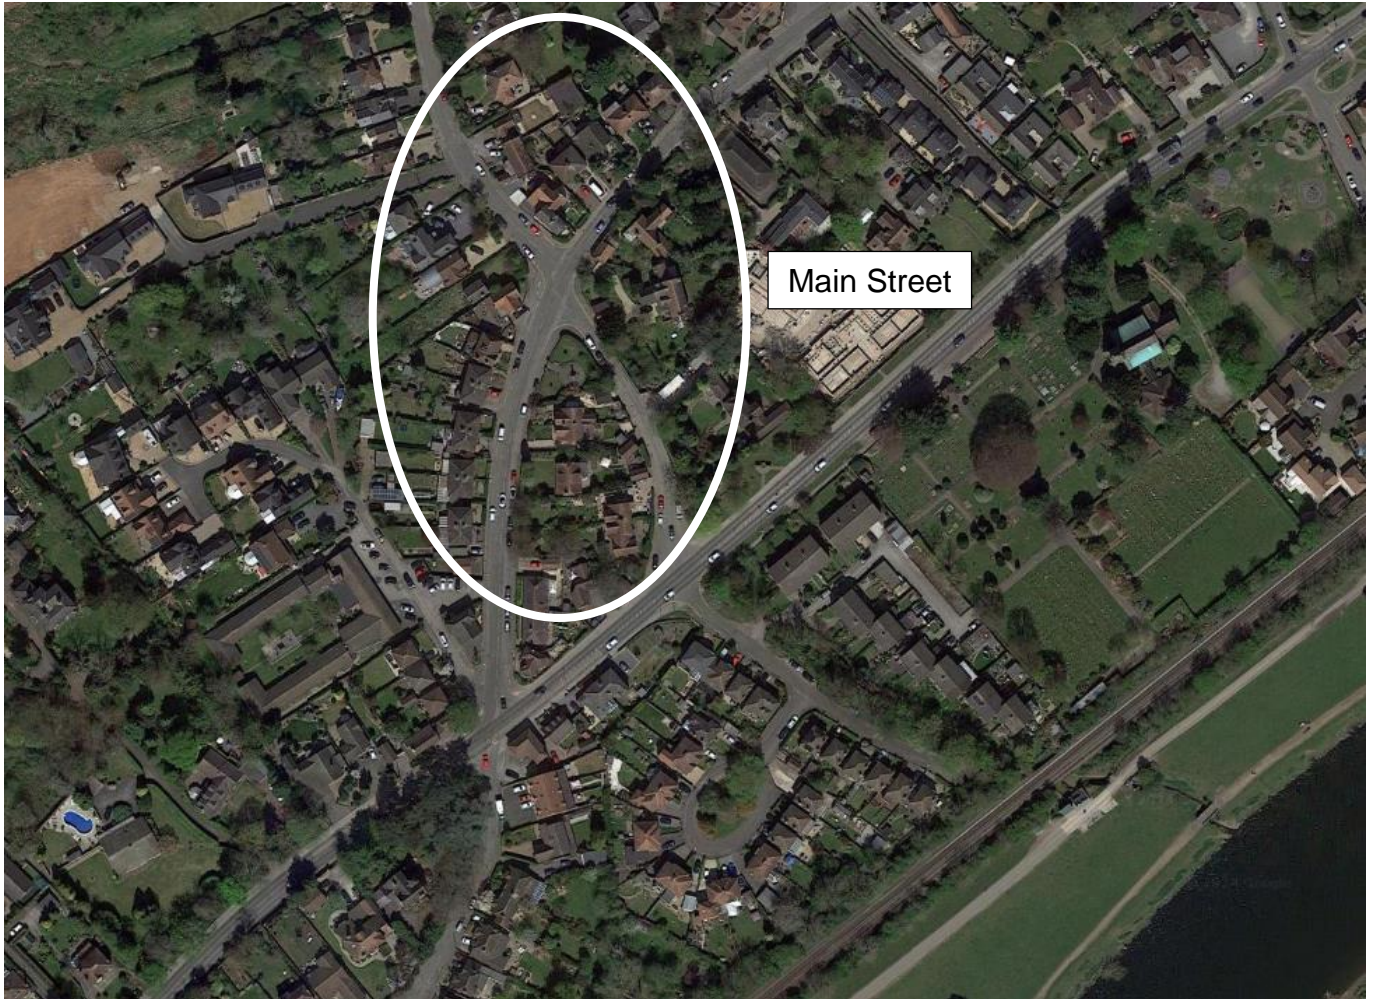
14. On Main Street, 1 residential property was internally flooded by water from the Crock Dumble which has its upper catchment in the north of the village (Figure 5). The Dumble it culverted under the village itself with the Main Street culvert identified as a pinch point for conveyance. Due to persistent rainfall over a saturated catchment, the Crock Dumble exceeded its channel capacity with water flooding Main Street and a property. Although the road was closed by the Burton Joyce Flood signage scheme wardens, residents local to this area stated that vehicles traveling through the floodwater created bow waves which exacerbated the flooding.

**Figure 5.** *View of Main Street.*

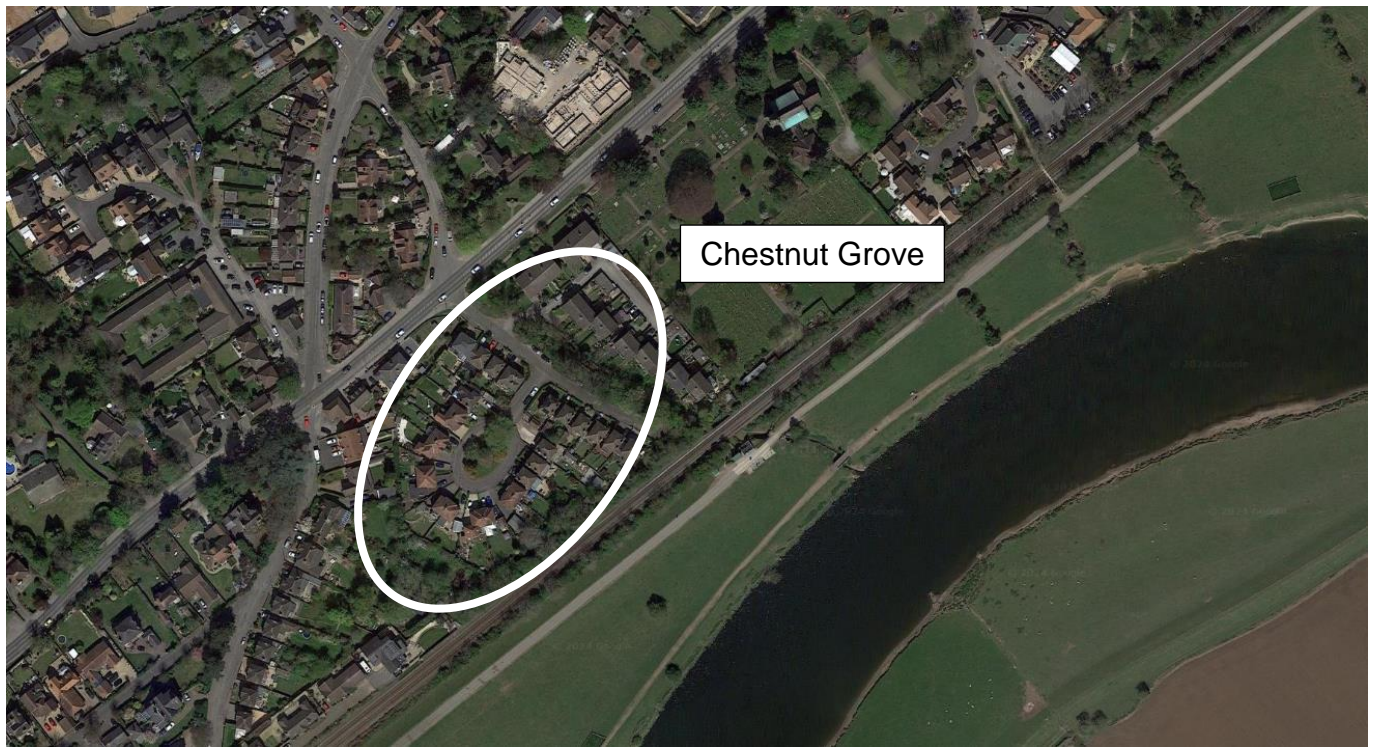
15. Four residential properties suffered internal flooding on Chestnut Grove (Figure 6) due to surcharging of the sewer system. Investigations by STW into the causes of sewer flooding in this area are still ongoing at the time of writing (May 2024).

**Figure 6.** View of Chestnut Grove.
