APPENDIX A

SECTION 19 REPORT – OLLERTON – 16 AUGUST 2020

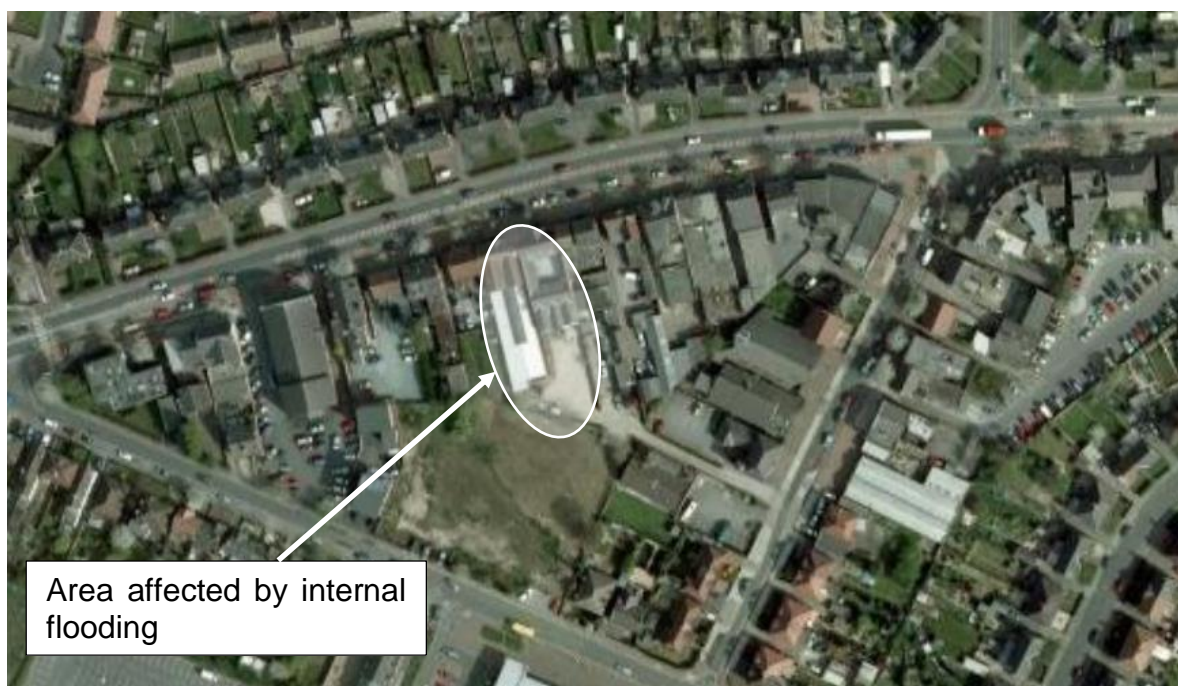
Figure 2. Plan highlighting area affected by internal flooding.

7. The internal flooding was very isolated in nature with 5 adjacent businesses affected. Investigations showed that excessive surface water entered the businesses from the rear doors, adjacent to a small, privately owned car park. Discussions with business owners that were on site at the time of flooding concluded that the cause of the flooding must have been a very isolated downpour that resulted in water running off the carpark and into the businesses. Figures 3-5 below show further detail of the flooding for reference.

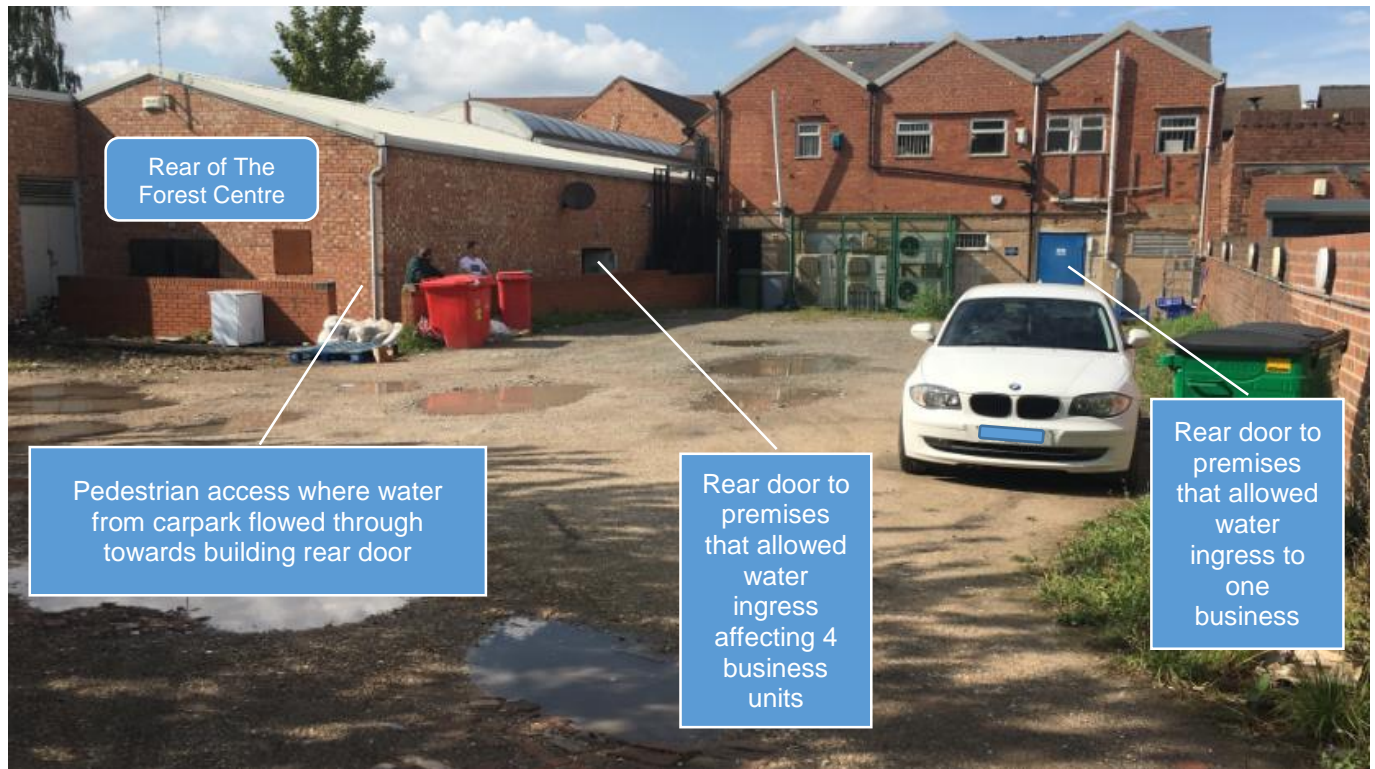
Figure 3. Photo showing flood entry points (taken at rear of The Forest Centre shopping arcade).

10. This was a very isolated flooding incident and onsite investigations concluded that it was the result of a heavy localised rainfall event falling onto a privately-owned semi-permeable surface with no other obvious contributing factors. There was no evidence or suggestions that any flood water came from the public highway network.

12. Provision of Property Flood Resilience measures will be considered for the affected properties as part of the Authority's Property Flood Resilience project. Initial contact with property owners to discuss the options is scheduled for November.

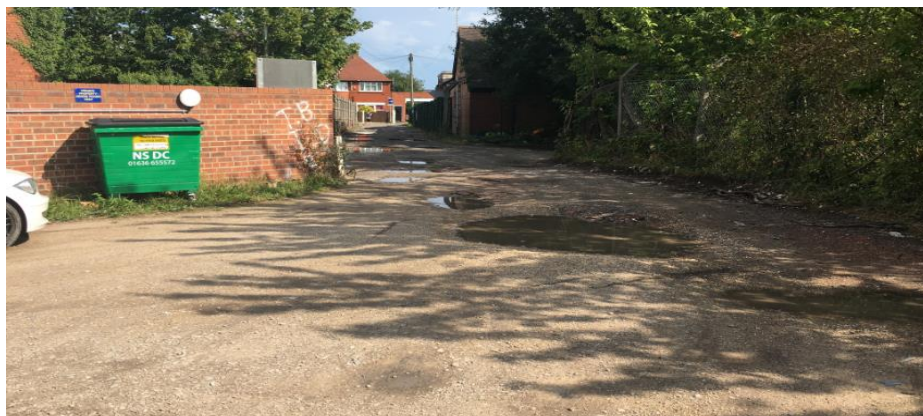
Figure 4. Photo showing carpark and access to rear of affected businesses.

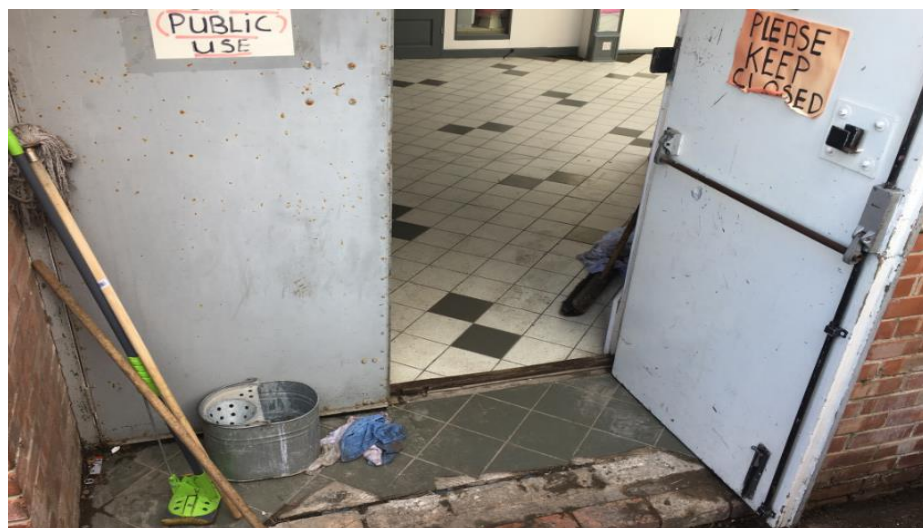
Figure 5. Photo showing rear access to The Forest Centre shopping arcade where flood water entered the building.
