## APPENDIX A

### SECTION 19 REPORT – BURTON JOYCE – STORM HENK, JANUARY 2024

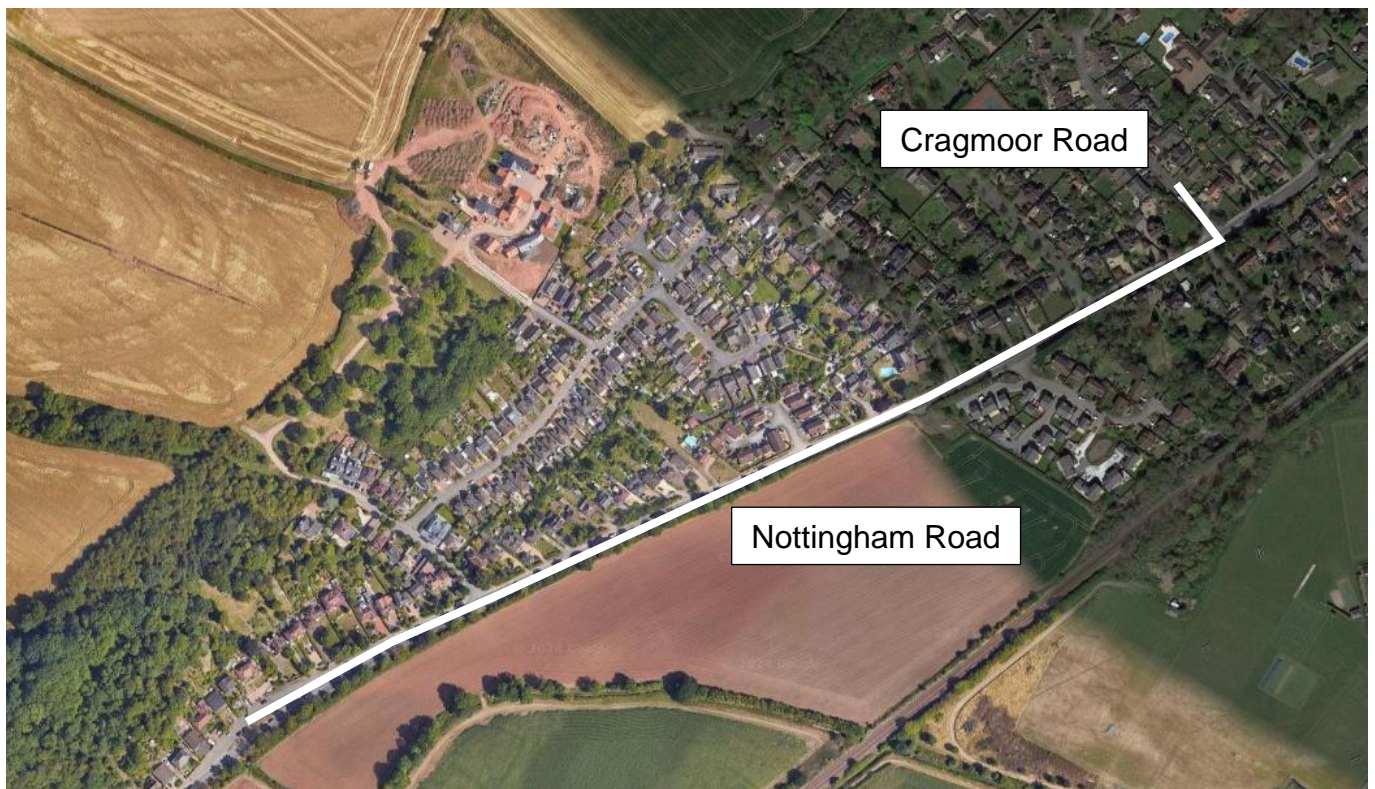
11. Areas impacted by flooding on Nottingham Road and Cragmoor Road are shown in Figure 4. In total, 4 residential properties were impacted by internal flooding on Nottingham Road with 1 impacted on Cragmoor Road. Many other properties suffered external flooding in this area during Storm Henk.

12. Three watercourses exist in this area; one flowing from the north along Whitworth Drive, another originating north of Woodside Road and a third originating from north of Crow Park Drive. These three watercourses become culverted as they enter the village, with the Woodside Road and Crow Park Drive watercourses ultimately flowing through the STW surface water sewers within the village. During Storm Henk, upper catchment runoff influenced by rainfall onto an already saturated catchment caused all three watercourses to exceed the capacity of the downstream culverts, with water then flowing along the adjacent roads/gardens. At Whitworth Drive, water flowed eastwards along Nottingham Road which caused highway flooding and consequent issues for vehicles, but was not found to directly cause internal property flooding. The watercourse originating from the north of Crow Park drive caused some external flooding locally.

13. Following the flooding, investigations by NCC and STW have found that the watercourse originating from the north of Woodside Road had an unauthorised connection into the STW combined sewer system which caused the system to surcharge onto Woodside Road and Nottingham Road. This may have contributed to the flooding on Nottingham Road and further along the combined sewer system at Cragmoor Road. It should be noted it should be noted that STW have stopped water entering the combined system through the unauthorised connection, with NCC and STW monitoring for any flooding occurrences in the area.

**Figure 4.** View of Nottingham Road and Cragmoor Road.

26. Investigations by NCC and STW on the flooding issues originating from the watercourse north of Woodside Road have been undertaken with the misconnection now resolved. NCC and STW are monitoring the flooding situation.

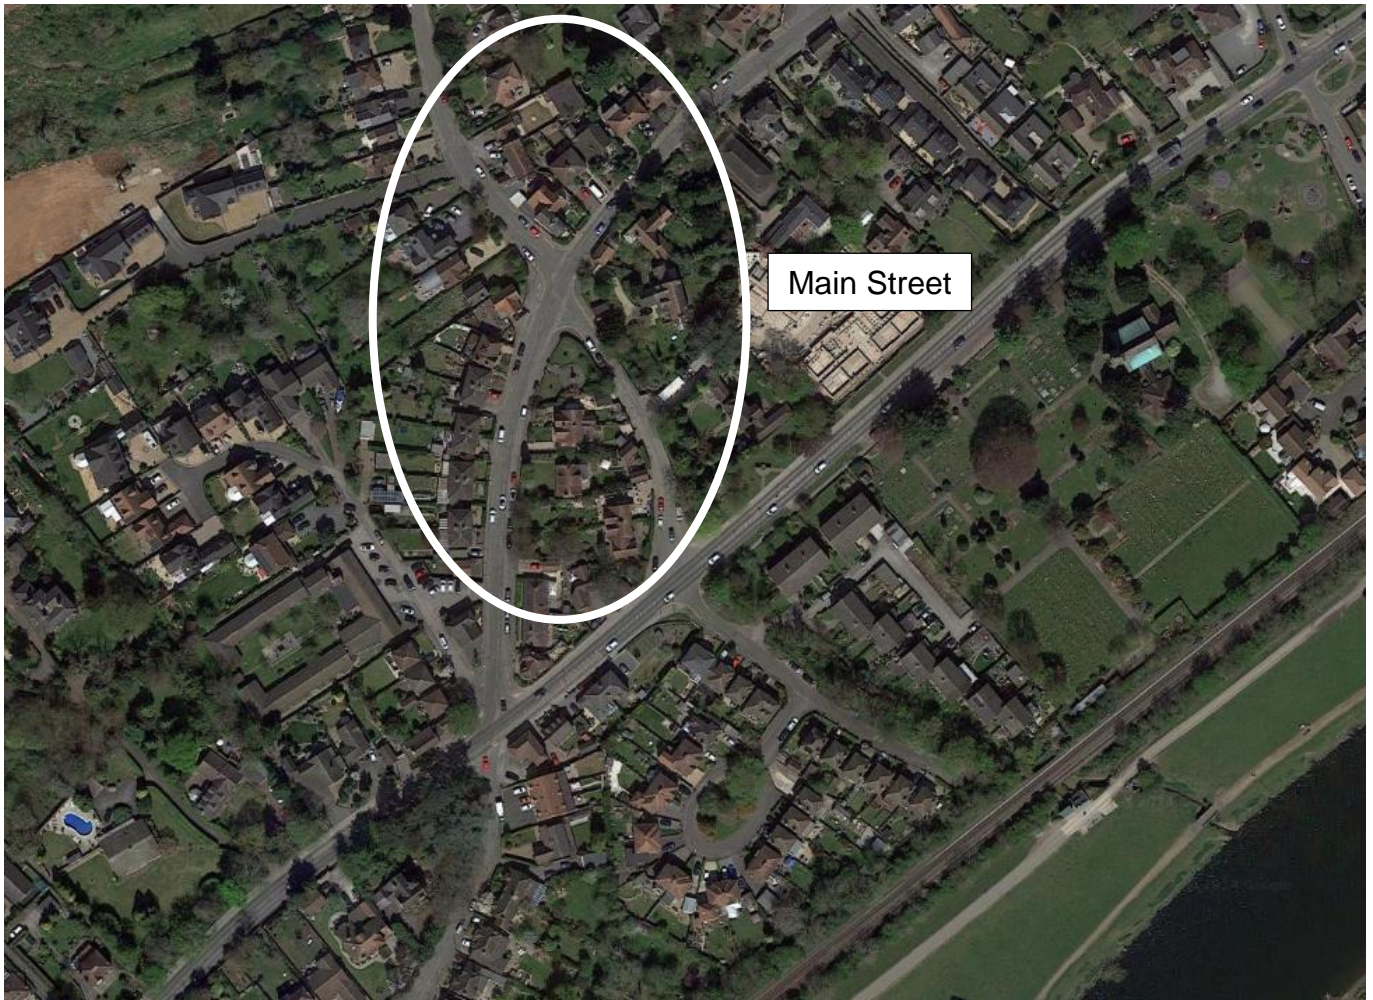
14. On Main Street, 1 residential property was internally flooded by water from the Crock Dumble which has its upper catchment in the north of the village (Figure 5). The Dumble it culverted under the village itself with the Main Street culvert identified as a pinch point for conveyance. Due to persistent rainfall over a saturated catchment, the Crock Dumble exceeded its channel capacity with water flooding Main Street and a property. Although the road was closed by the Burton Joyce Flood signage scheme wardens, residents local to this area stated that vehicles traveling through the floodwater created bow waves which exacerbated the flooding.

**Figure 5.** *View of Main Street.*
