Chestnut Grove Level Crossing – s118A Application Form

Additional Information

The following relates to section (h) of the s118A application form regarding reasons for the proposed extinguishment of the rail crossing.

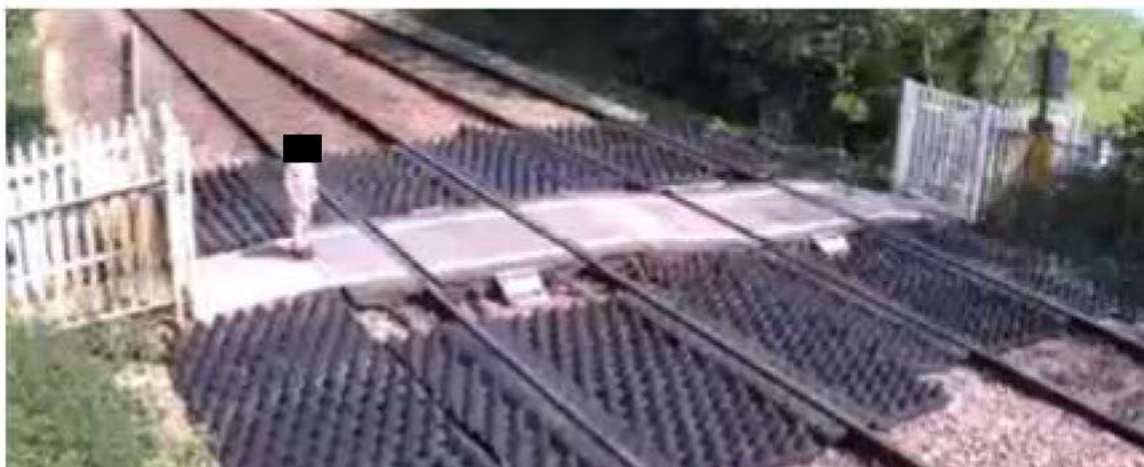
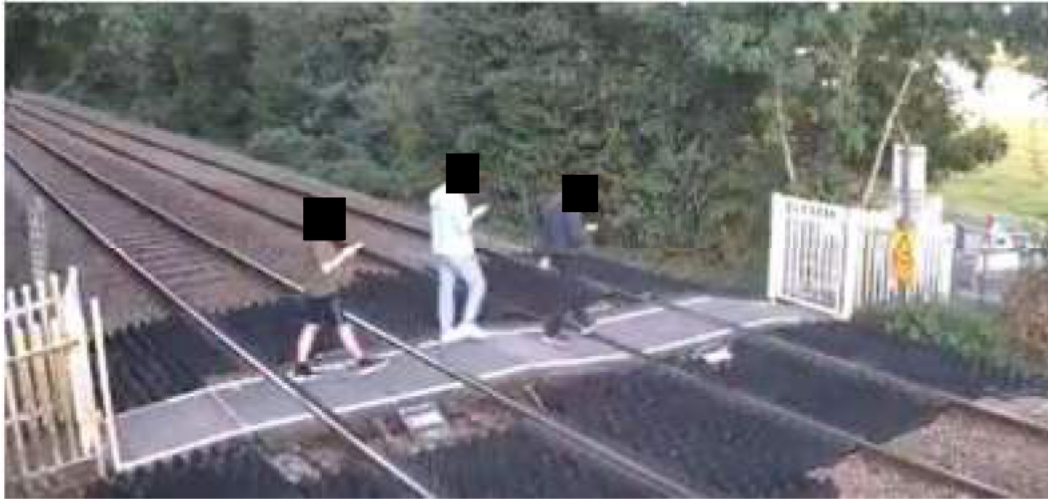
The CCTV camera footage has shown countless examples of misuse at the crossing. Some examples of this include:

- a) a couple taking pictures on a chair in the 6 foot (between the two lines of rail)
- b) children walking over the railway looking at phones and not looking for approaching trains either prior to crossing or while crossing
- c) Multiple examples of people stopping to take photographs of the railway with their back to trains
- d) A young child (2/3 years old approx.) allowed to loiter on the crossing less than 1m from the running rail while the accompanying adult was some distance away.
- e) Examples of people taking selfies on the live railway
